Rocky Mountain Research Station Science You Can Use **Bulletin**

NOV/DEC 2021 | Issue 51

Forests, Fire, and Faucets: What We Are Learning About Linger Water Quality Effects of High-Severity Wildfires

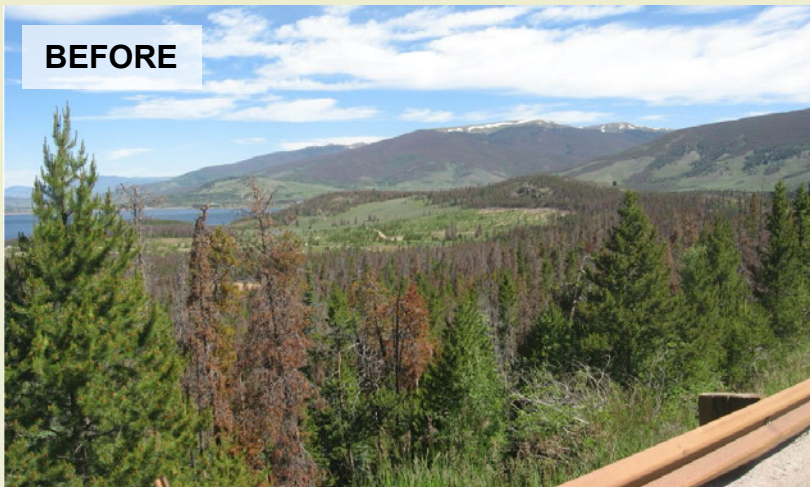
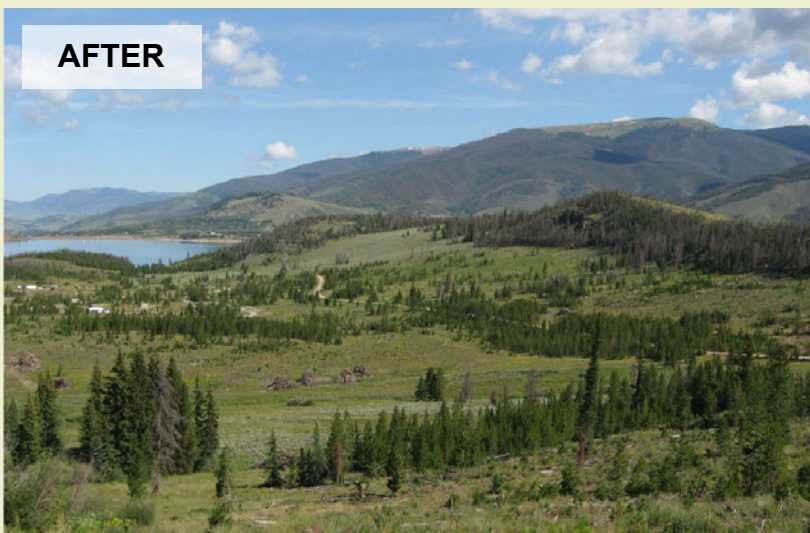
Before and after photos of a 98-acre treatment near Dillon Reservoir under the From Forests to Faucets program. Photo courtesy of Denver Water.

The aim of the partnership is to restore watersheds through large-scale planting in burned areas as well as improving watershed resilience through proactive forest fuel treatments, using prescribed fire and thinning, to prevent or mitigate the effects of large-scale fires. Since 2010, From Forests to Faucets funding has paid for forest treatments across more than 100,000 acres, including planting more than a million new trees in burned areas within priority watersheds.

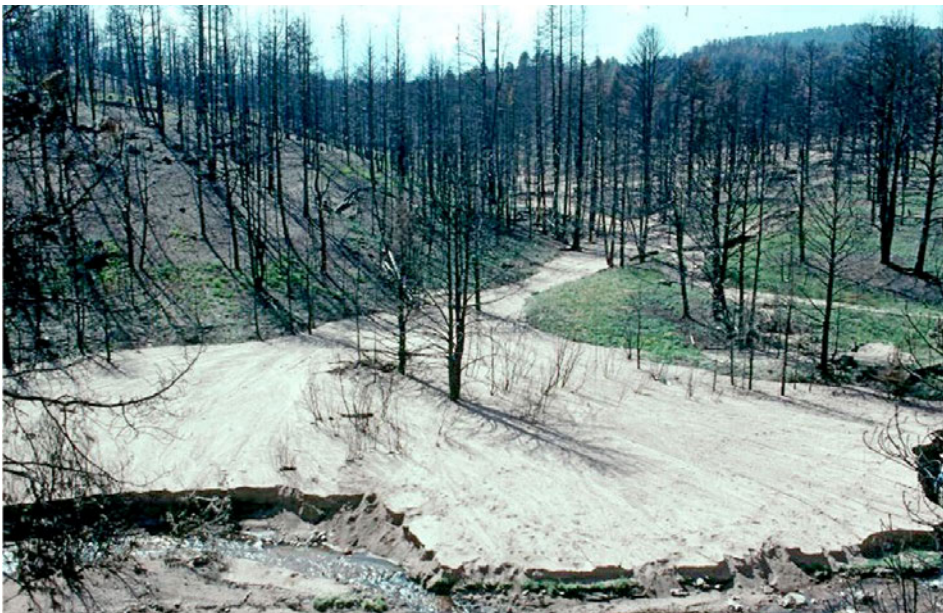
Sedimentation after the 1996 Buffalo Creek Fire. Photo courtesy of Denver Water.

The 1996 Buffalo Creek Fire is a prime example of how sediment can disrupt water storage after a fire. The intense fire scorched 12,000 acres of forest in the South Platte River watershed. Less than two months after the fire, flash flooding sent an estimated 160,000 cubic yards of debris and sediment—equal to 17,000 dump truck loads—into Strontia Springs Reservoir. Similar flash flooding occurred six years later when the Hayman Fire burned 138,000 acres around Cheesman Reservoir. Denver Water spent more than \$28 million to repair infrastructure, remove sediment, and restore forests in the Buffalo Creek and Hayman burn areas. This work was not immediately after the fire; it happened over a number of years. However, Denver Water still is incurring recovery costs today.

Christina Burri, a watershed scientist with Denver Water, said that sedimentation related to the Buffalo Creek and Hayman fires is still a significant problem for the reservoirs in the South Platte watershed.
