General Technical
Report RM-182

Improving Southwestern Riparian Areas Through Watershed Management

Leonard F. DeBano and Larry J. Schmidt

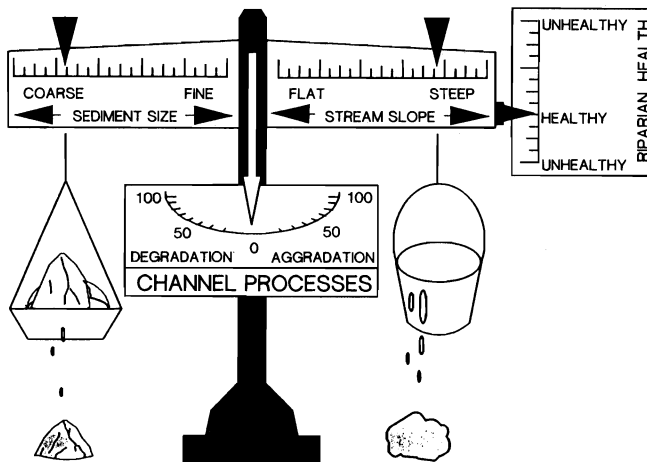
Figure 1.—Healthy riparian areas depend upon a dynamic equilibrium between channel aggradation and degradation processes. The equilibrium illustrated oscillates both in time and space throughout the channel network. The channel network adjusts in form and slope to handle increased storm flows with limited perturbation of channel and associated riparian plant community.

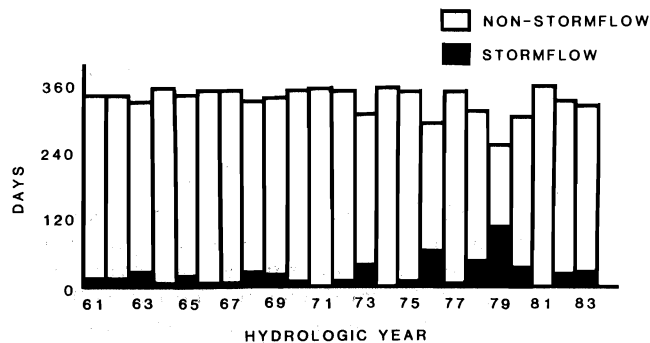
Figure 11.—The number of days per year of storm and nonstorm flow through Whitlow Dam, 1961-1983 (Szaro and DeBano 1985).

improved moisture relations and site fertility. Temporary impoundment of water in the reservoir charges both trapped sediment and surrounding reservoir banks with water, which provides nonstorm streamflow for a large part of the year. A hydrologic analysis of the inflow records for the dam over time since its construction in 1960 showed that, had the dam not been present, the channel reach would have only been wetted during stormflows an average of 24 days per year between 1960 and 1983 (fig. 11). In contrast, outflow records indicated that after construction, streamflow occurred about 340 days annually (fig. 11).
