# Interagency Aviation Accident Prevention Bulletin

**No. IAAPB 16-02**

**Subject:** Plastic Sphere Dispensers (PSD)

**Area of Concern:** PSD Jamming

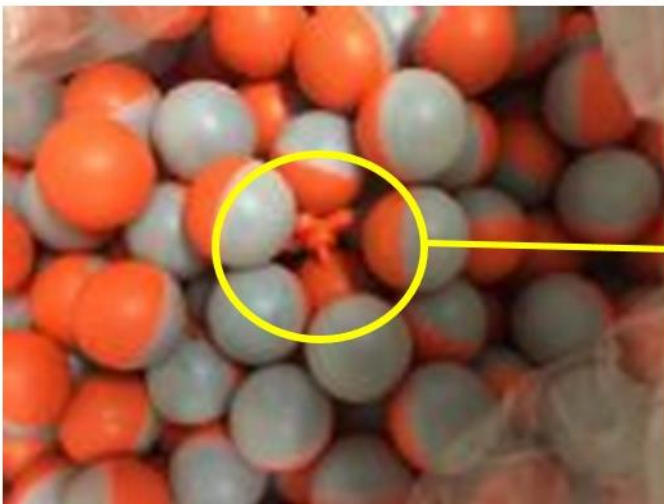
**Figure 1. Aerial Ignition Plastic Spheres**

After approximately 1000 plastic spheres, the prescribed burn machine operator went to fill the machine with more spheres. As she was pouring the spheres into the hopper, she saw a piece of orange plastic fall in with the spheres and subsequently removed it from the hopper (Figures 1, 2). If the plastic piece had remained in the hopper and entered the machine, it could have jammed it or worse - caused a fire. The bags of spheres had been loaded the day prior to the burn and the spheres were stored in the original bags for an undetermined amount of time. The remaining bags were inspected for similar anomalies but none were discovered.

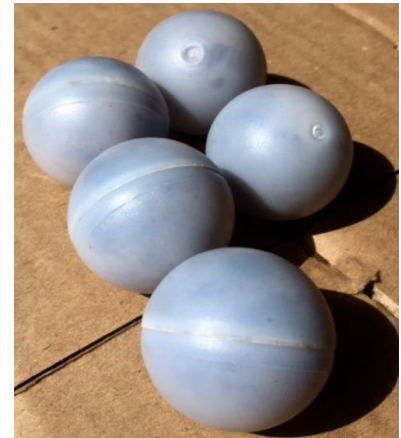
While conducting PSD operations, the aircrew encountered several episodes of PSD spheres cracking during the injection stage. After cracking, the PSD spheres became lodged in the slipper block of the PSD machine and blocked the hopper chute. After landing, the aircrew inspected the machine and discovered a large amount of potassium permanganate residue in and around the injection stage, caked on the needles, and in the exit chute. The needles were cleaned and sharpened but the aircrew continued to experience similar issues.

During a separate inspection of the plastic spheres, the crew discovered a raised seam around the middle that cracked when the needles punctured near that area, were darker in color, and contained residual powder clinging to the inner wall of the sphere. The crew compared these attributes with other successful operations where they used a different batch of plastic spheres that contained smooth seams, appeared light in color, and lacked any residual powder adhering to its inner walls. According to the aircrew, “it would increase safety on burn operations and decrease wear and tear on the machine if quality spheres were available.”. [SAFECOM 16-0292](#)
