# Recreation Management Tech Tips

February 2011

### All-Terrain and Utility Terrain Vehicle Safety: Alternative Vehicles for Towing Trail Grading Equipment

*By Ellen Eubanks, Landscape Architect*

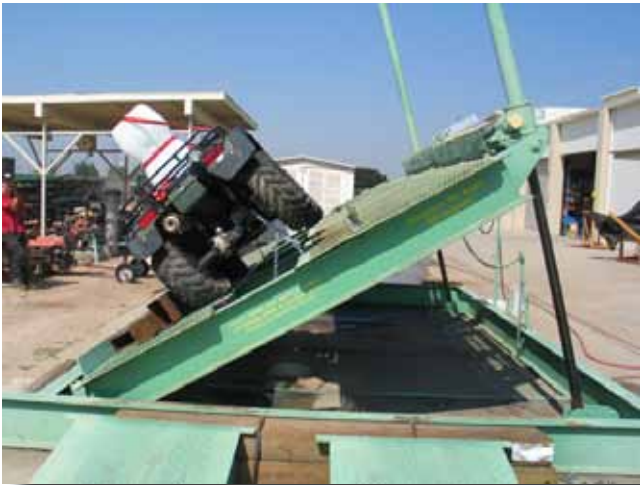
Figure 1—Tilt table shown at 40 degrees.

Each vehicle was tested on the SDTDC tilt table. We (SDTDC) conducted the tilt tests to determine the static-roll threshold of a vehicle. The angle at which the uphill tires lifted off the table's surface is the maximum angle of inclination (cross slope, hill climb) under static conditions. There is a strong relationship between the static-roll stability (determined by the tilt test) and the actual occurrence of rollovers in accidents (Winkler 2000). The SDTDC tilt table's maximum tilt is 40 degrees. See figure 1.

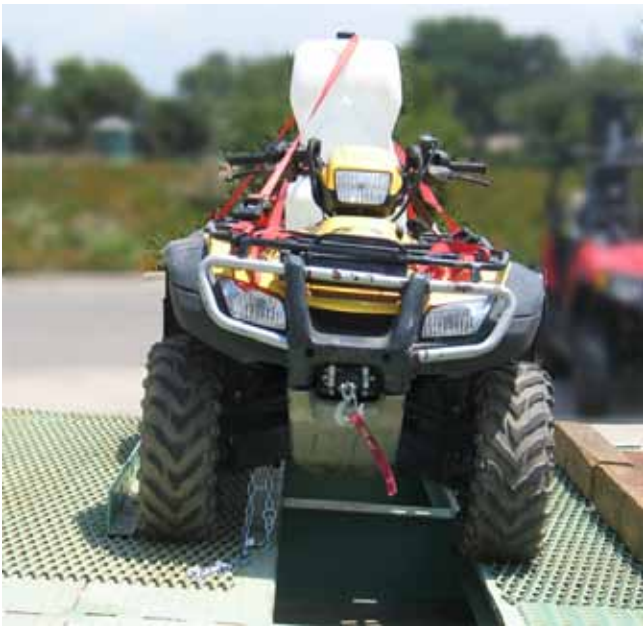
Figure A1—Foreman ES strapped and ready for the lateral test. There is a winch and a fire extinguisher on the front and a trailer hitch on the back that add weight.

Vehicles were secured to the tilt table by attaching chains loosely to the axles or, in the case of the RZR, to the front axle and to the trailer hitch. On the longitudinal test, the RZR was secured by a half-inch nylon rope.

A 175 pound, water-filled dummy was used to represent an average driver. It was strapped to the ATV seat. In the RZR, the dummy was secured by the seat belt. See figures A1 through A5.

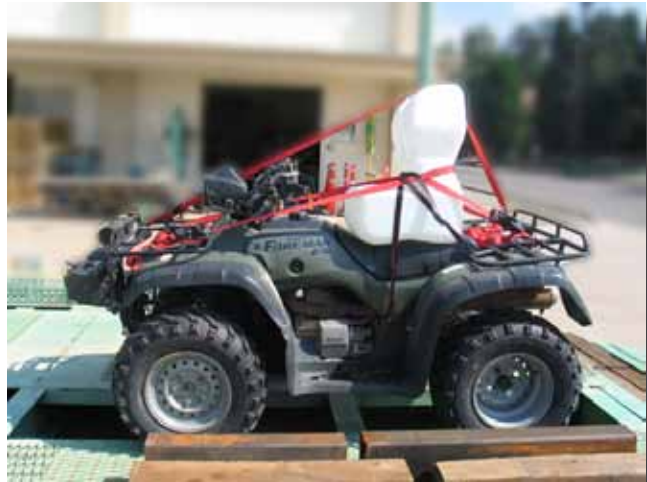
Figure A2—The Rubicon shown strapped during the lateral test. There is a winch on the front and a trailer hitch on the back that add weight.

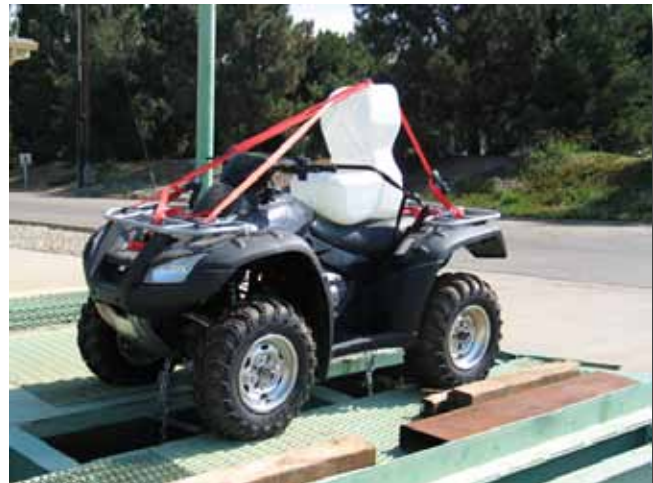
Figure A3—Rincon chained to the table for the lateral test.

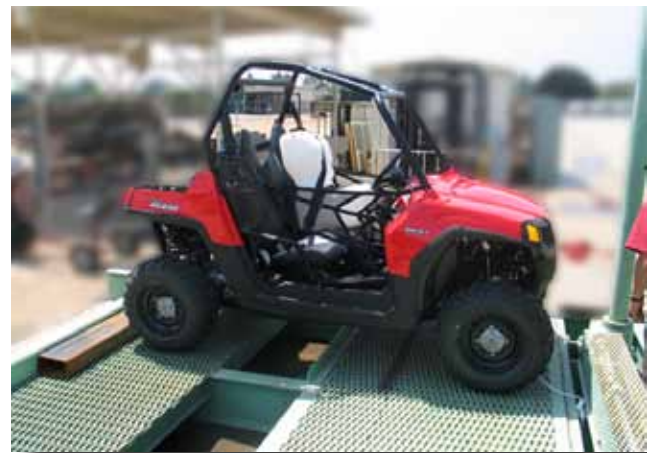
Figure A4—RZR with the dummy strapped in with a seat belt.

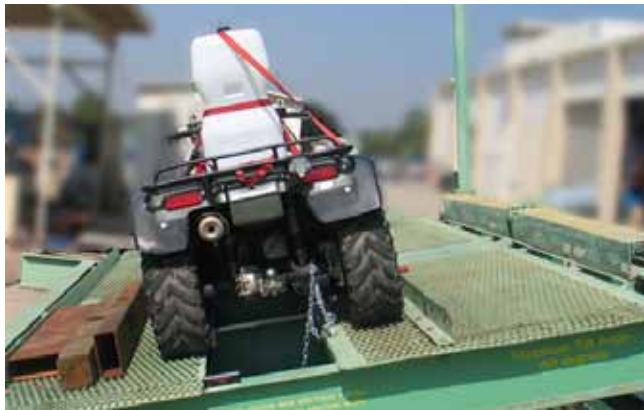
Figure A6—Some distortion in downhill tires on the Foreman ES.

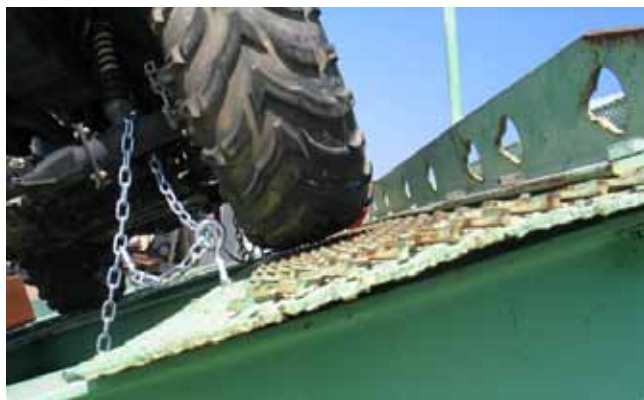
Figure A7—Foreman ES rear wheel lifted at 27.4 degrees.

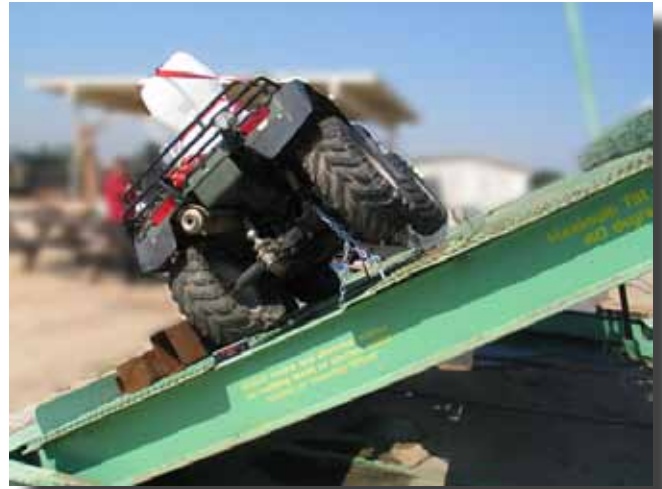
Figure A8—Foreman ES at rolling point, 30.9 degrees.

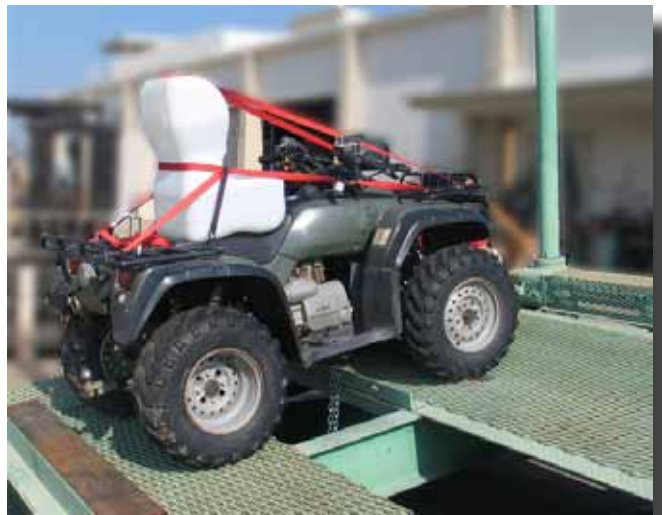
Figure A9—The Foreman ES beginning the longitudinal test. Notice that the rear tires are several inches from the blocks.

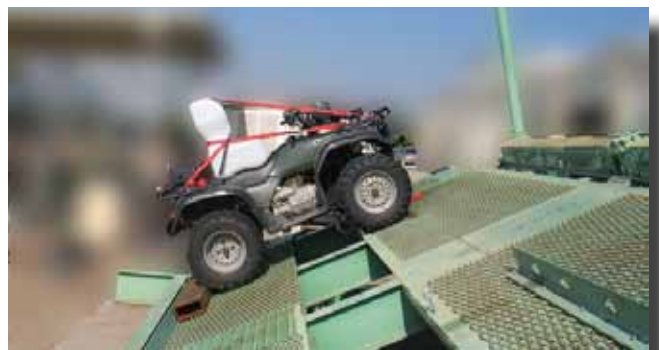
Figure A10—Because of the brakes releasing and catching, the Foreman ES's rear tires at the end of the test are on the blocks at 40 degrees.

\*\*\* In increments, brakes let go and grabbed.

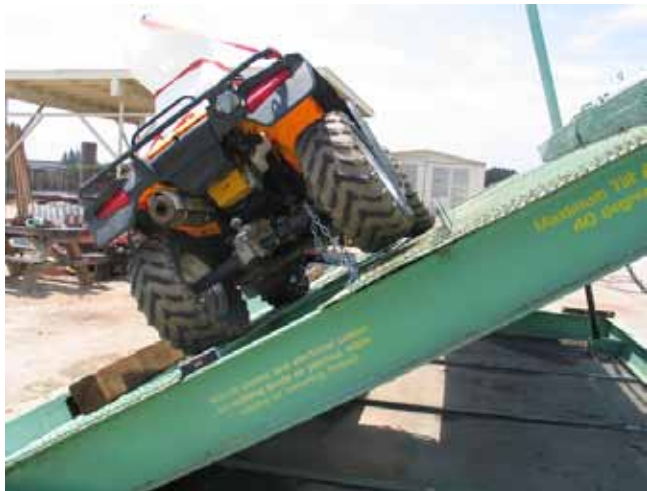
Figure A11—The Rubicon's rear wheel lifted at 27.5 degrees.

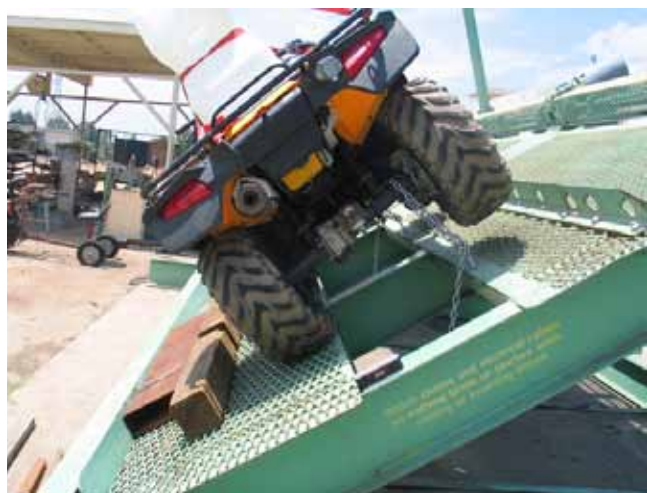
Figure A12—Rubicon ATV rolls at 34 degrees.

Statistics for the second tires are more interesting. The Rubicon rolled at the highest angle. The second tire lifted at 6.5 degrees higher than the first tire. The Foreman's second tire lifted at 3.5 degrees higher than the first tire, and the 2006/7 Rincon and RZR lifted at 2.2 and 2.1 degrees, respectively.

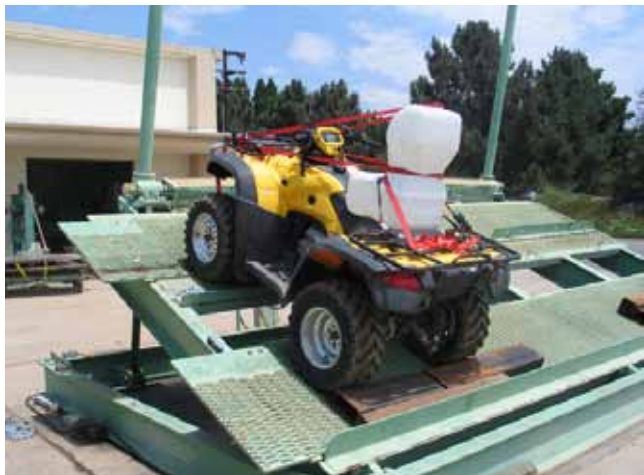
Figure A13—The Rubicon's rear tires on blocks at 19 degrees.

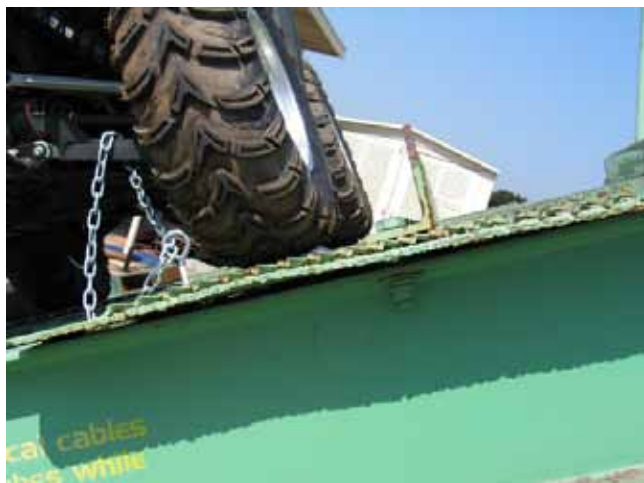
Figure A14—The Rincon front tire, in right portion of photograph, is barely off the table at 30.0 degrees.

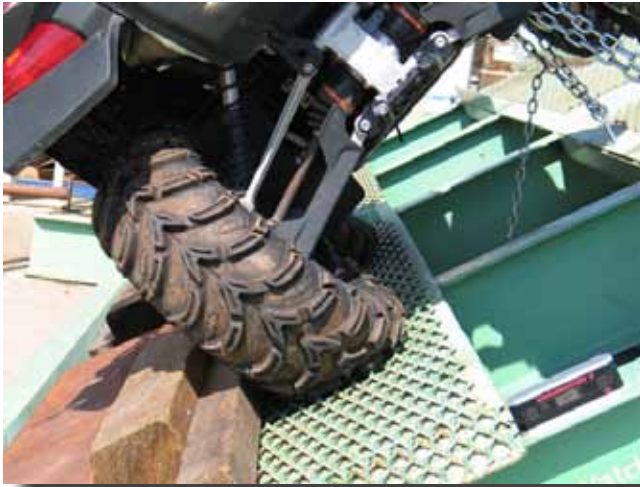
Figure A15—Notice tire distortion.

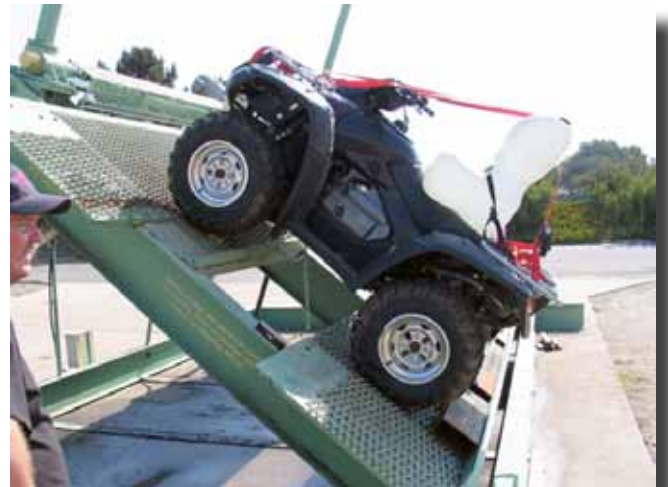
Figure A18—The Rincon tilted at 40 degrees.

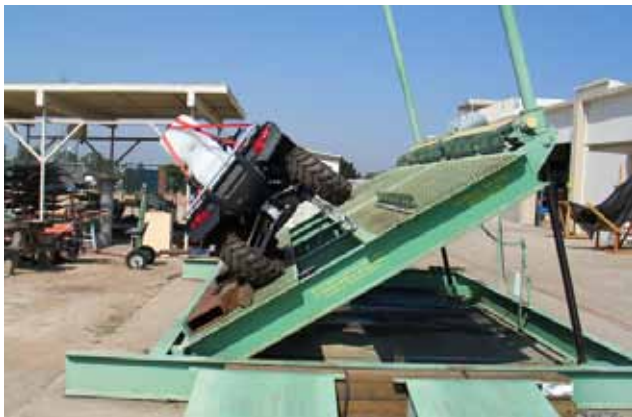
Figure A16—The Rincon rolls at 32.2 degrees.

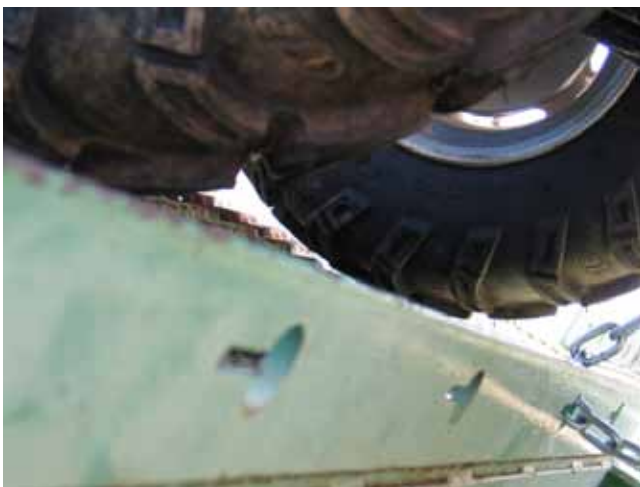
Figure A17—The right front tire lifted off at 39.5 degrees.

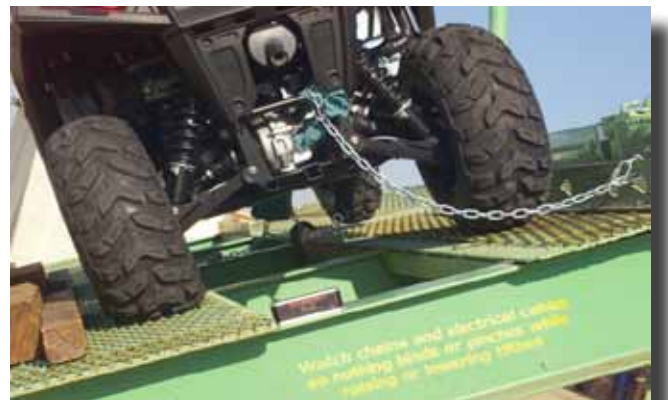
Figure A19—Front tire of the RZR is off the table at 30.8 degrees.

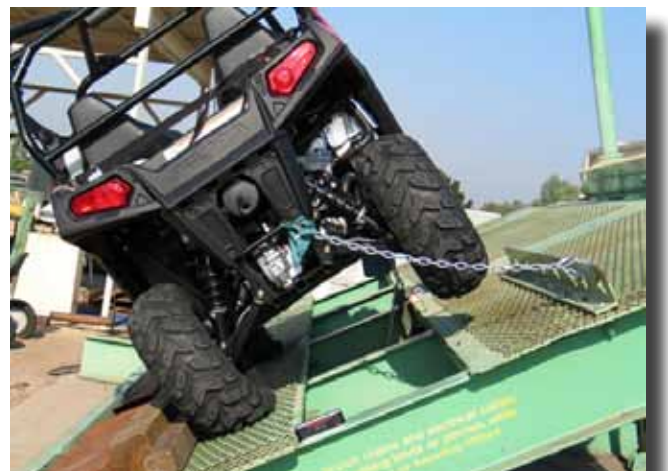
Figure A20—The RZR rolls at 32.9 degrees.

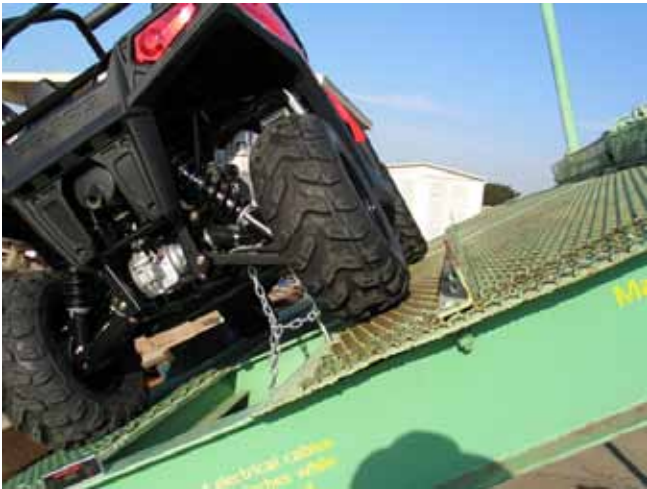
Figure A21—The right front tire lifted off at 30.8 degrees.

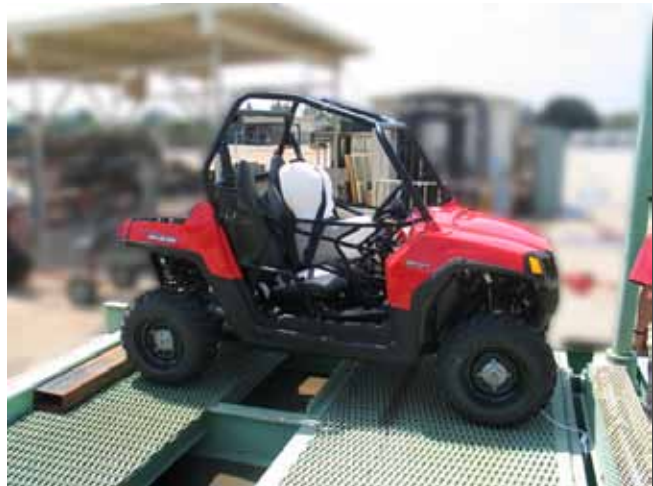
Figure A22—The RZR ready to begin the longitudinal test.

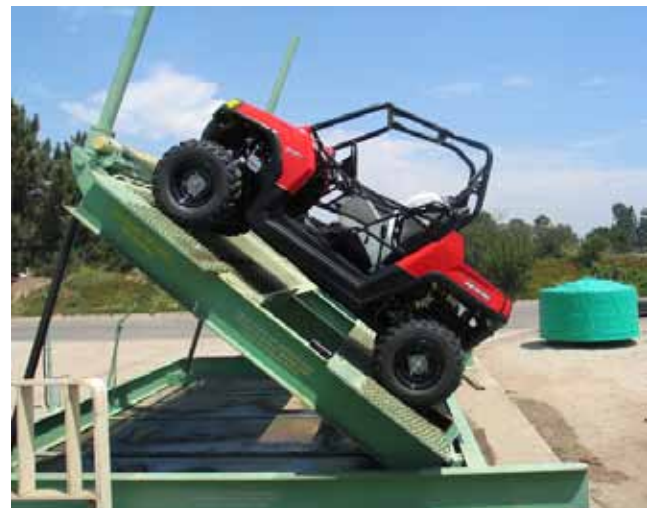
Figure A23—RZR at 40 degrees. Security ropes are still slack and RZR is on blocks.
