2300—Recreation Management
1123 1804—SDTDC
April 2011

Plastic Wood and Alternative Materials for Trail Structures

By
Martha Willbee, Outdoor Recreation Planner
Forest Service

San Dimas Technology & Development Center
San Dimas, CA

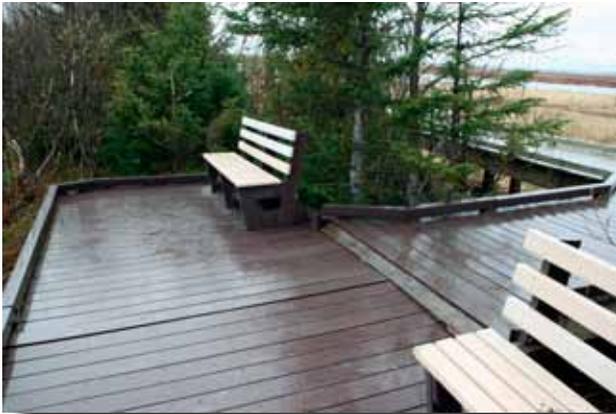
Figure 1—Recycled plastic lumber example.

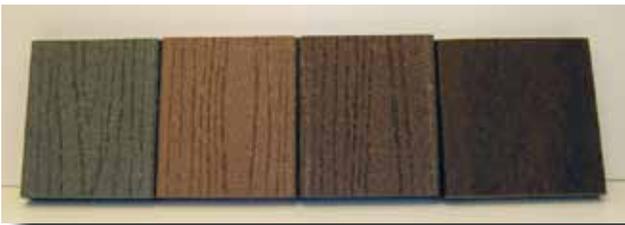
Figure 3—Wood composite example.

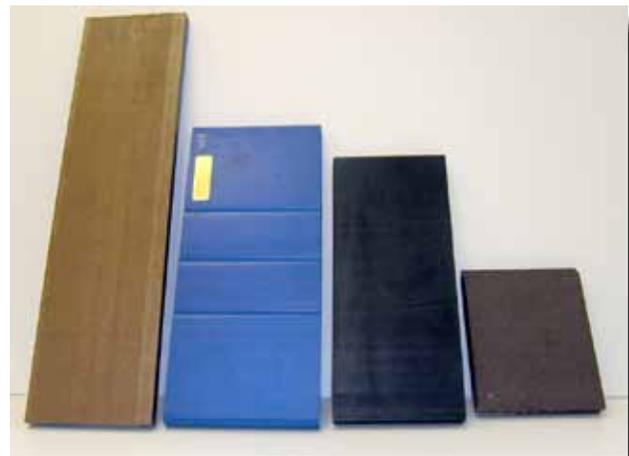
Figure 4—Fiberglass-reinforced plastic lumber example.

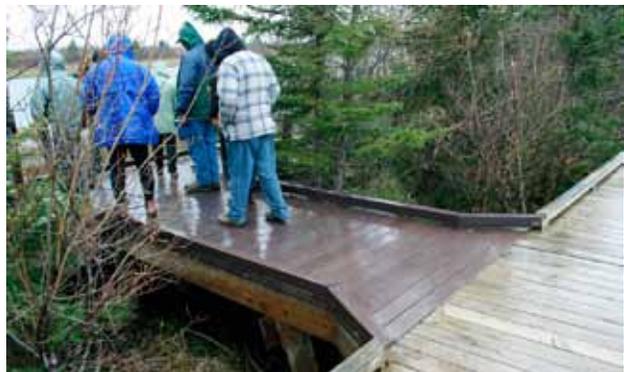
Figure 6—Alaska boardwalk shows a combination of plastic wood with natural wood.

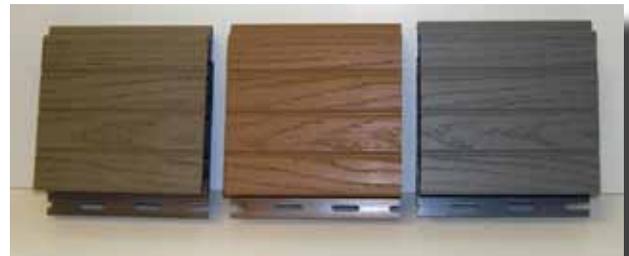
Figure 7—PVC lumber example.

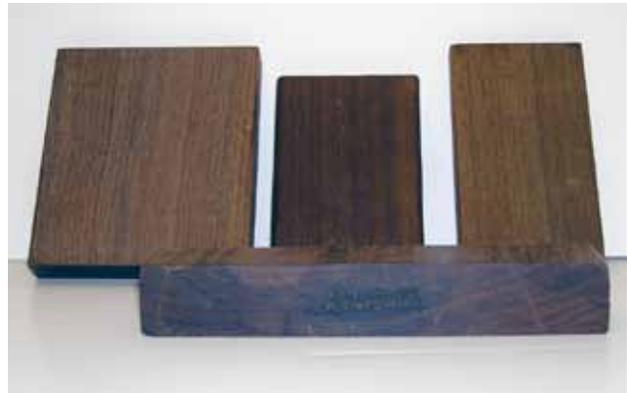
Figure 8—Ipe wood example.

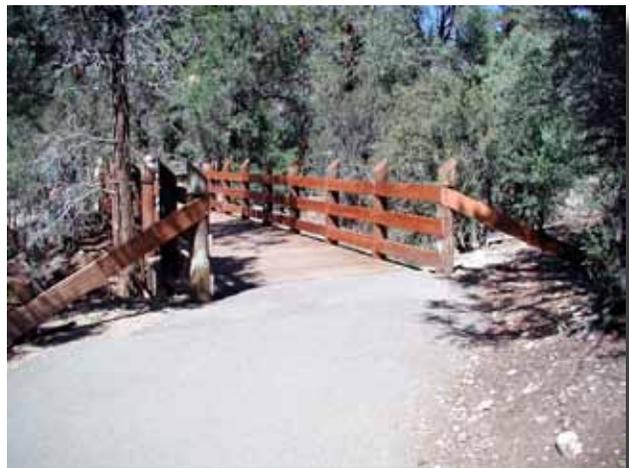
Figure 9—Bridge made of Ipe wood.

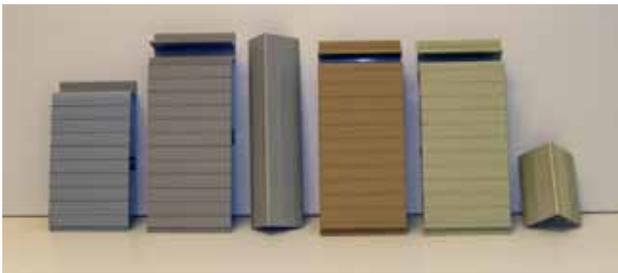
Figure 12—Aluminum decking material.

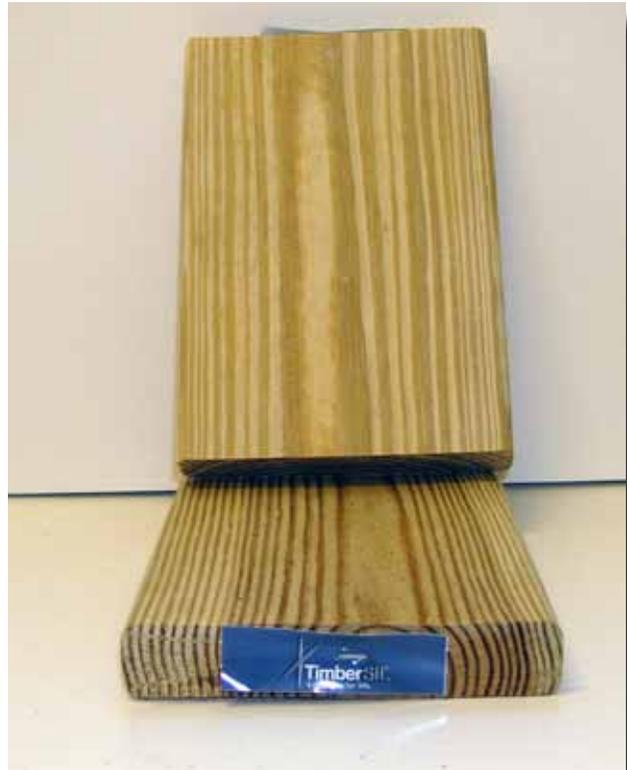
Figure 13—TimberSIL™ lumber.

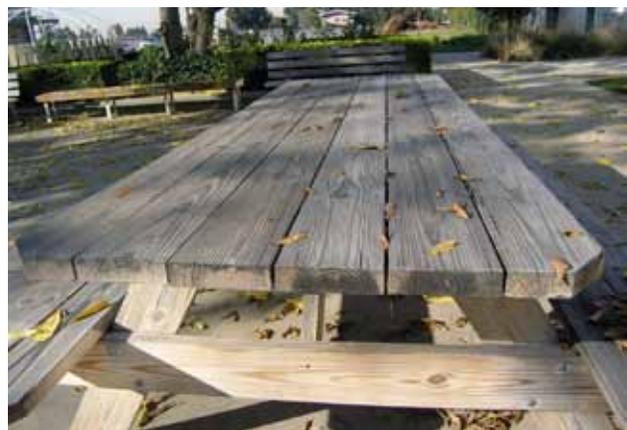
Figure 14—TimberSIL™ picnic table.

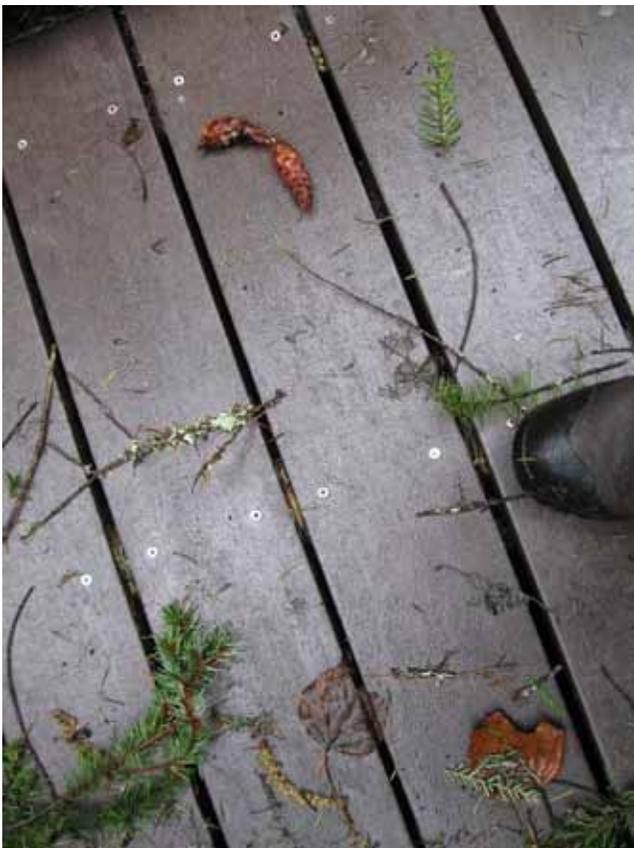
Figure A.3—Trail is 5 years old.

The plastic lumber cost \$12,000, which was about twice as much as treated lumber; installation time was probably about twice as much too. However, the manufacturer said the plastic material should last 50 years or more, whereas treated wood puncheons on the same trail are having slippery deck issues after 10 years, and we may have to replace them after 20-25 years. After 5 years of use, the puncheon with plastic lumber is in good condition, and we are pleased with the results. The deck isn't slippery and we have not done any maintenance on it. At some point we will need to remove any algae.

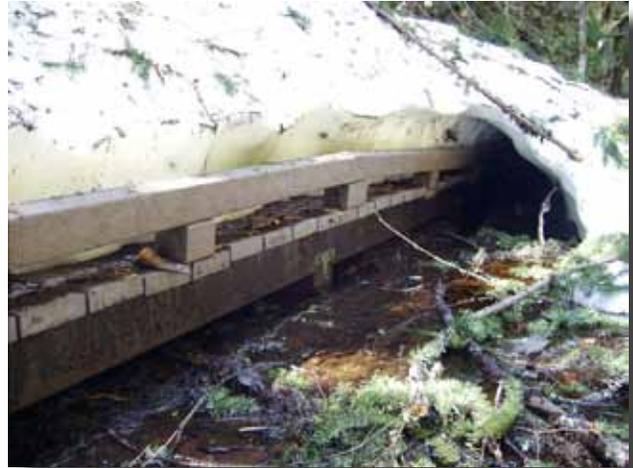
Figure A.4—The puncheon in May 2008 after a winter of very heavy snow loads. After the snow melted and some summer heat, it bounced back to normal (or so close to normal it's not noticeable).

Heavy snow loads a couple of winters ago caused the curbs to bend but they bounced back to normal. The puncheon is located in a shady spot, so issues with direct sunlight and warping are not a factor.

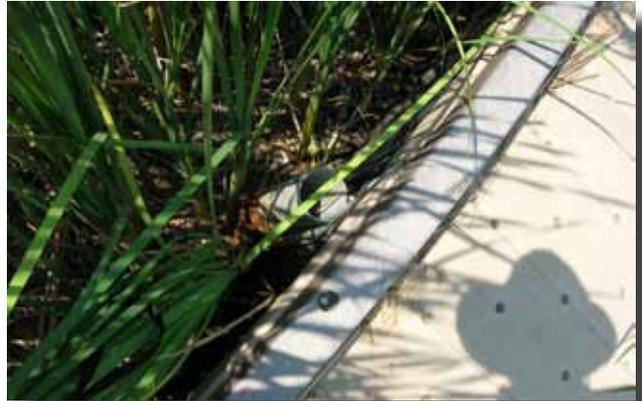
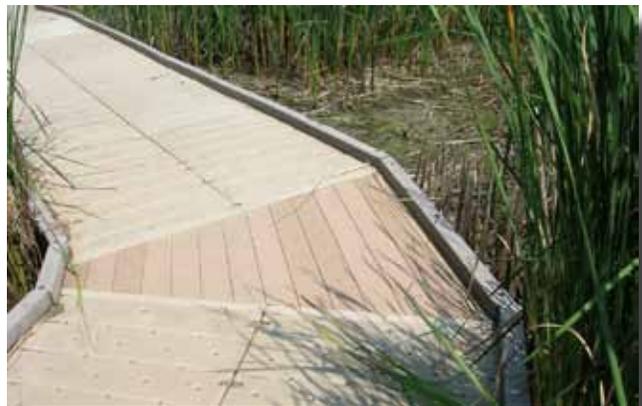
Figure A.6—Kestral Pond boardwalk.

Figure A.7—Kestral Pond boardwalk.

In Golden, CO, B.J. Ellison, architect and open-space planner for Jefferson County Open Space, said they installed a floating boardwalk at Crown Hill in their Kestral Pond wetland area, a park in Wheat Ridge (figure A.5). They used Superdeck when they built the boardwalk 10 to 16 years ago and are looking to replace it. They are thinking about putting in a helical pier (a steel shaft with helices, similar to a large screw, that provides a foundation support). They are commonly used to correct and support existing foundations that have settled or failed. Ellison said the boardwalk is not really in bad condition. However, the most common complaint is that it is too bouncy or spongy when it is hot. One of the photos shows what happens if the guidepost is not high enough and allows the guide bracket to become misaligned (figures A.6, 7).

The bracket in this case is stuck on the top of the post and is warping the deck. They used Trex™ as fillers at the transitional angles (figure A.8), and that is holding up well. In their renovation efforts, Ellison may suggest that they add Trex as a more user-friendly wearing surface, rather than replace the entire system.

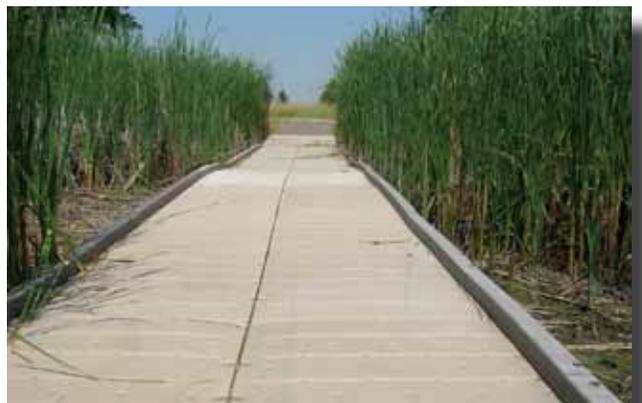
Figure A.8—Kestral Pond boardwalk.

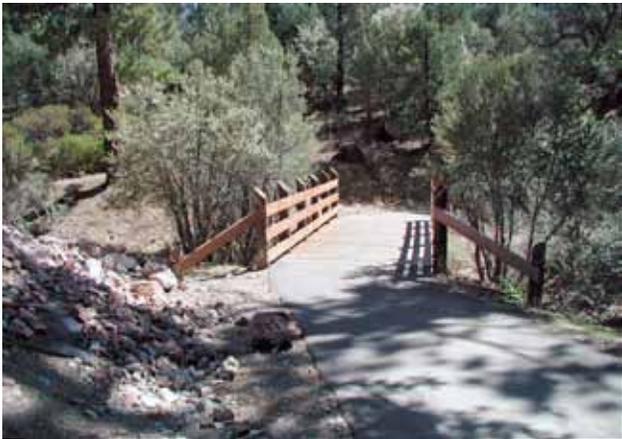
Figure A.10—Downstream view of the Ipe-wood bridge.

Trail bridges were installed in 1998 or 1999 and have lasted well with little or no maintenance. They are made of Ipe wood and are expensive, but due to high vandalism, they are well worth the investment because people cannot carve on them. The forest staff would definitely use this material again.

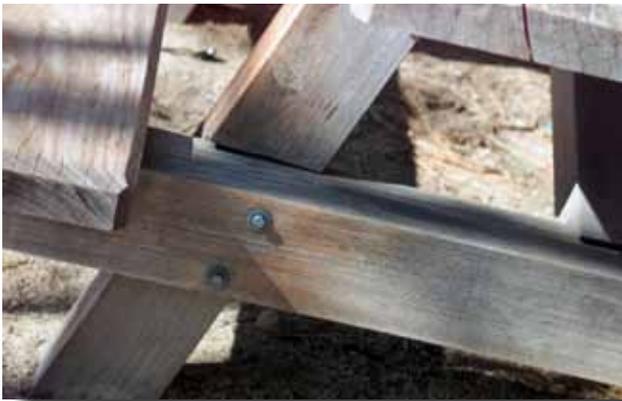
Figure A.12—Jenks Lake picnic table made of Ipe tropical hardwood. Notice the denseness of the Ipe wood.

Picnic tables were built of Ipe wood and installed in 1996. They get heavy day use. The picnic tables are in excellent shape with little or no carving, extremely heavy, and cannot be moved easily.

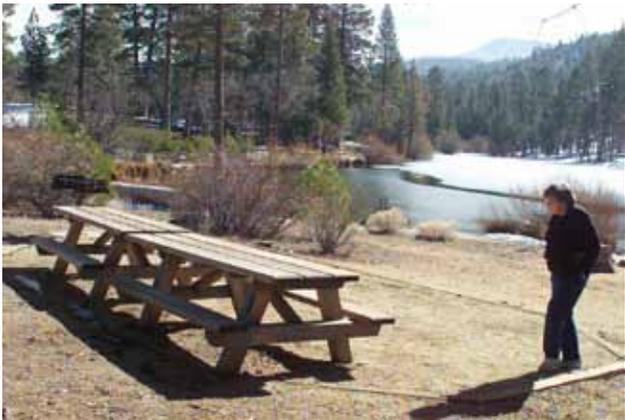
Figure A.13—Jenks Lake picnic table made of Ipe tropical hardwood. Visitors cannot lift it and there is no carving on it; the wood is too dense and heavy.

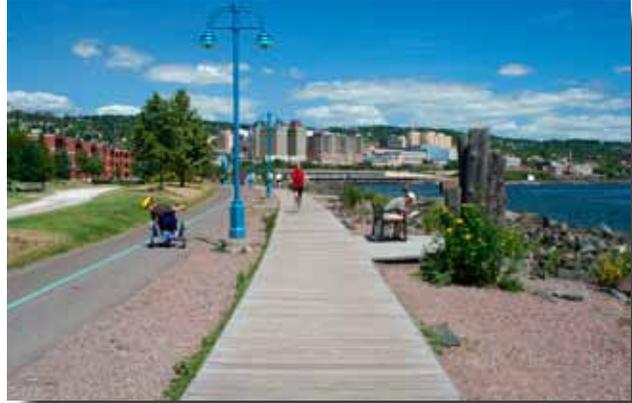
Figure A.16—Duluth, MN, Lakewalk made of Ipe wood.

Lake Superior’s lakeshore boardwalk, called the Lakewalk, is an ongrade Ipe boardwalk about 2.5 miles long. It was built in 1988 and has worn like iron. It has weathered to a silver-gray color and is not maintained with any stain or UV protection.

Extreme weather ranges from -40 °F to 105 °F. Late October northeasters cause lake surges (figures A.16, 17) that displace the boardwalk. After the storm passes, crews pick up the boardwalk and put it back into place.

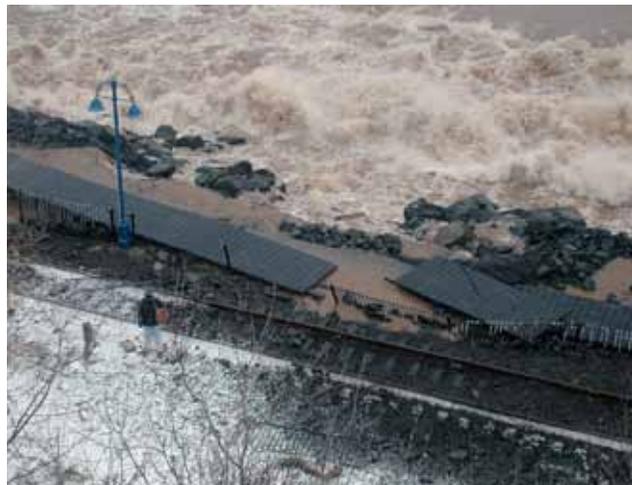
Figure A.17—Lake Superior. Lake surge takes out boardwalk during storm.

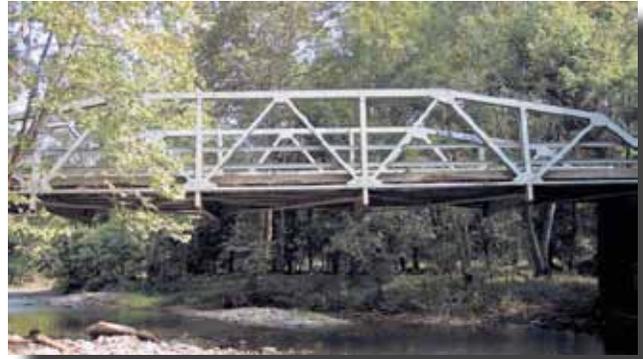
Figure A.19—Aluminum bridge in Kentucky.

Initial cost is the primary disadvantage of the aluminum deck.
