2300 Recreation
October 2002
0223-2821P-MTDC

Managing Degraded Off-Highway Vehicle Trails in Wet, Unstable, and Sensitive Environments

Kevin G. Meyer, *Environmental Specialist/Soil Scientist*
National Park Service, Alaska Support Office
Rivers, Trails, and Conservation Assistance Program

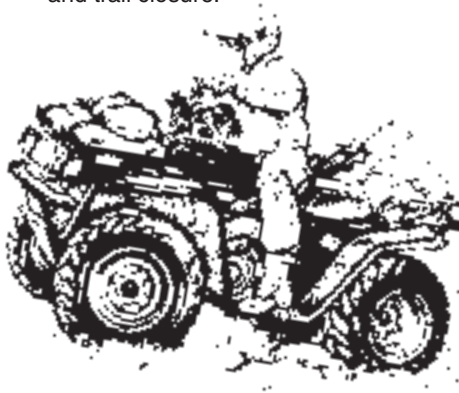
Figure 1—A degraded trail in interior Alaska. Heavy use has stripped surface vegetation and exposed permafrost soils to accelerated melting, resulting in muddy, rutted trail surfaces, erosion, and deep muck holes.

For land managers, degraded trails are a significant environmental problem because of their direct effects on vegetation, soils, and site hydrology. In addition, degraded trails may have indirect effects on wildlife, site esthetics, and other resource values. For trail users, degraded trails reduce the utility of trail systems and lead to a less enjoyable ride. Unfortunately, with increased use of backcountry resources by OHV enthusiasts and other trail users, the miles of degraded trails are increasing rapidly (figure 1).

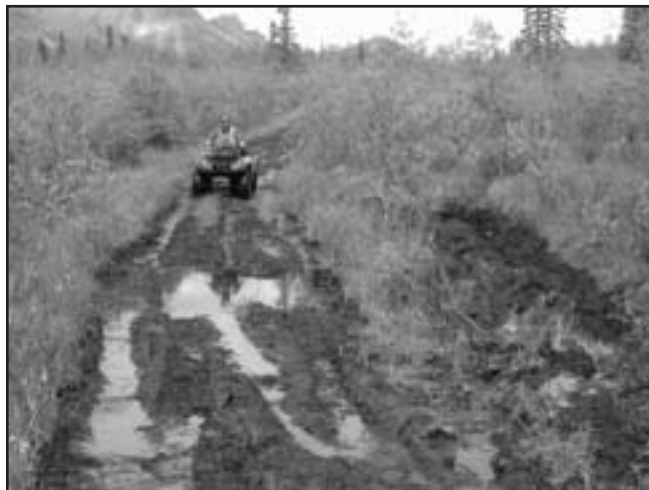
Figure 4a—Ponded water in ruts and muck holes prompt riders to pioneer new routes in adjacent undisturbed areas.

The first consequences of pioneering a trail across a virgin landscape are the stripping of surface vegetation, the abrasion of roots, and the compaction of surface soil layers. These impacts destroy soil structure, reduce water infiltration, and break bonds between soil particles. Soil particles are more vulnerable to displacement and loss from wind or water erosion. Soil compaction also leads to surface subsidence—the lowering of the trail relative to the adjacent ground surface. Trails become entrenched. This lower surface intercepts and drains water from adjacent surfaces and channels that flow along the trail. This dramatically increases the risk of water erosion on sloped areas and the pooling of water in low-lying sections. As trail surfaces degrade due to rutting or the formation of muck holes, users widen the trail and seek new routes, usually on adjacent soils where environmental conditions are identical to the original impact site. As this new route degrades, it is abandoned. A third route is pioneered, and then a fourth—until finally the area is scarred with a number of routes in various stages of use and abandonment. This condition is called trail braiding. Trail braiding significantly expands the environmental impacts of trail use. Trail braiding occurs because trail use levels repeatedly exceed the carrying capacity of soils to support that use. Figures 4a and 4b illustrate the process.

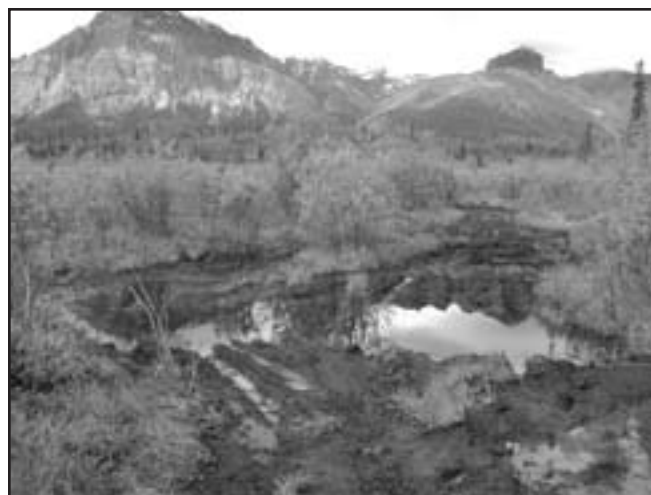
Figure 4b—Results are an adjacent degraded alignment and the development of a braided trail.

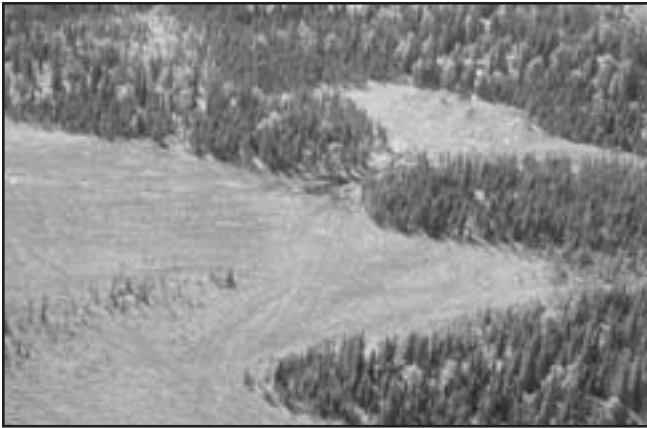
Figure 5—A braided trail in Alaska. More than a dozen separate routes have been pioneered in this section crossing a wetland. Note the wet trail conditions and numerous potholes. At this site, trail impacts affect an area more than 250 feet wide. Braiding significantly extends the area of impact by modifying vegetation cover, surface hydrology, and soil characteristics.

The impacts associated with braiding are a major concern for land managers because they dramatically increase the area of impacts associated with trail use (figure 5). Studies conducted in one area of Alaska documented that the average OHV trail had an impact area 34.6 feet wide (Connery 1984)—that's four times the width necessary for a single OHV track. Using that average width (34.6 feet), each mile of trail affects 4.2 acres. A single-track trail (8 feet wide) of the same length would affect just 0.97 acre per mile. Braided trail sections more than 200 feet wide are not uncommon within Alaska. For resource managers, the increase in area affected by braiding is significant in terms of resource destruction, habitat loss, and esthetics.

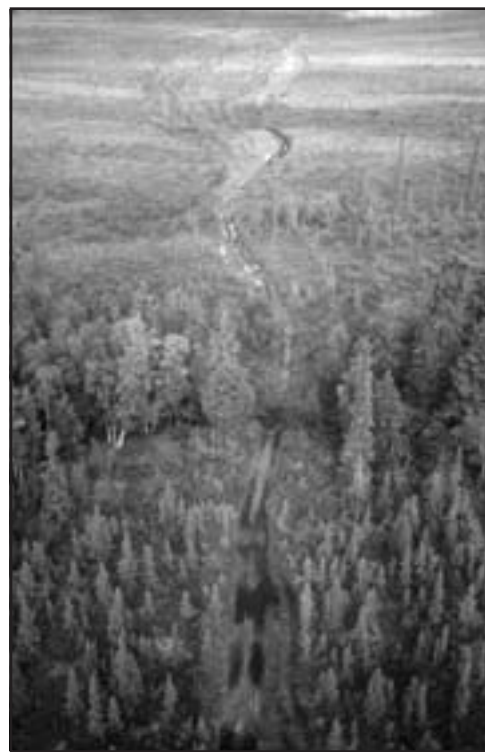
Figure 7—A heavily used OHV trail in Alaska crosses two distinct soil types. In the foreground, the trail passes through a mixed forest ecosystem where the soils support use along a single track. In the background, the trail crosses degraded wetland soils where users have created a braided trail. Managers should consider rerouting the trail to stay within the forest system.

In some cases, moving a trail or segment may be an effective method of responding to trail degradation. For example, moving a trail from a foot slope to a side slope may significantly reduce trail wetness. Moving a trail from an open wetland to an adjacent woodland may stop trail braiding. Figure 7 shows an example where rerouting should be considered.

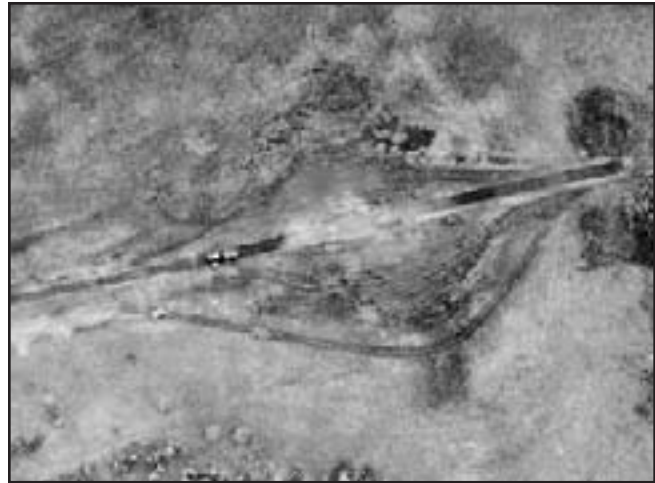
Figure 8—This aerial image shows a recently installed section of hardened trail crossing a wetland in southcentral Alaska. The new trail alignment defines a single route of travel that will prevent the continued development of braided trails.

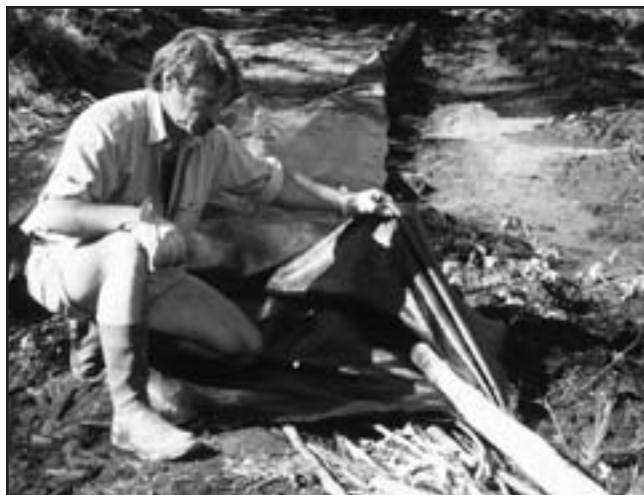
Figure 11—The author installing woven geotextile around a rim log in the geotextile gravel-capping test installation at the Yukon-Charley Rivers National Preserve in Alaska. The rim log held the gravel cap on the installation.

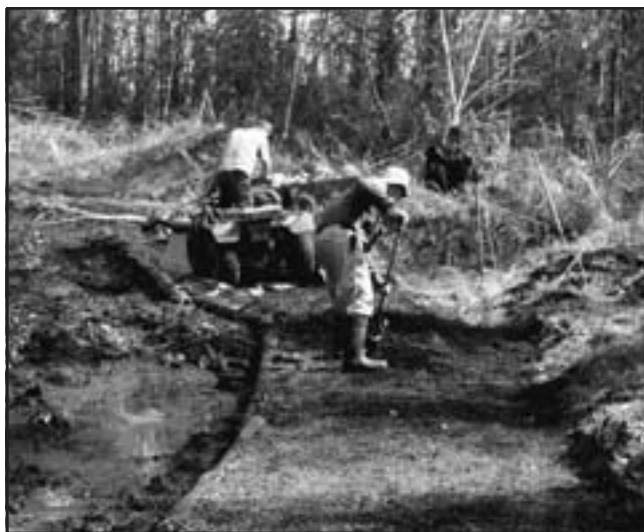
Figure 12—A geotextile and gravel-cap installation over permafrost-degraded soils in Yukon-Charley Rivers National Preserve in Alaska. Use of geotextile and a gravel cap on this trail allowed the National Park Service to construct a 6-foot-wide OHV trail over a 3- to 4-foot-deep muck hole.

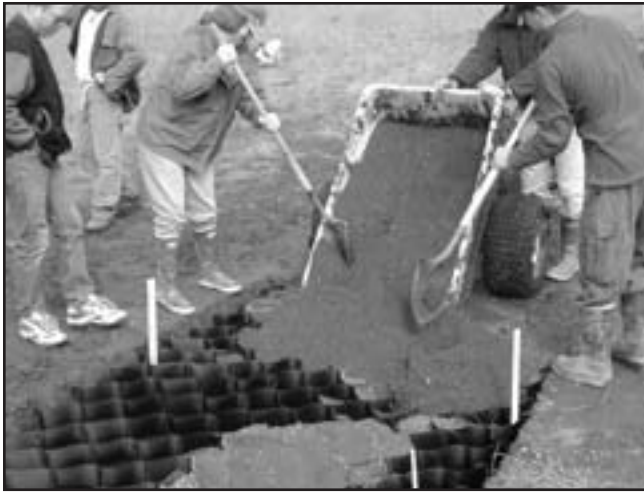
Figure 13—A cellular confinement system being installed on an experimental trail in southcentral Alaska. Four-inch-deep cells were formed by expanding the cellular product accordion style, then backfilling and compacting with a suitable fill material—in this case, sandy gravel. The sides of the installation were confined by a 6-inch-deep trench.

Cellular Confinement Systems—Cellular Confinement Systems (CCS) are three-dimensional, web-like materials (figure 13) that provide structural integrity for materials compacted within the cell. They are engineered so cell walls limit the transfer of shear forces within the soil. Employed worldwide for a wide variety of uses, cellular confinement systems are a well-accepted soil engineering tool (Ron Abbott 2000). In Alaska, these systems have been used with success on military runways and remote radar sites, Arctic tank farms, construction sites, and boat ramps (Joseph Neubauer 2000). The systems also have been used when

A cellular confinement system consists of a surface-aggregate wear surface, the cell membrane, fill material, and an optional separation fabric (depending on site characteristics). Fill material is usually imported gravel, but onsite material can be used in some circumstances (the use

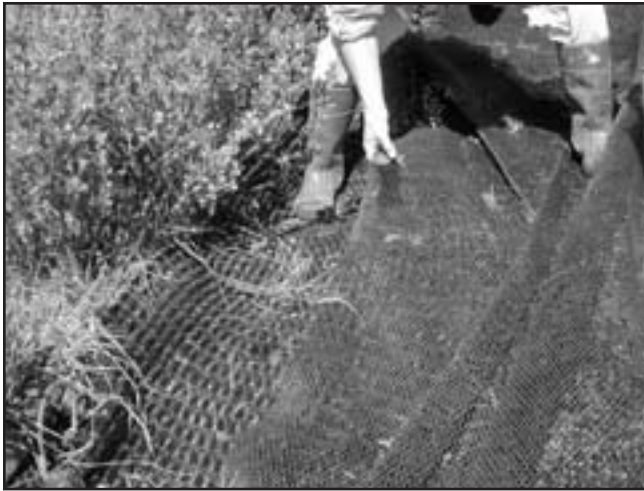
Figure 14—Polynet over Pyramat was used in this National Park Service installation to test the addition of a synthetic turf reinforcement mat. The Polynet, with its more durable wear surface, was installed over the less durable Pyramat.

The manufacturer had extensively tested Pyramat as a soil-reinforcement product. The company had documented significant increases in resistance to erosion and shear stress after vegetation regrowth (Synthetic Industries 1999). The National Park Service tested both turf reinforcements to see whether they would support existing roots and cushion soil bodies from direct impact. Polynet provided a wear surface, while the open weave of Pyramat allowed for active plant growth and eventually was integrated into the soil surface layer.

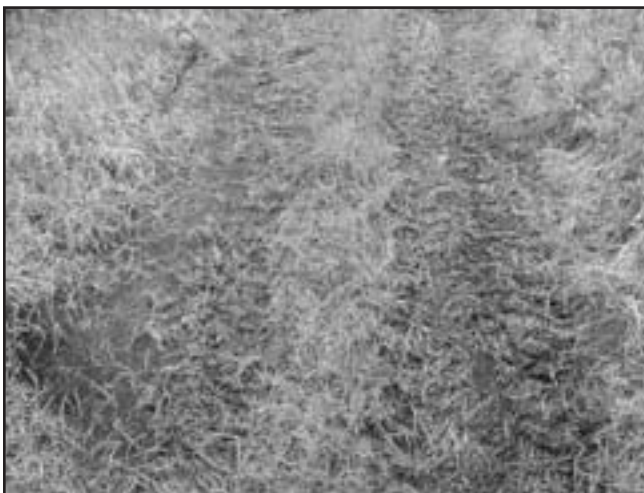
Figure 15—A Park Service Polynet/Pyramat test installation after 3 years in a wetland area with a high percentage of sedge. By the third year, sedge had become well established and its roots well entwined with the Pyramat matting.

The Park Service field tests were encouraging because the materials appeared to protect the underlying soils from impact. They stabilized degradation and provided a durable wear surface for OHV use. Vegetation regrowth on the sites increased from 54-percent cover at installation to 79.5 percent 3 years later (figure 15). On sites with a high percentage of sedge and cotton grass, the materials were well integrated into the root mass by the end of the second year.

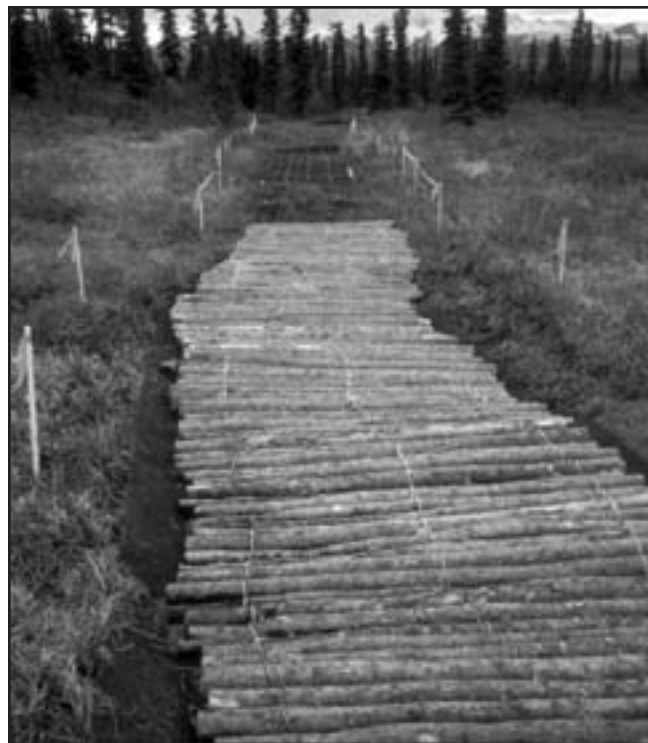
Figure 16—Spruce pole corduroy laid across permafrost soils in Alaska. These poles were imported to the site and secured by weaving them with three strands of $\frac{3}{8}$ -inch nylon line.

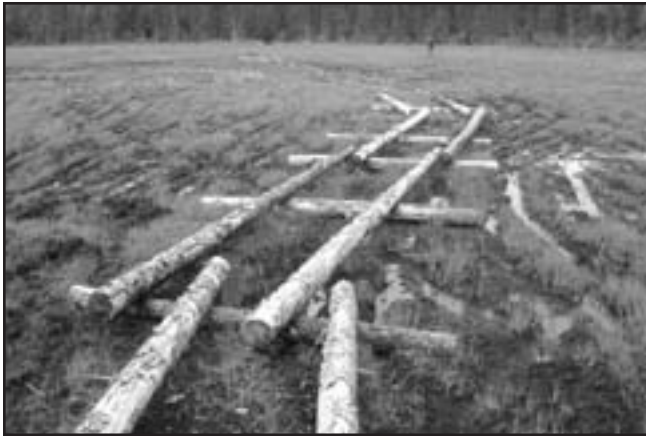
Figure 19—Rough layout of the sill and stringer timbers for puncheon trail construction over a wetland area in southcentral Alaska. Stringers are laid with tops meeting tops and butts meeting butts.

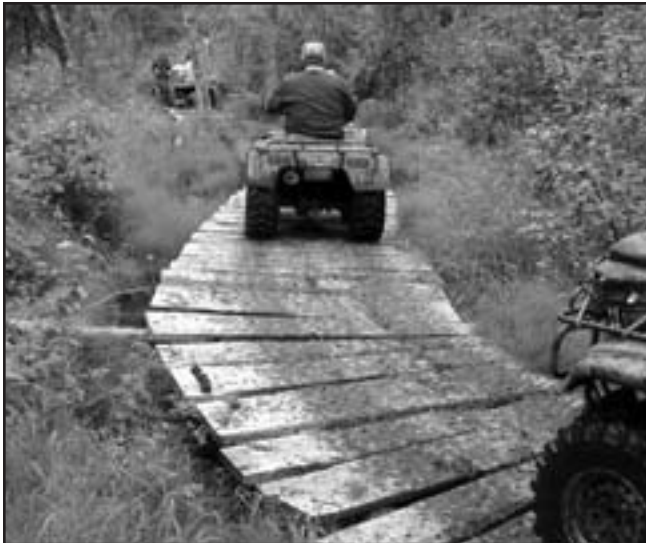
Figure 20—A finished puncheon trail. Note the placement of the plank taper to accommodate the curves along the trail.

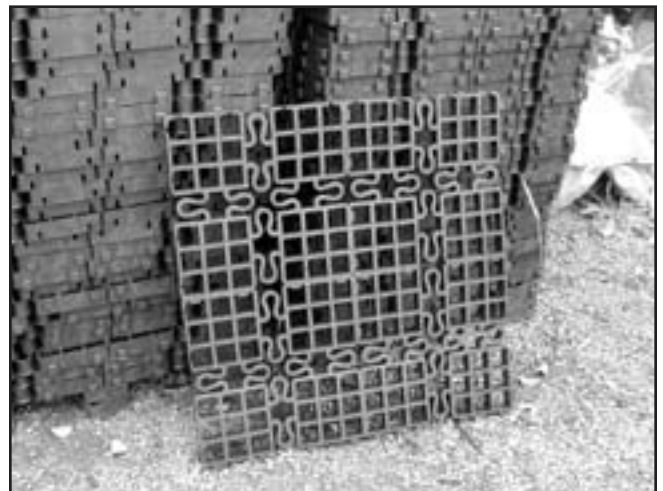
Figure 22—Two SolGrid panels. Note the U-shaped flex connectors between panel subsections.

The SolGrid product has a 2½- by 2½-inch-tall vertical grid pattern with an 8- by 8-inch subpanel. When assembled, subpanels form 16- by 16-inch weight-transfer panels. Flexible U-shaped connectors join the subpanels. There is no base sheet. About 85 percent of the grid surface is open for vegetation regrowth. Weight transfer between panels is poor because of the integrated flexible connectors. This can be mitigated somewhat by the use of supplemental geosynthetics underneath the panel. Polynet-PN3000 has been used for that purpose in Alaska and has demonstrated some benefit.

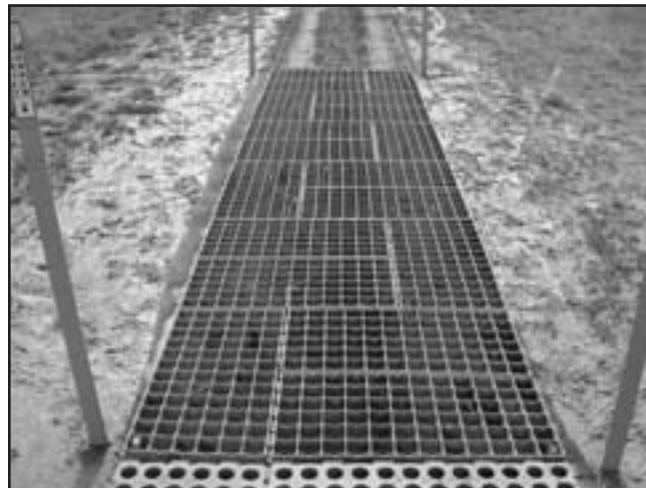
Figure 23—Test installation of 2-inch GeoBlock at the Palmer Hay Flats State Game Refuge in Alaska. This configuration of panels provided a 4.8-foot-wide trail. Note the interlocking tabs along the panel edges. These tabs transfer weight between panels. In this test, GeoBlock was installed over Polynet PN-3000.

was installed with a clay-sand fill and a 2-inch cap over a geofabric layer. The installation completely stabilized the soils at the site. More than 3,500 passes had been made over the installation by enduro-type motorcycles within the first 3 months of installation. According to the project manager, not one vehicle has ventured

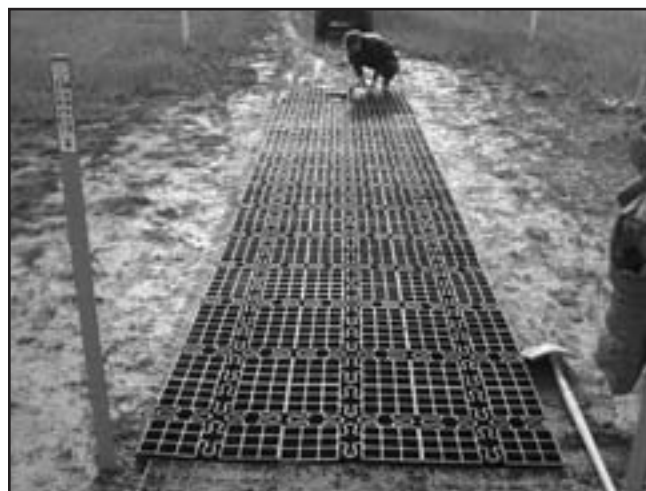
Figure 24—Test installation of SolGrid at the Palmer Hay Flats State Game Refuge in Alaska. Note the U-shaped flex joints between sub-panel sections. The SolGrid was tested without Polynet PN-3000 to test the characteristics of the product when installed on a soft, silty substrate.

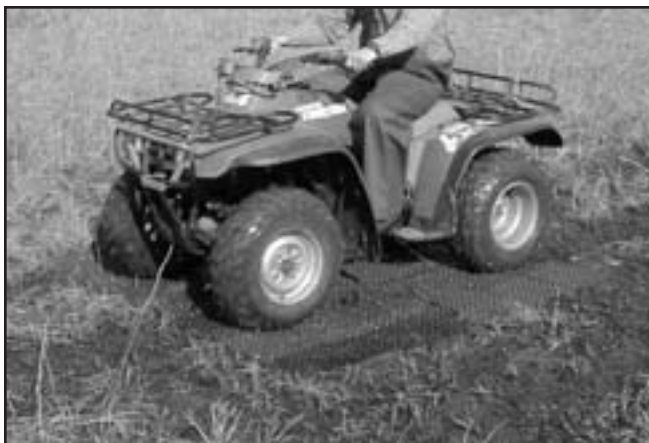
Figure 26—A section of rubber antifatigue mat undergoing preliminary field trials at the Palmer Hay Flats State Game Refuge in Alaska. The large panels install quickly, but the rubber's flexibility limits the panels' ability to transfer lateral loads.

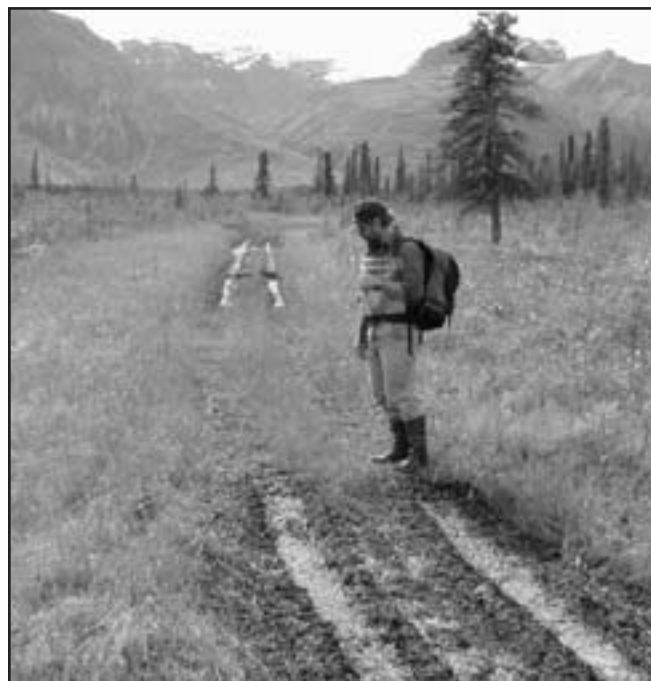
Figure 27—A hardened, protected section of trail 4 years after installation.

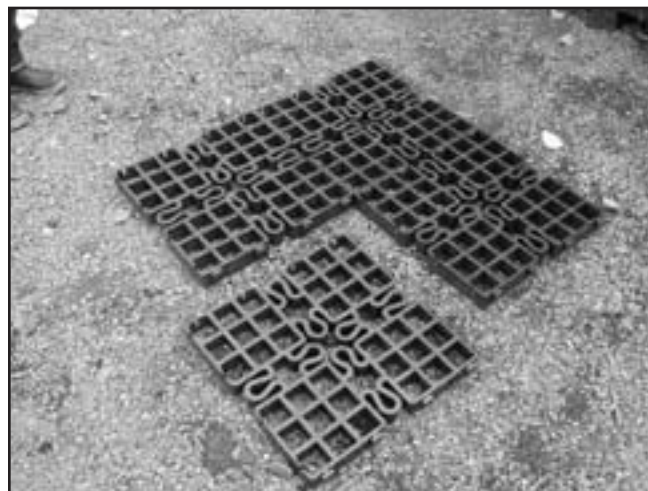
Figure B5—Two SolGrid panels. Note the slot and tab fasteners along the edges and the integrated U-shaped expansion components.

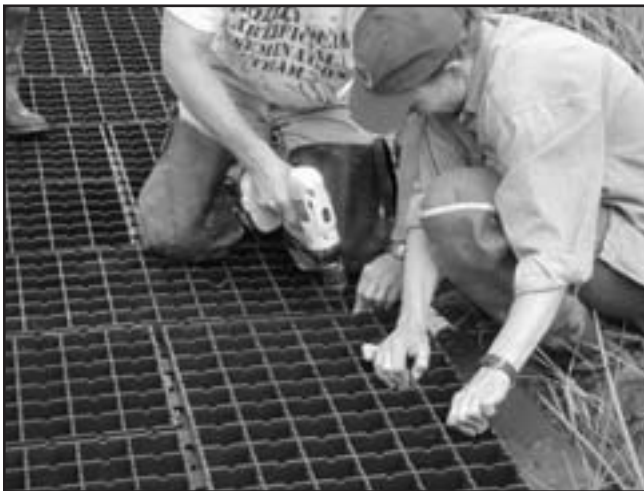
Figure B7—Joining the sections using a screw gun. Note the underlying plywood.

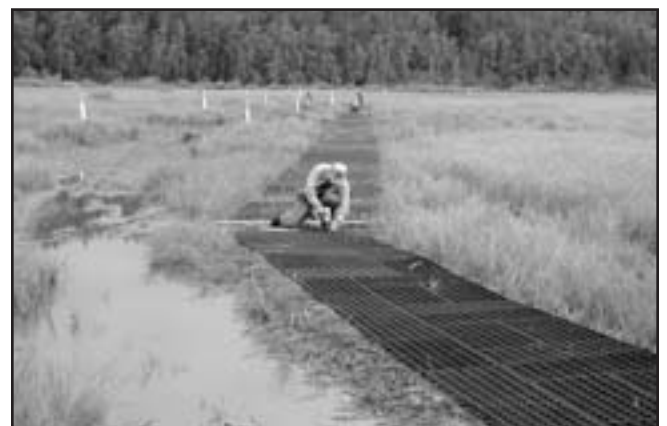
Figure B8—Angular cuts in the panel sections help form the turns in the trail.

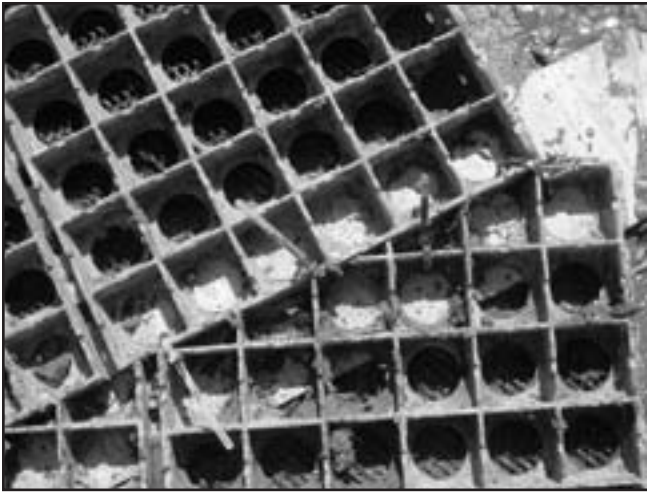
Figure B9—Corner joint showing cut, underlying plywood, and cable ties. Note the screws through the panel's plastic baseplate that secure the panels to the plywood.
