Maintenance Issues and Repair Guidelines for Precast Concrete Toilets and Utility Buildings

Gary Kees, Project Leader

Cracked panels and peeling paint on some concrete Sweet Smelling Toilets (SSTs) have USDA Forest Service field personnel wondering how best to repair and maintain these toilets and other precast concrete buildings (figure 1). Though concrete SSTs are virtually indestructible, vandals, weather, and the nature of the concrete itself, can still take their toll. Small cracks in panels typically won't affect the building's structural stability. This report describes the best methods and materials for repairing cracks in concrete and coatings. The tech tip also documents field inspections we conducted, manufacturing information, safety and structural issues, and warranty and contract issues.

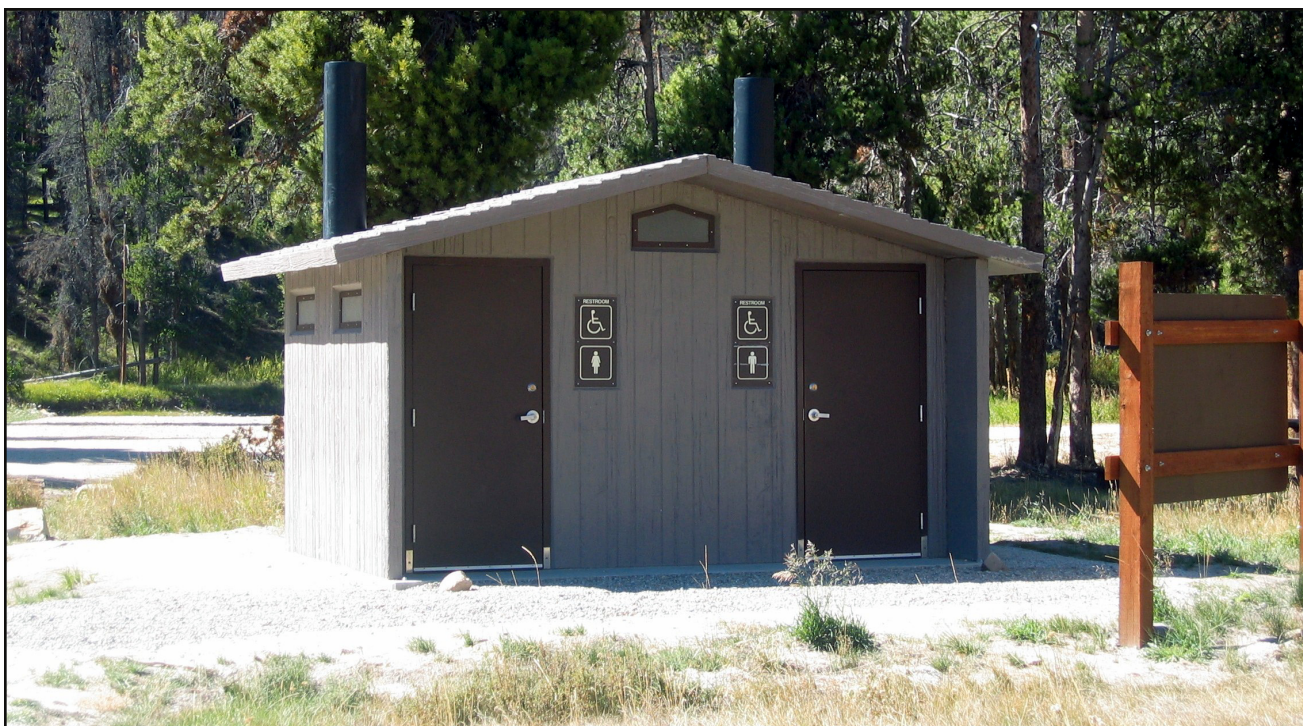
Figure 1—Precast concrete toilets are tough, but still require some periodic maintenance. This Tioga special double-vault toilet is made by CXT, Inc., of Spokane, WA.

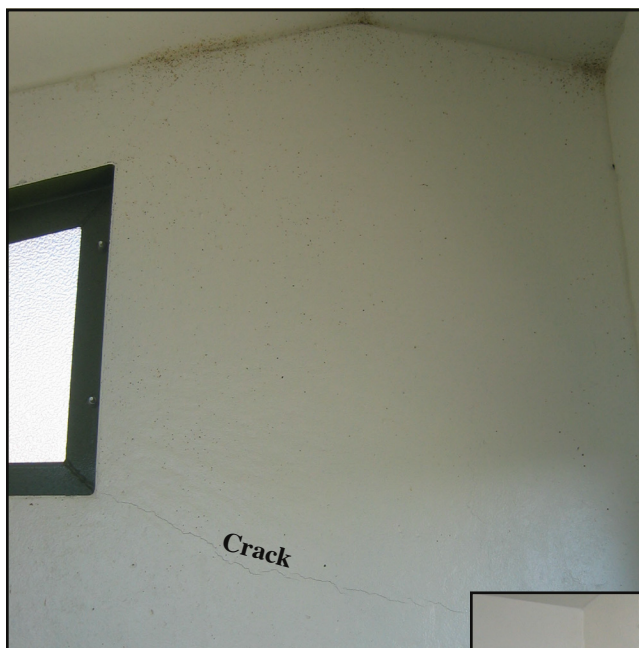
The Missoula Technology and Development Center (MTDC) randomly inspected about 35 SSTs in Idaho, Montana, Wyoming, Colorado, and Nevada. The SSTs ranged from 1 to 7 years old. We typically found cracks in panels at sharp angles near doors and windows, and at panel connection joints (figure 2). A few panels had full-length, full-depth cracks across the roof and wall sections (figure 3). Only one SST had a visible crack in the floor panel. Coatings were commonly seen peeling under the eaves or in areas where concrete was cracking. The coating on one SST was peeling off in sheets on flat, open areas of the panels (figure 4).

Figure 2—Cracks in concrete typically begin at the sharp edges of doors and windows.

Recommendations from CXT for repairing small cracks in the interior and exterior walls and the roof of precast concrete buildings include:

- Clean foreign material from the surface of the crack with a damp cloth and allow adequate time for the surface to dry.
- Rough up the area along the crack, including any paint edges and exposed concrete, with 100- to 125-grit sandpaper. Wire brushes are not recommended because they may remove too much paint .

- Use a dry paintbrush with stiff bristles to remove loose material inside the crack.
- Wipe the area around the crack with a damp cloth to remove fine particulate matter on the surface. Allow time for the surface to dry completely.

- Caulk the cracked area with an acrylic latex caulk plus silicone in brilliant white (DAP “Alex Plus” 35 Year Brilliant White is a good choice). Cut the tip of the tube of caulk so it has a $\frac{1}{16}$ - to $\frac{1}{8}$ -inch opening. A clean 45-degree angle cut will help ensure an even application of caulk. Begin caulking at the point that is the farthest from you. Gently squeeze the caulk gun's handle until caulk appears in the crack. Apply just enough caulk to fill the crack and move the tip of the caulk tube toward you until you have applied caulk along the entire length of the crack. Avoid applying more caulk than needed to fill the crack.

- As soon as you have filled the crack, smooth out the caulk. Place your thumb squarely on the caulk that is farthest from you and apply gentle pressure in a smooth, even motion down the entire length of the crack. Whenever your thumb has too much caulk on it or is pushing caulk outside the crack area, stop and clean your thumb with a damp rag. Clean excess caulk from the surface. If you use a damp rag, be careful not to let it touch the crack, because the rag will pull caulk out, leaving a depression.

- The caulk will dry (become tacky) in about 30 minutes, depending on the weather and the type of caulk. After the manufacturer's approved drying (tack up) time has passed, check to make sure that the entire crack has been filled to the surface. If so, the caulk may be painted. If not, fill areas that are not level with the surface. Allow any new applications of caulk to dry for at least 30 minutes before painting.

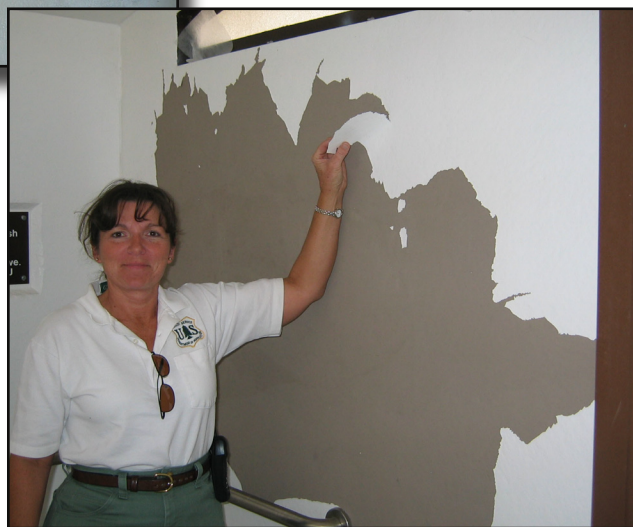
Figure 4—Coatings that come off in sheets are not considered normal. Such problems probably are caused by poor surface preparation or unusual weather conditions.

Follow the manufacturer's recommendations for repair or recoating and the manufacturer's specific safety precautions. United Coatings, Inc., a major supplier of coatings, offers this general advice for repairing or restoring water-based coatings on walls and roofs:

- Remove any loose coating, flaking concrete, or other foreign materials with a putty knife or scraper.
- Clean areas to be coated with a cleaner recommended by the coating manufacturer or another approved cleaner (such as Simple Green, 1-800-228-0709).
- Thoroughly rinse all cleansed areas with freshwater and allow them to dry to the touch (in most cases 2 to 4 hours).
- Repair damaged concrete with an approved patching material, such as QUIKRETE or United Coating's Uni-Crete. Follow the manufacturer's instructions and allow the product to cure at least 24 hours.
- Repair all cracked areas as described earlier.

- Apply the first coat of Canyon Tone stain with a standard paint roller or brush at a rate of 1 gallon of stain per 100 square feet of surface. A thin coat that just covers the patch area is best.
- Allow the first coat to dry to the touch (in most cases 2 to 4 hours), then apply the second coat at the same rate as the first.

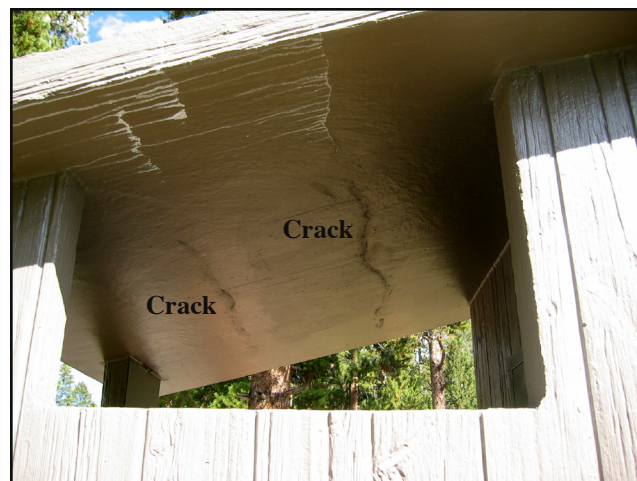
Figure 3—Full-length, full-depth cracks in panels may not be a serious structural concern.

So how do you determine whether cracks in SST panels present a structural concern or are just unattractive? The steel reinforcing bars (rebar) specified for each panel (figure 5) help hold the panel together, even if the concrete is cracked. A simple test recommended by CXT can help determine whether a crack might affect the structural integrity of a panel. If a credit card can be inserted deeper than $\frac{3}{16}$ of an inch into the crack, send a photo of the crack (with a ruler beside it for scale) to the manufacturer's engineering department or to a Forest Service facilities engineer. Rust stains found around cracks, or exposed reinforcing steel, are other causes for concern. Engineering analysis will help determine the severity of damage and whether repairs are required. MTDC did not find any SSTs in danger of failing structurally because of cracks.
