# FOREST-WIDE COLLABORATIVE TRAILS ASSESSMENT

CHATTAHOOCHEE-OCONEE  
NATIONAL FOREST

CHATTOOGA RIVER RANGER DISTRICT

JANUARY- MAY, 2012  
CONTRACT #: AG-435H-S-12-0001

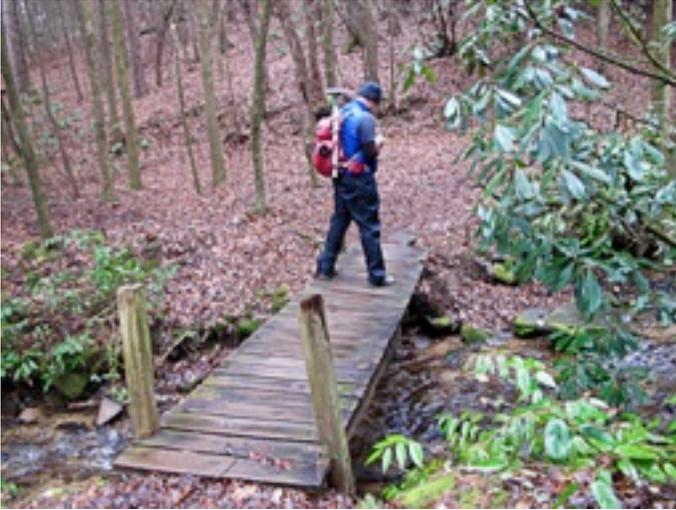
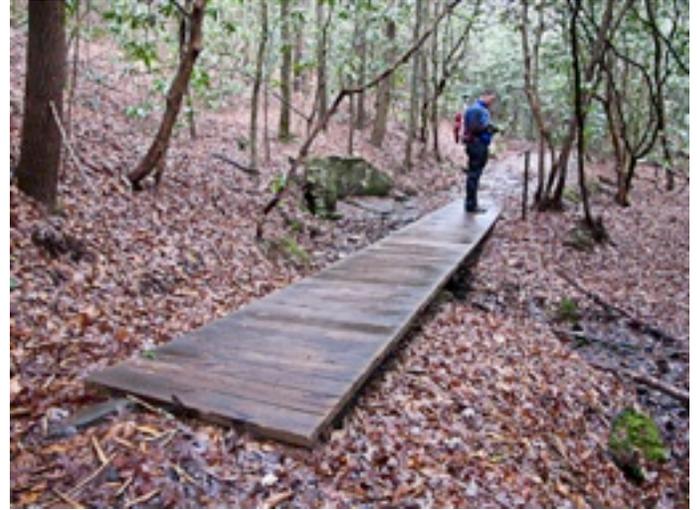
*Top Left and Right: A number of simple bridges are present on the trail, most in need of inspection/repair*

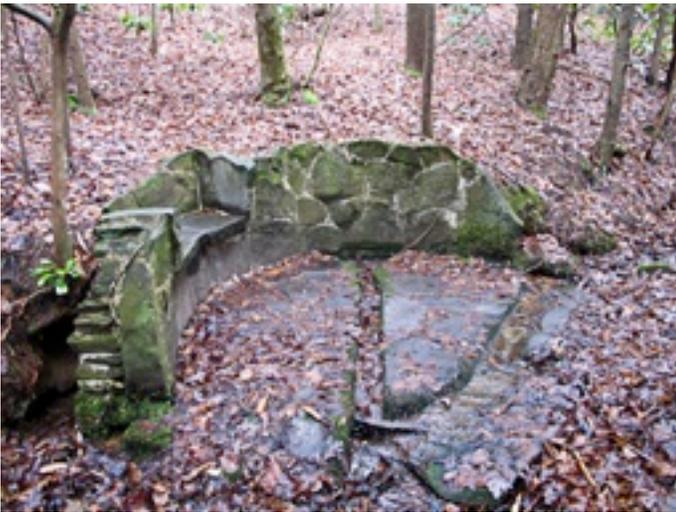
*Middle Left and Right: Historic CCC-constructed spring box adjacent to trail, but lack of water management (nearby seeps) keeps the area saturated and beginning to erode*

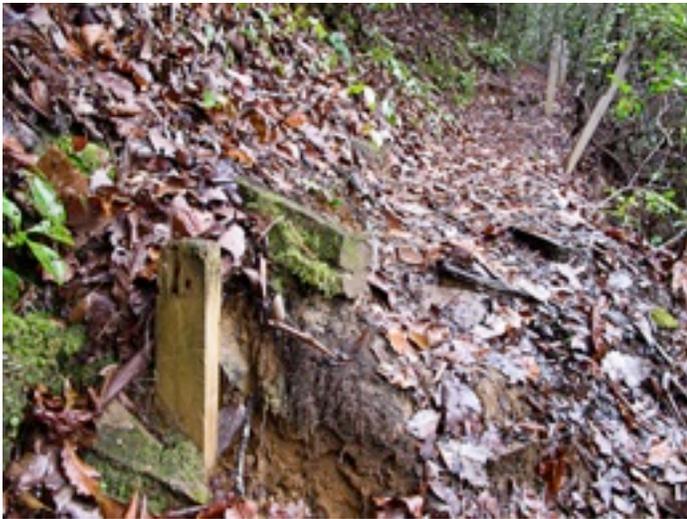
*Top Left and Right: Lack of water management has numerous saturated and eroding areas. Guide wires are broken and loose in numerous locations.*

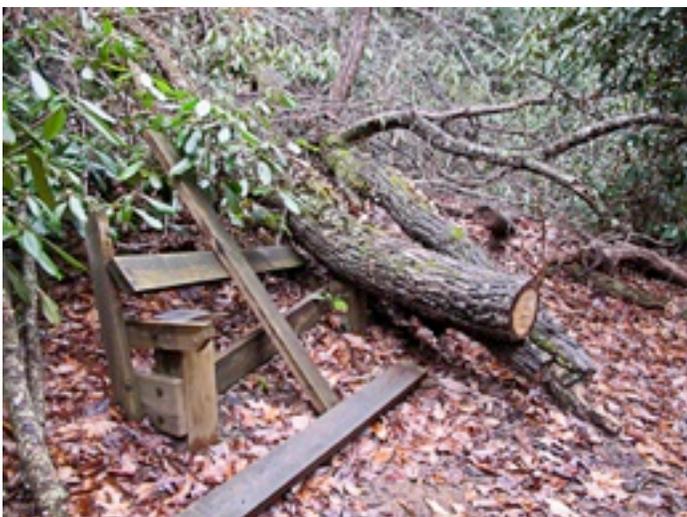
*Bottom Left: Deadfall has ruined bench. Corridor cleared, but broken structure left in place*

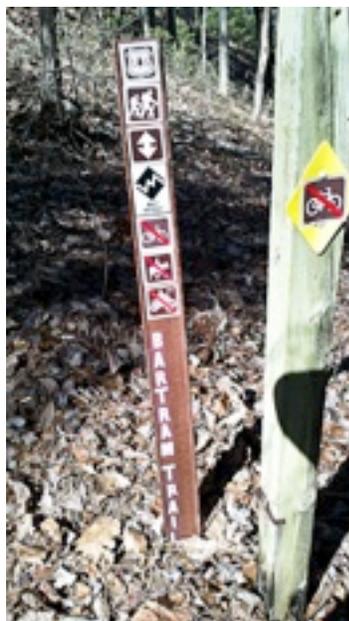
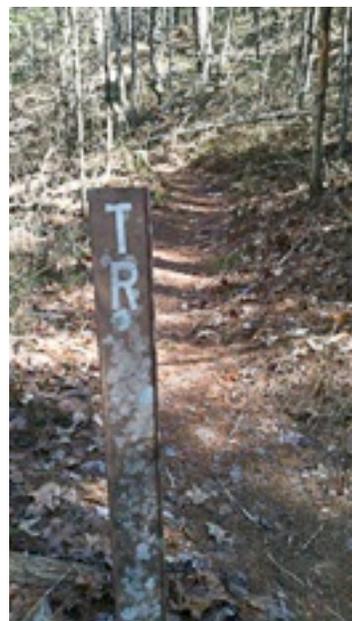
*Below: Pervasive carsonite signage appears at all junctions with open corridors, including system trails, roads, and non-inventoried corridors. The regulatory signage is not always appreciated and many have been vandalized.*

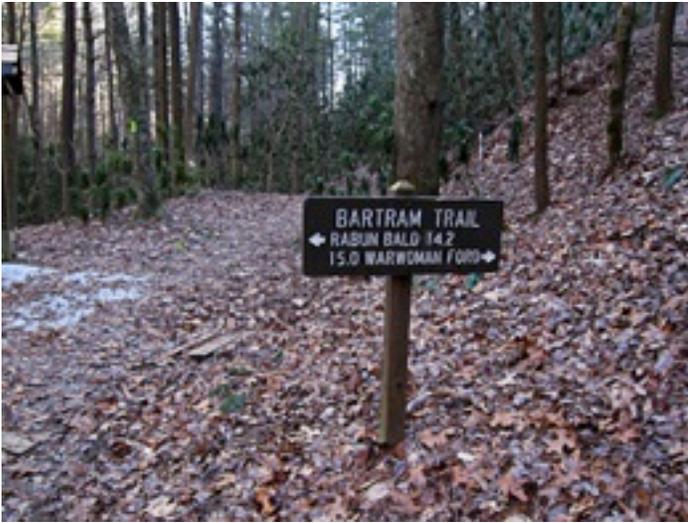
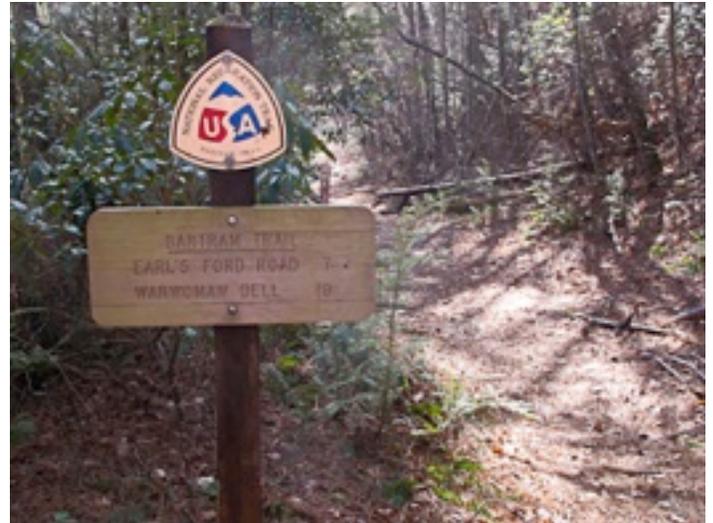
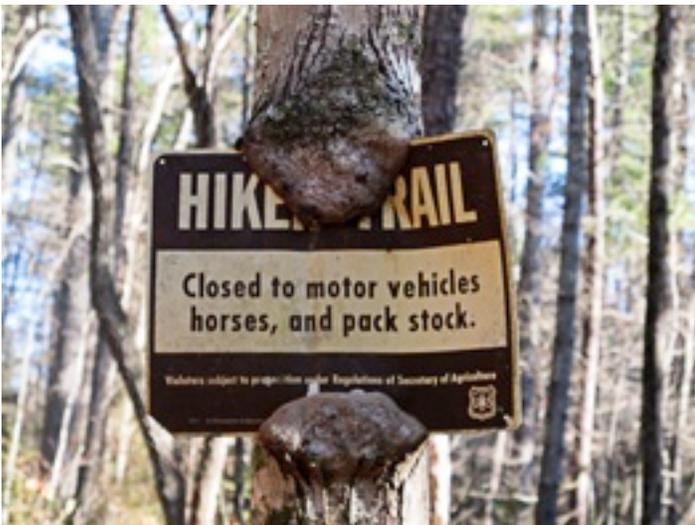
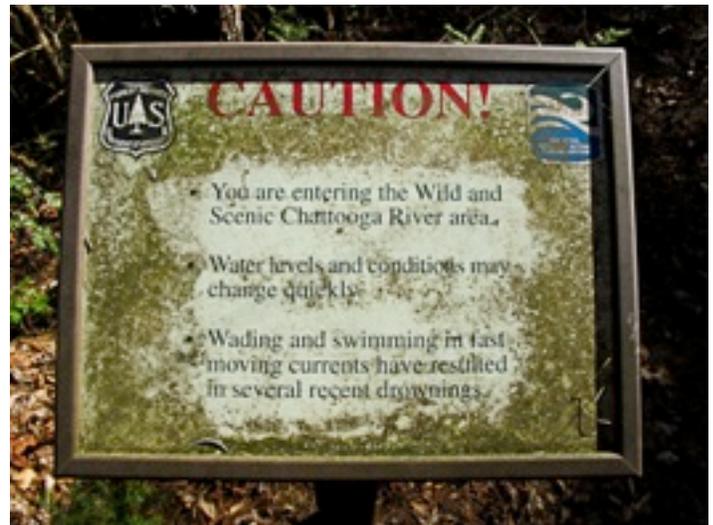
*This page: Additional signage of various types. Most old signs have not been removed when newer or additional signs were placed*

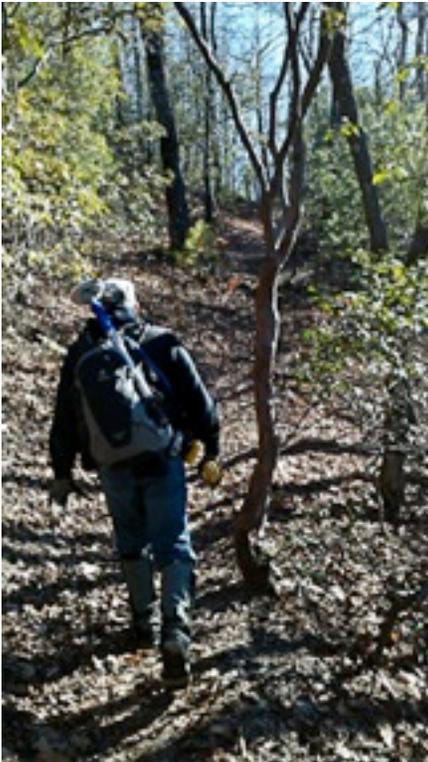
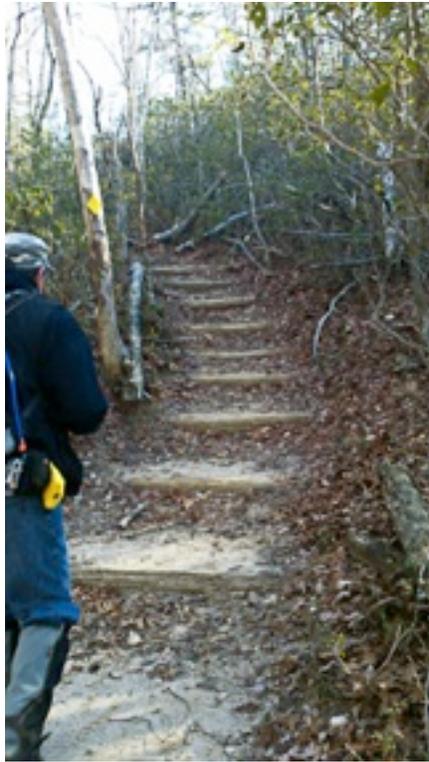
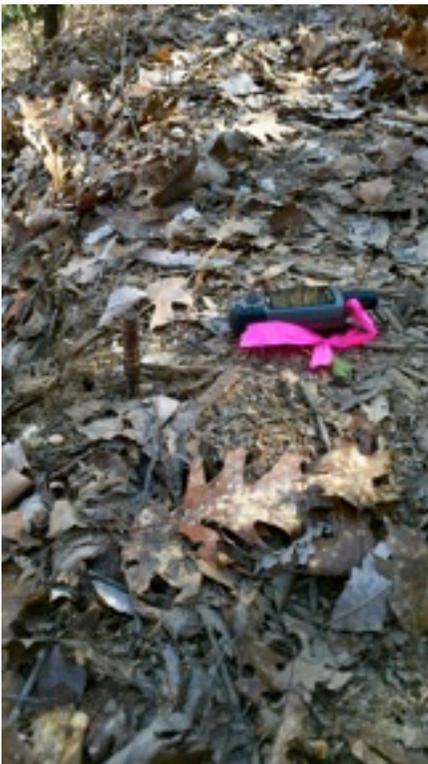
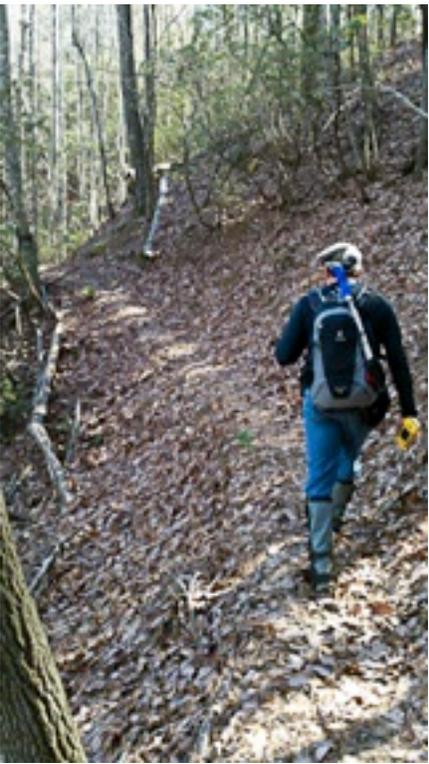
*This page: Most of the Bartram constructed as recreational trail is quite narrow, but often design grades exceed sustainability and design parameters. Steps were often constructed on these steep areas, but a lack of water management brings on scour under steps and eventually rotted steps break off to expose rebar.*

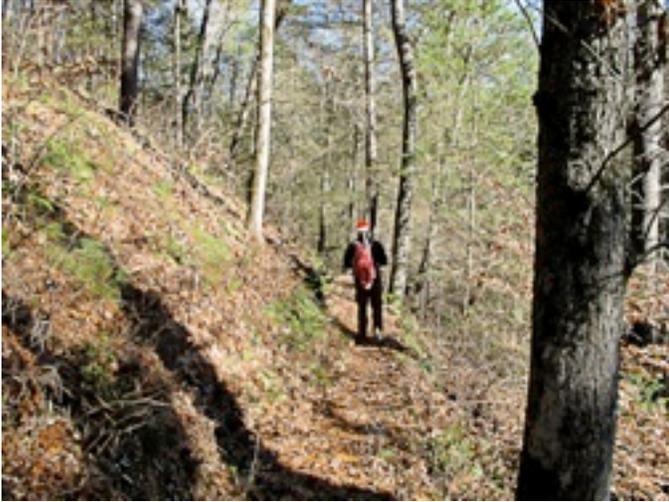
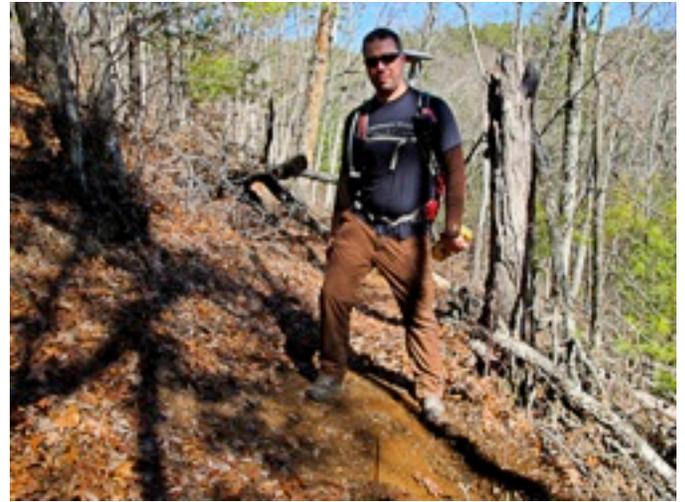
*Top Row: Narrow trail was only partially bench cut and fill slope is beginning to slough in many places, leaving 6-8" wide trail tread*

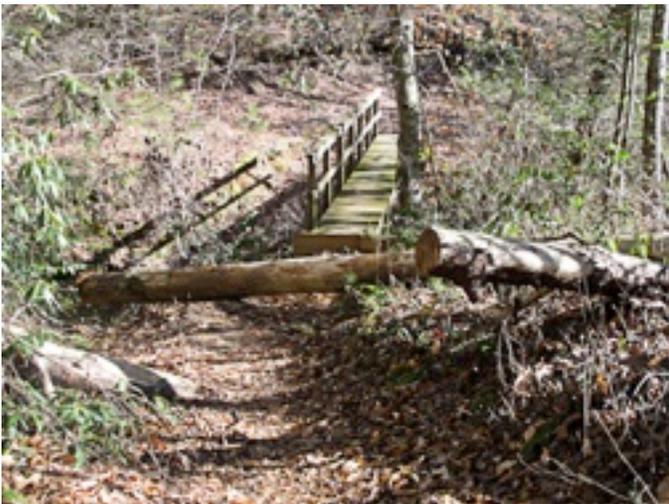
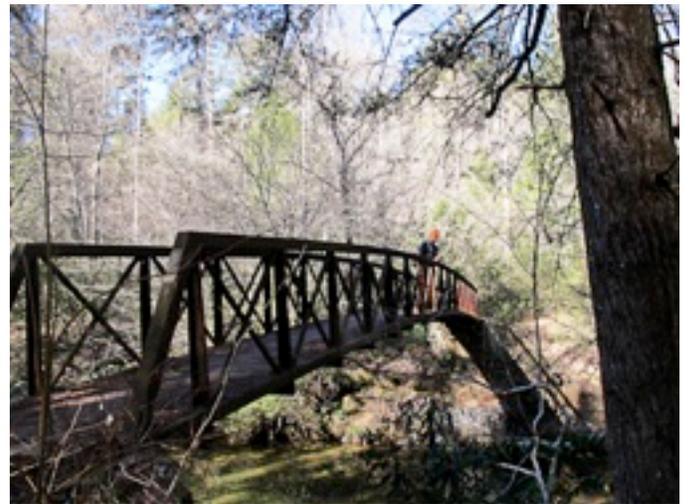
*Middle Row: Dozens of bridges have been built on this portion of the Bartram, including two large steel structures and many 24"-wide, single railing bridges over narrow creeks*

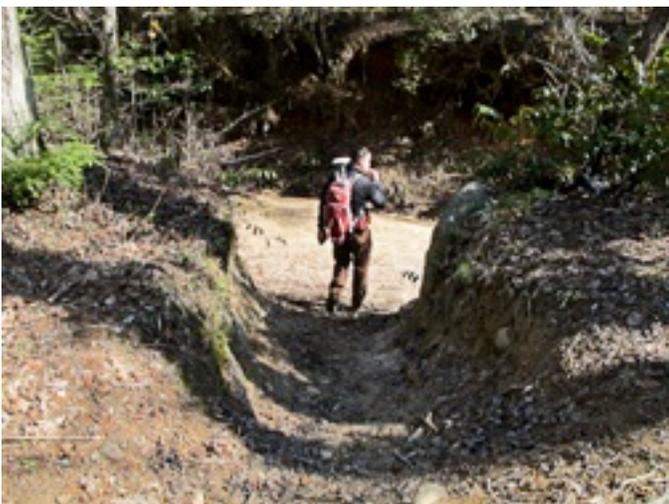
*Left: Erosion gully on fall-line portion of trail at a road junction*

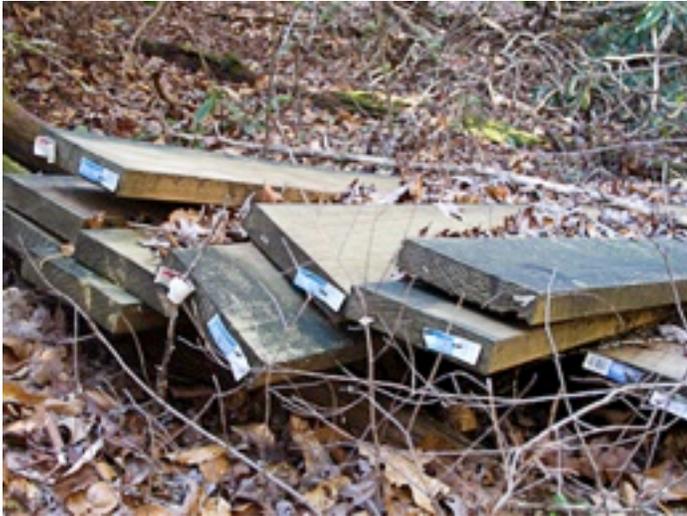
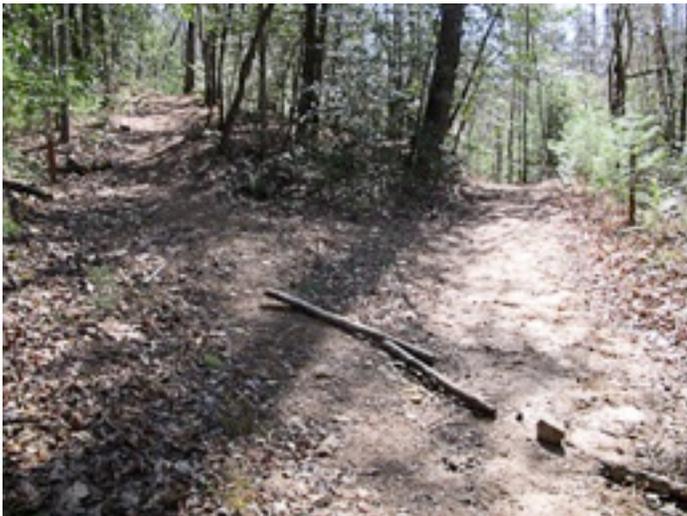
*Top Row: Extra bridge materials abandoned in forest. Some materials were left in the stream channel*

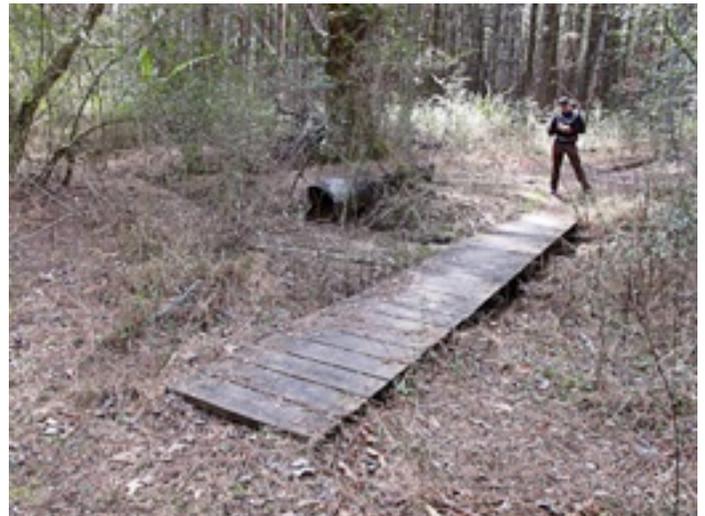
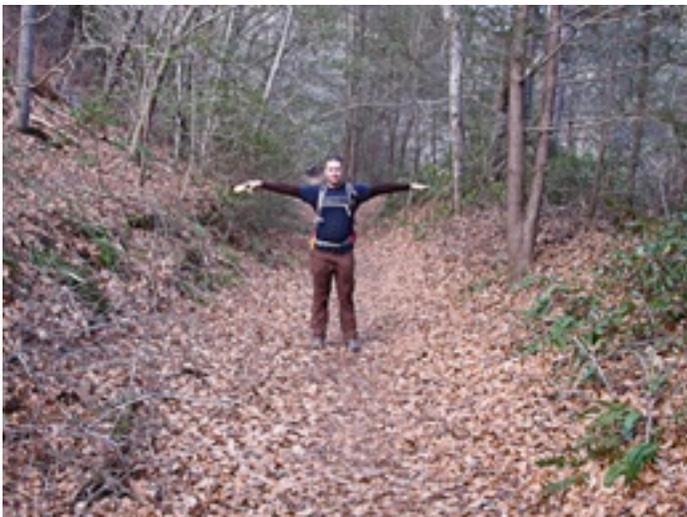
*Middle Row: Insufficient routing and simple bridge to replace culvert that has been left on-site near old homestead*

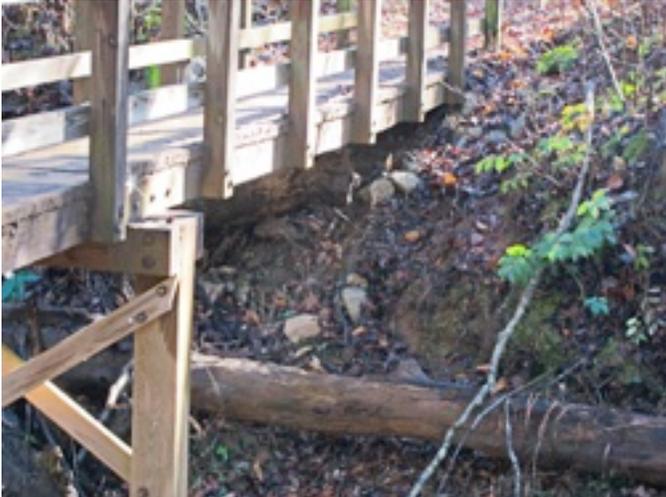
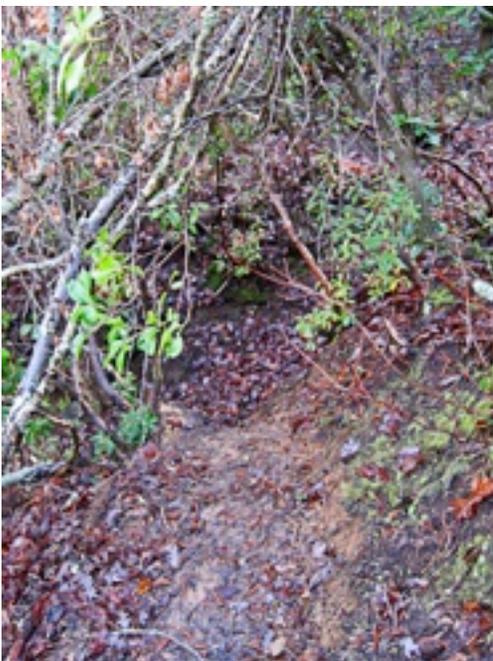
*Above, Right, and Below Right: Several bridges on the broad river trail are in need of inspection and repair.*

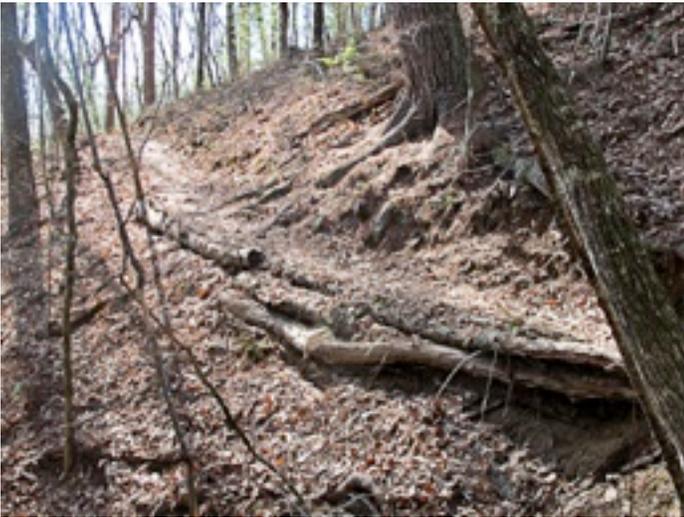
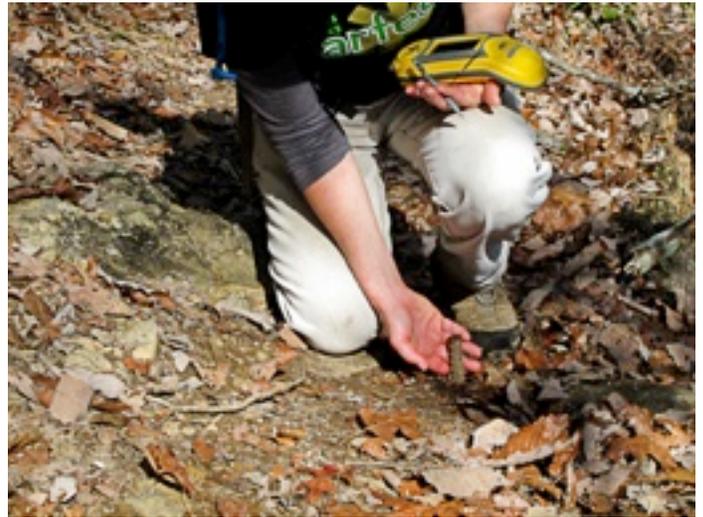
*Middle Left and Right: Crib wall and water bar structures are falling along the trail, leaving exposed rebar*

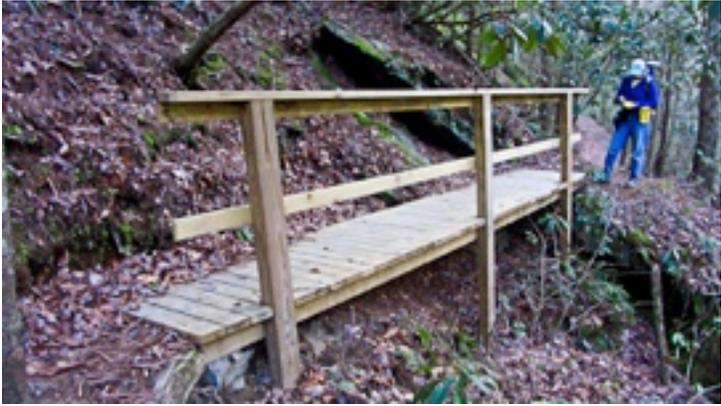
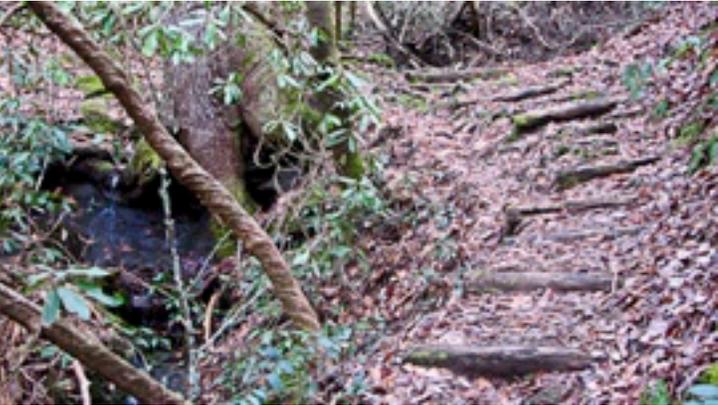
*Left: Old steps placed in trail to provide footing when tread is wet, no management of water on steep areas*

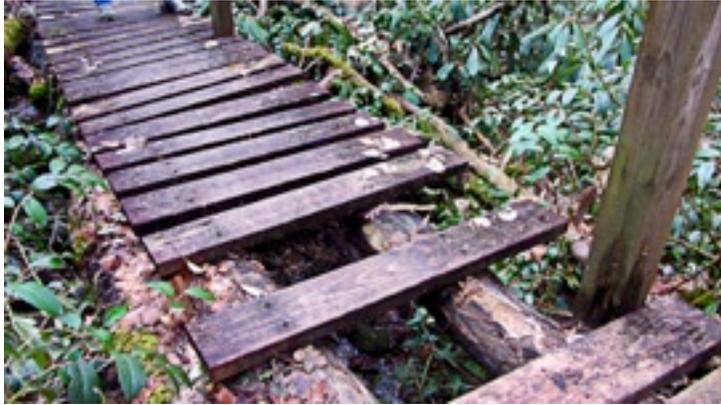
*Below: Bridge in need of inspection and repair*

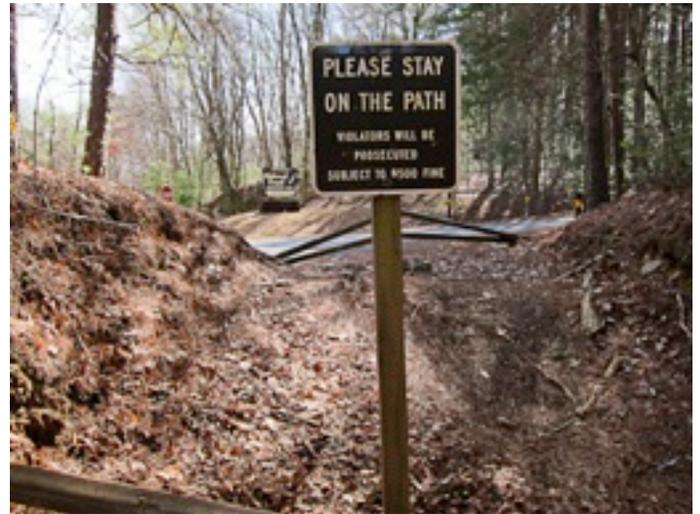
*Above Right: Regulatory signage installed, but little mitigation of problem attempted*

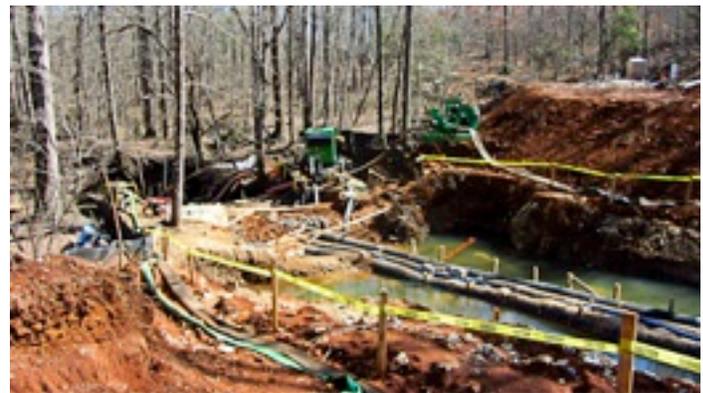
*Status of bridge repair at Trailhead access*

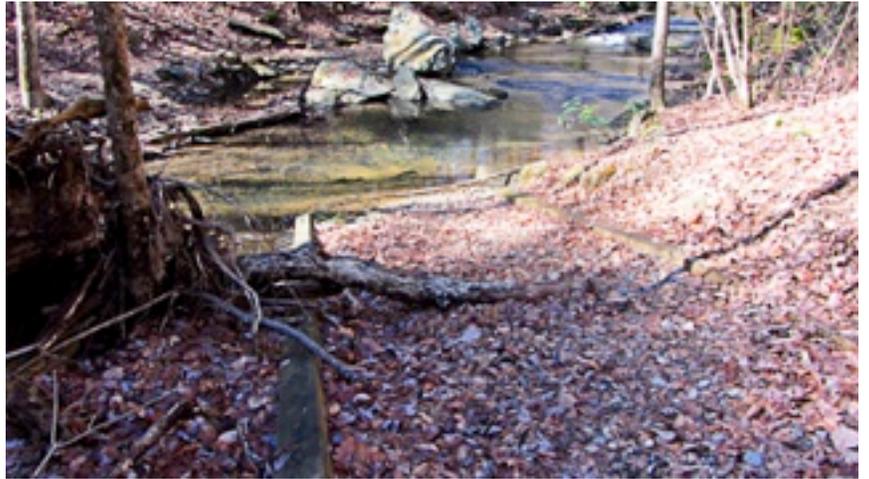
*Right: Old road bed/trail crossing of creek. No water management*

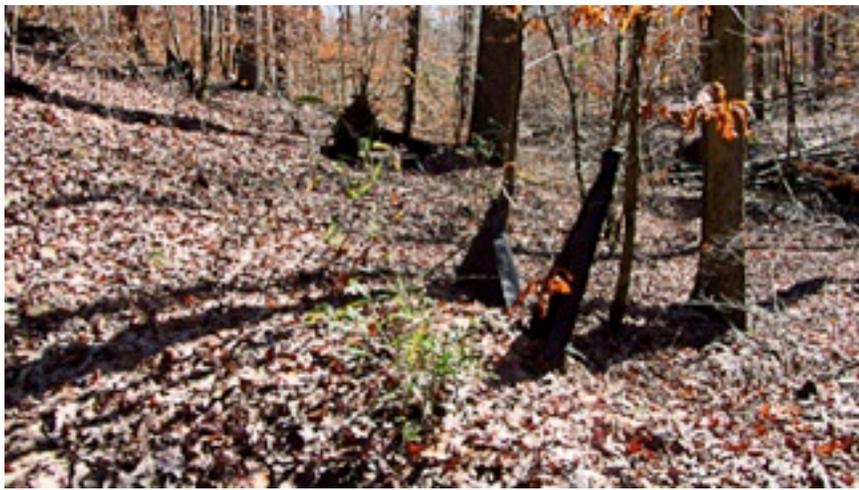
*Left: Abandoned silt fence from previous maintenance contract*

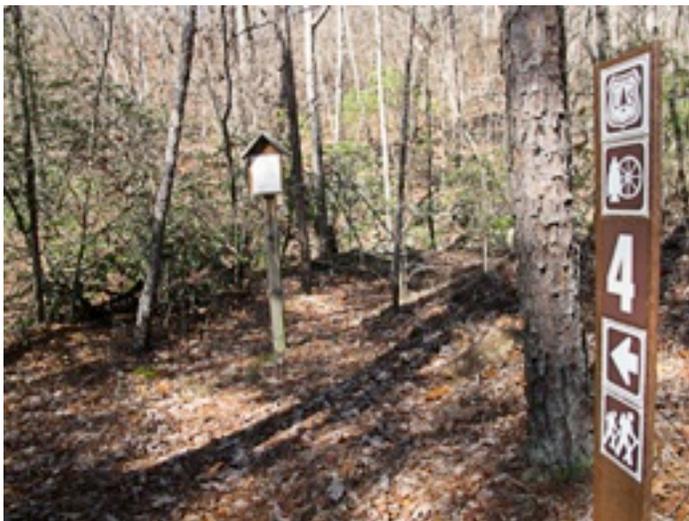
*Below: Steep road bed to unmanaged creek crossing*

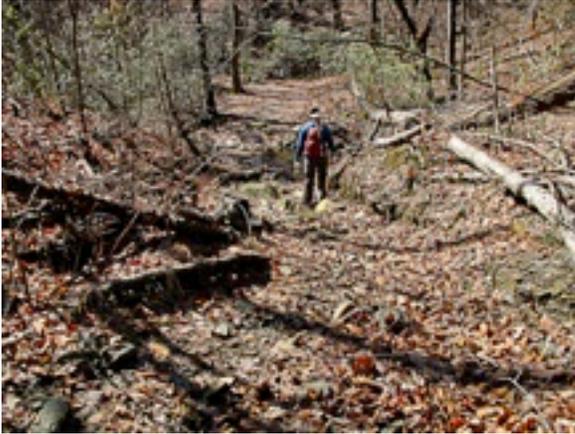
*Above: Steep road bed to creek crossing. No water management*

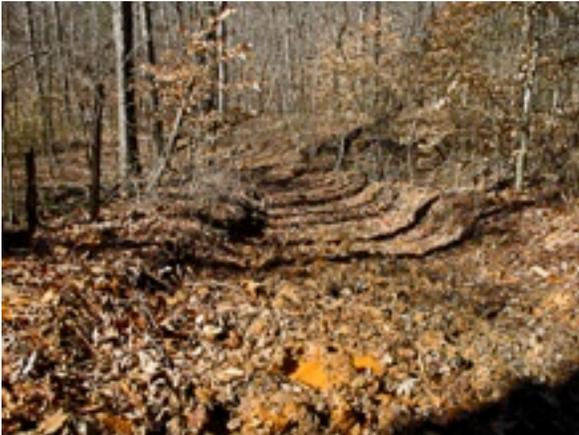
*Below: Incised portion of trail, no water management becoming linear mudhole*

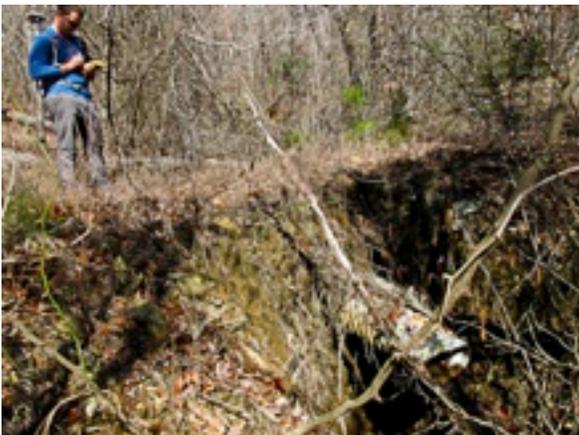
*Below: Lack of water management over trail has scoured a culvert crossing. Culvert damaged where exposed and ~3' deep gully below culvert headcutting back into trail*

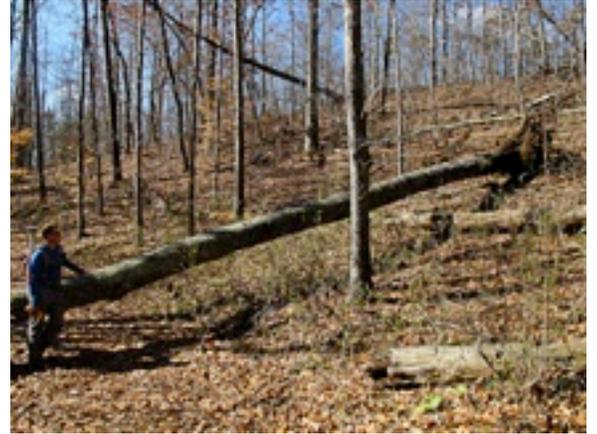
*Above: Large trees crossing trail all have fall line social trail development to avoid tree*

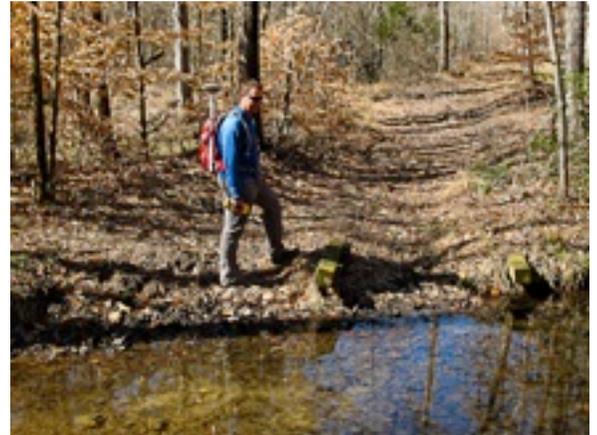
*Below: Creek crossing, no water management. Stringers abandoned at some point*

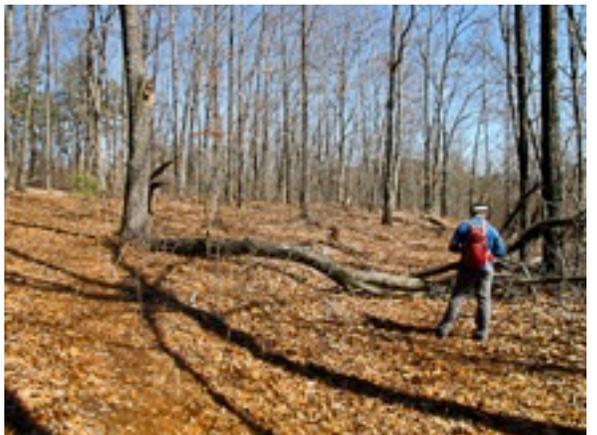
*Below: Dead fall over trail with social trail development*

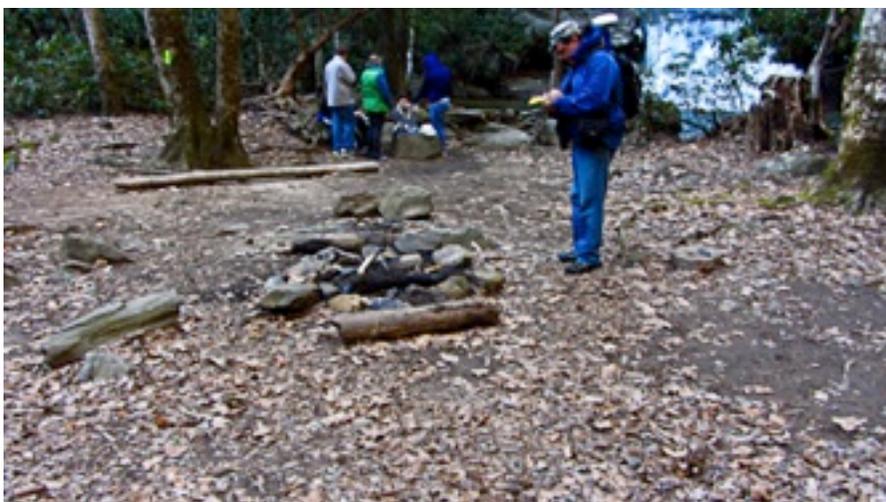
*Bottom: Typical, large camping area with trampling impacts*

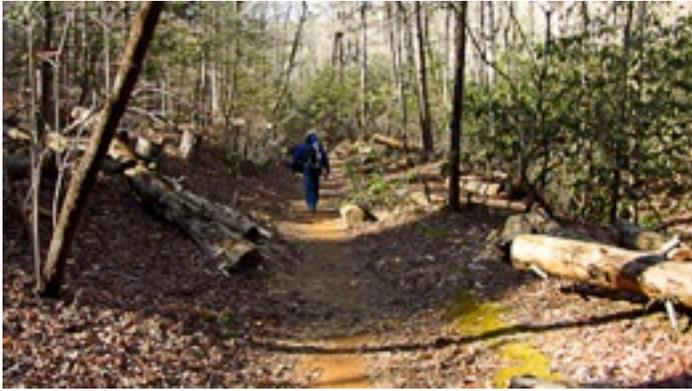
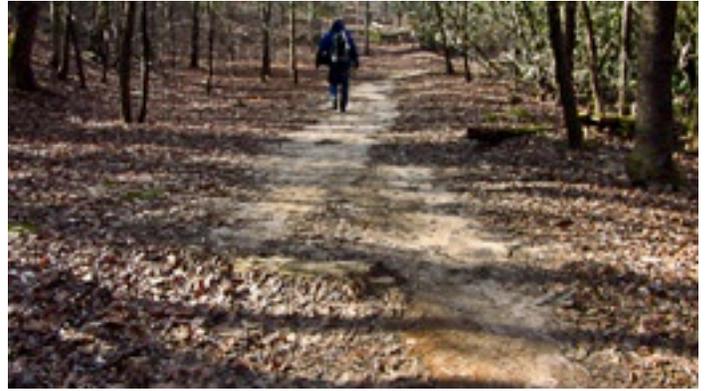
*Above Left and Right: Old road bed is at times incised/eroded and subsequently experiencing sediment deposition*

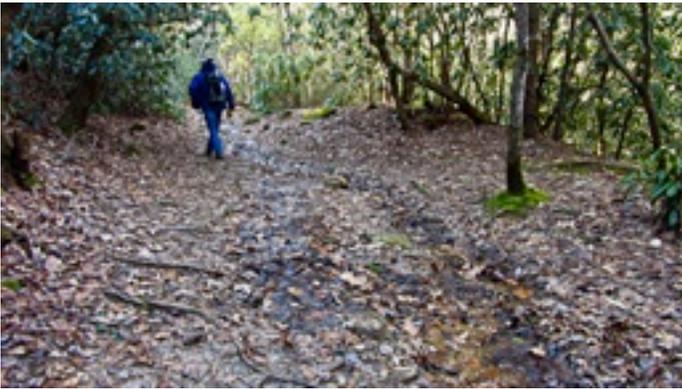
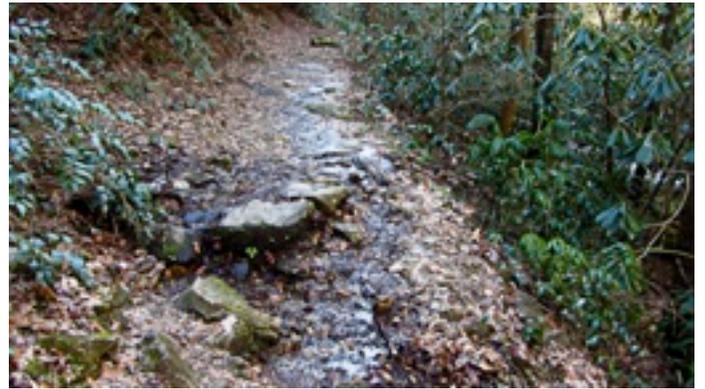
*Above and Below: Lack of water management across entire length of trail shows signs of long-term tread saturation, erosion, and much higher slipping potential than necessary on a Class 4 trail*

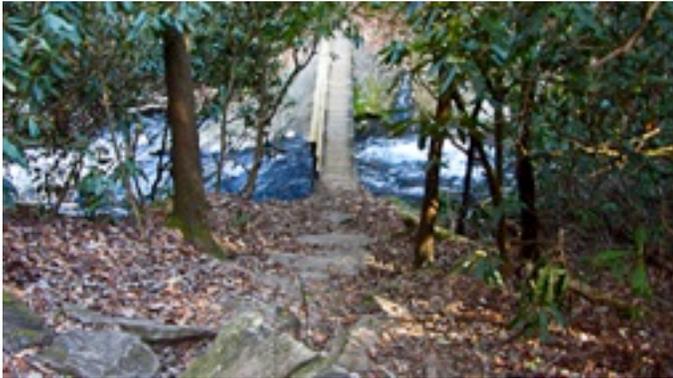
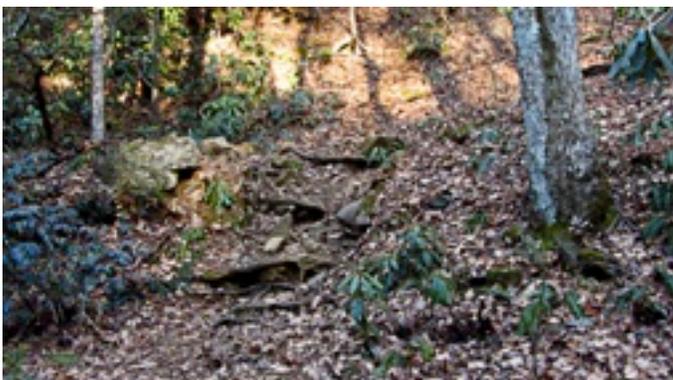
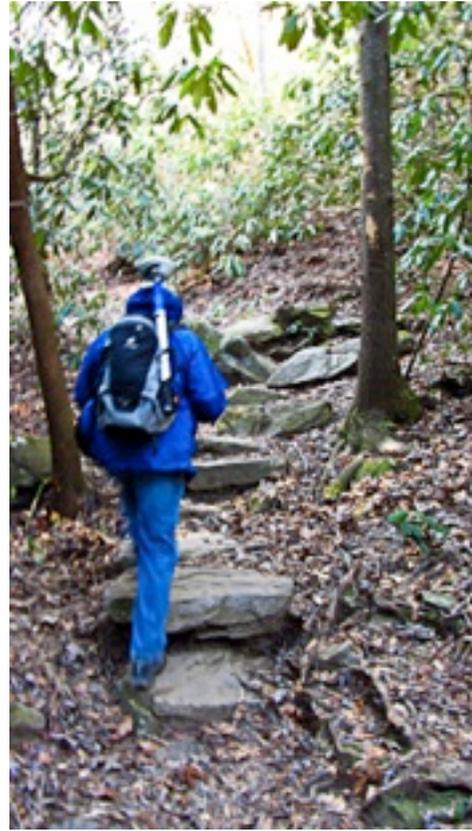
*Above: Very steep and eroding sections with large, uneven steps and scour erosion approaching bridge*

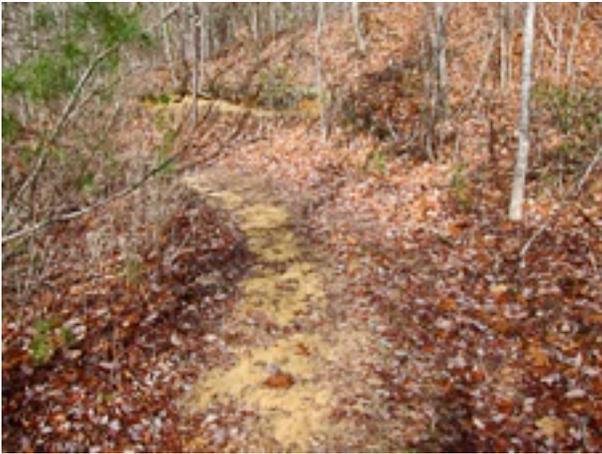
*Left, Above and Below: Trail conditions on  
Ladyslipper are complicated by illegal motorized  
use.*

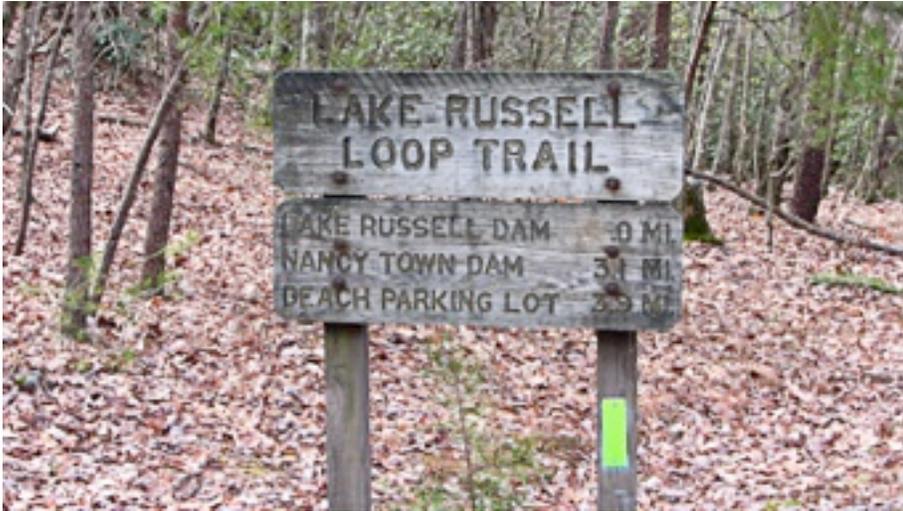
*Above: Older trail navigation signage*

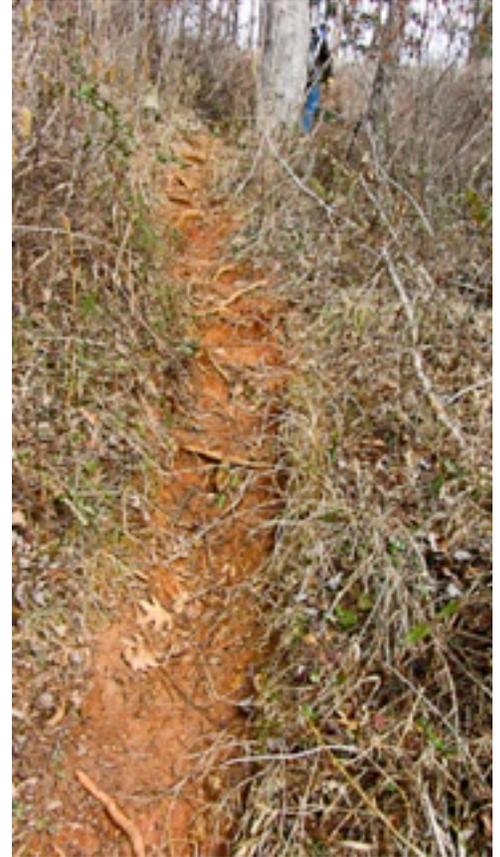
*Right: Steep fall-line trail eroding*

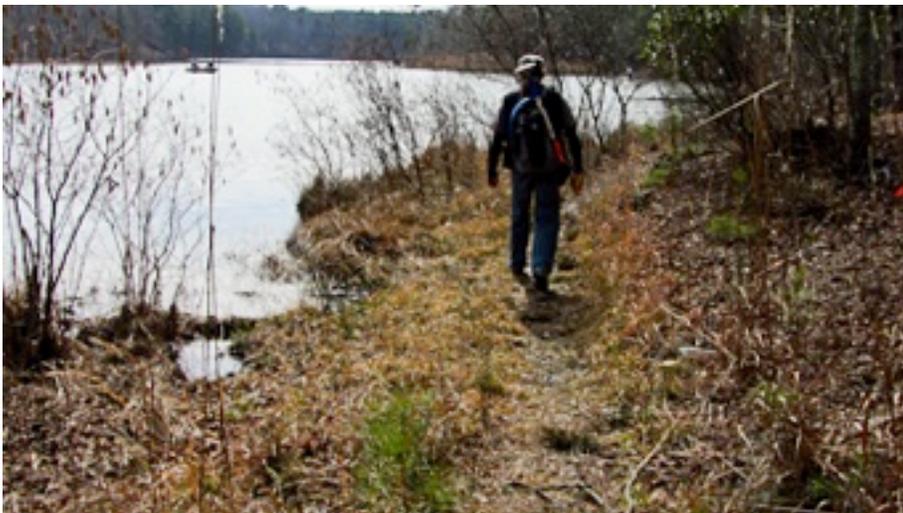
*Below: Minimally constructed trail at lakeshore*

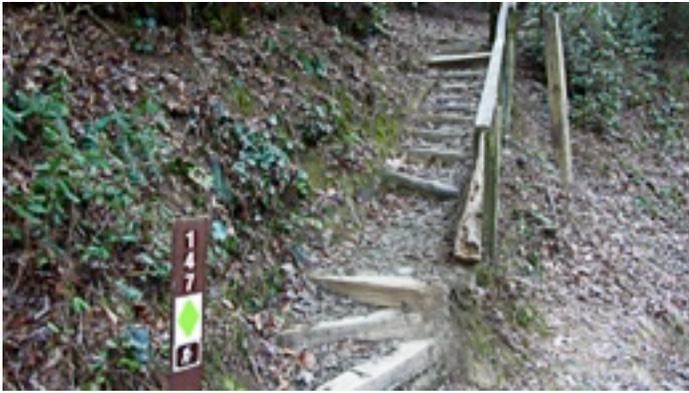
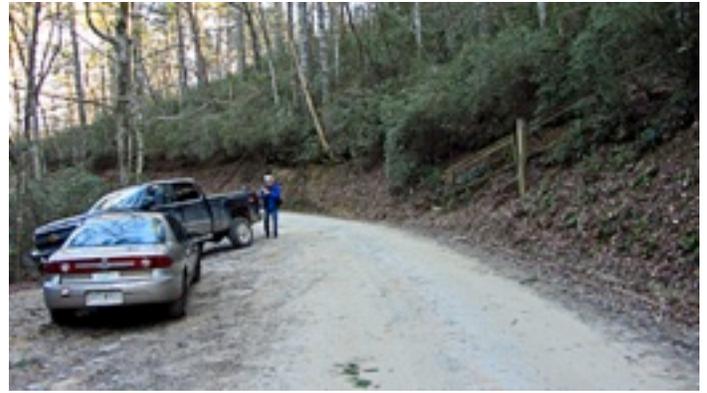
*Trailhead parking at maximum capacity (two vehicles) and initial stair step climb toward falls*

Priorities	<p>High- Parking and access improvement to reduce potential for accidents on road</p> <p>High- Structures need to be upgraded, both in number and size</p> <p>High- Initiate water management program</p> <p>Medium- Tread stabilization/surfacing to decrease roughness and improve accessibility</p>
------------	--

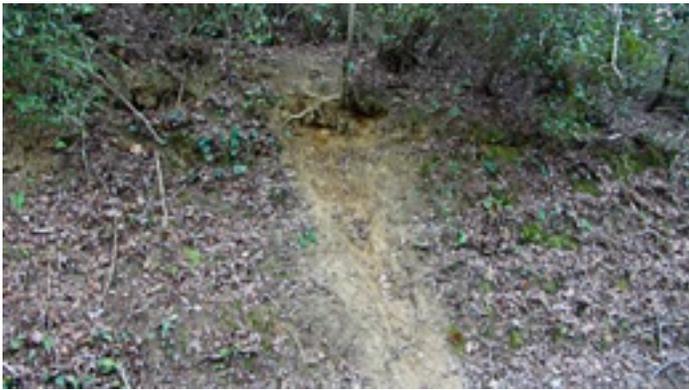
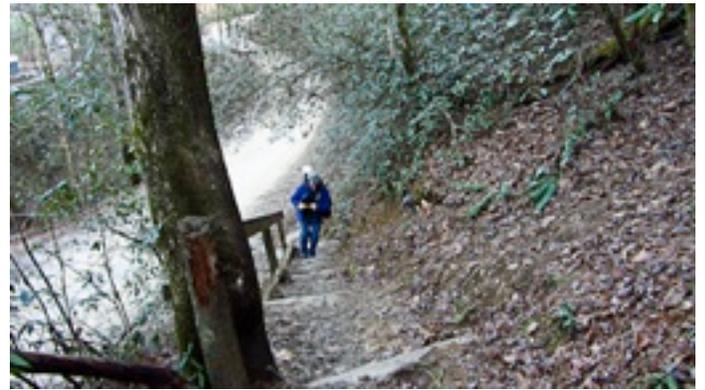
*Above: Social trail formation to avoid stair steps at beginning of trail*

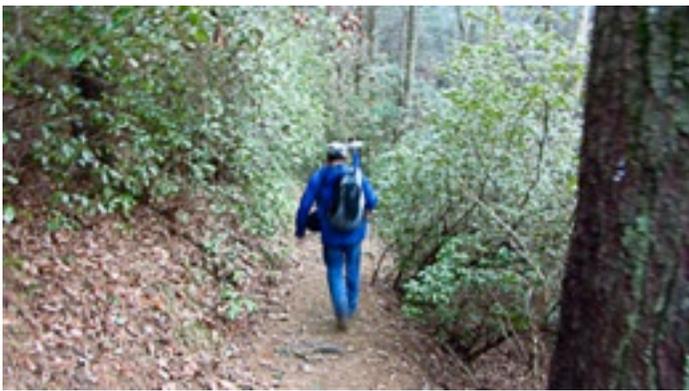
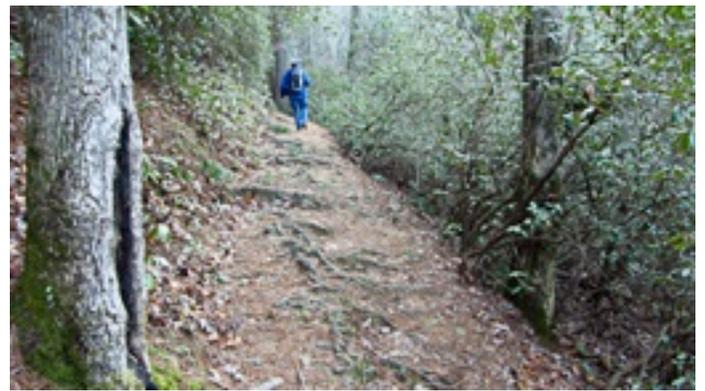
*Above and Below: Relatively narrow trail without active water management and beginning to show signs of erosion*

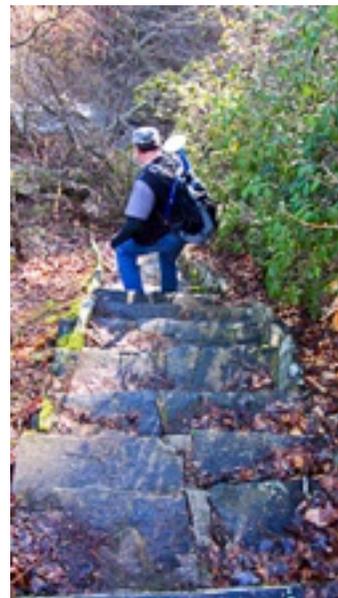
*Right: Steep stone steps downstream of the Nancytown Lake spillway*

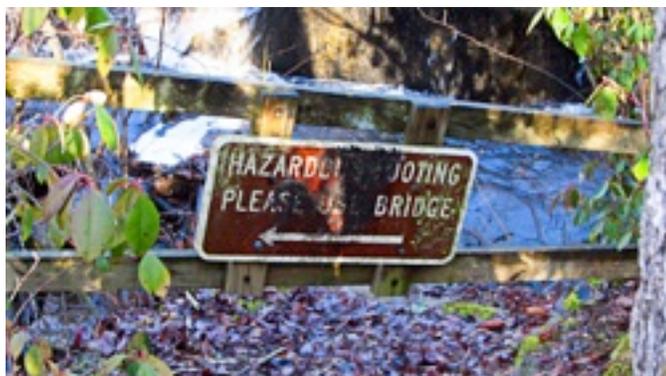
*Left: Vandalized risk management signage*

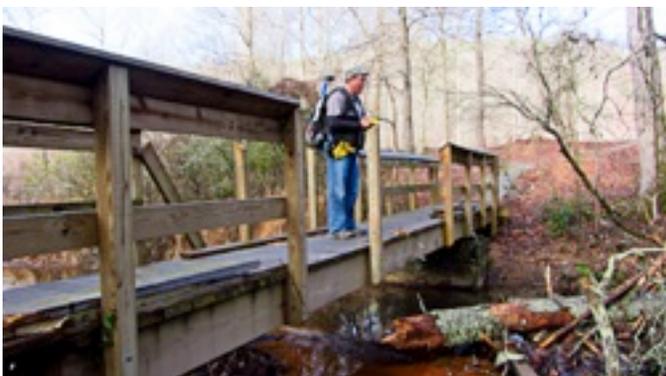
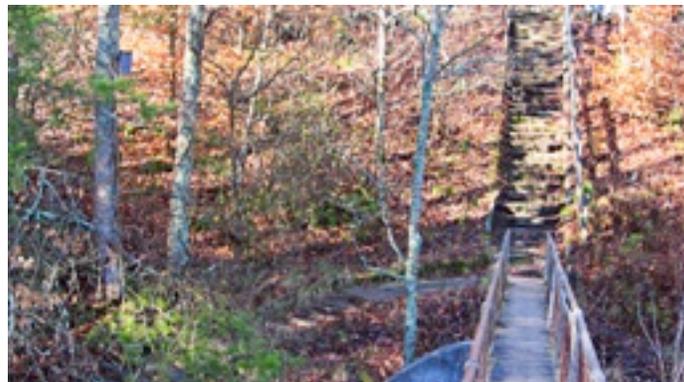
*Below Left and Right: Extensive steps and bridge structure showing damage from tree fall*

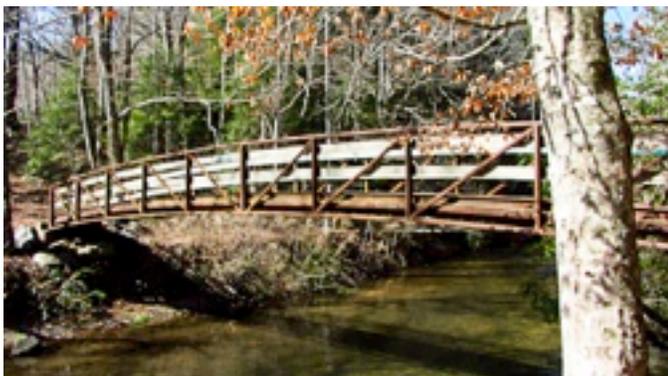
*Below: Large, steel bridge crossing Panther Creek and railing damage on a much smaller foot bridge*
