# FOREST-WIDE COLLABORATIVE TRAILS ASSESSMENT

CHATTAHOOCHEE-OCONEE  
NATIONAL FOREST

CHATTOOGA RIVER RANGER DISTRICT

JANUARY- MAY, 2012  
CONTRACT #: AG-435H-S-12-0001

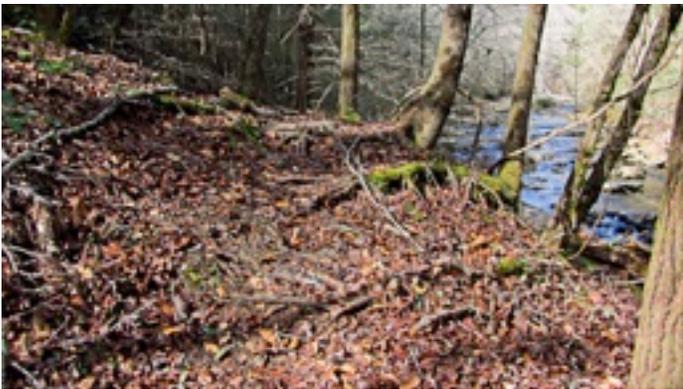
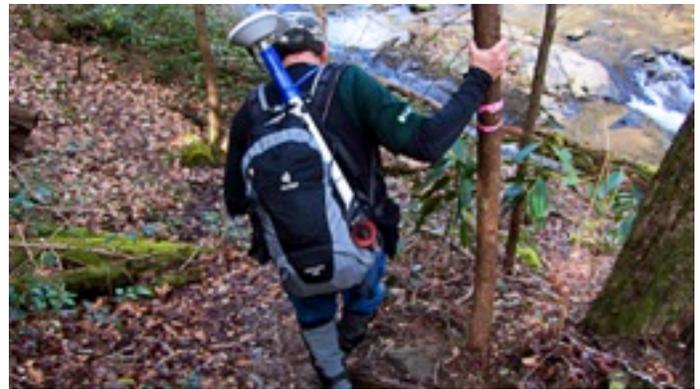
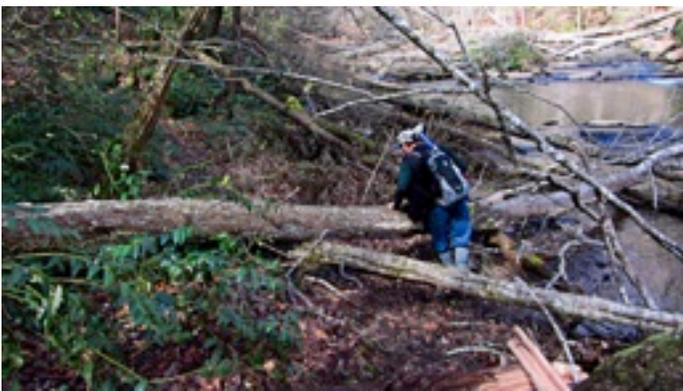
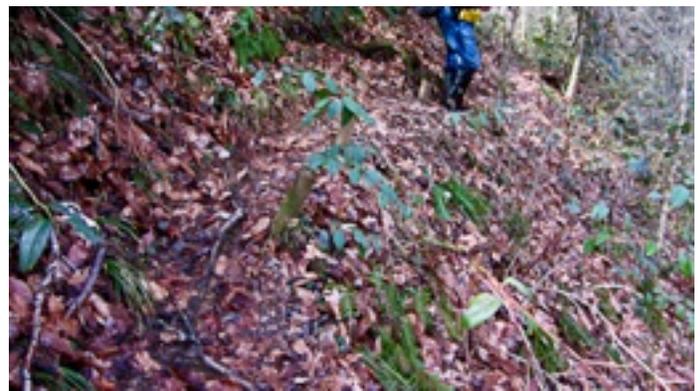
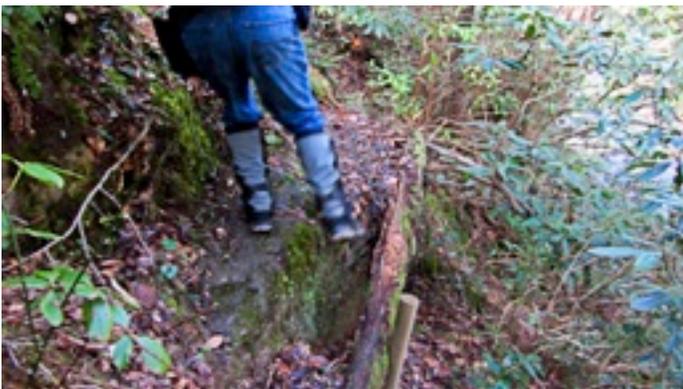
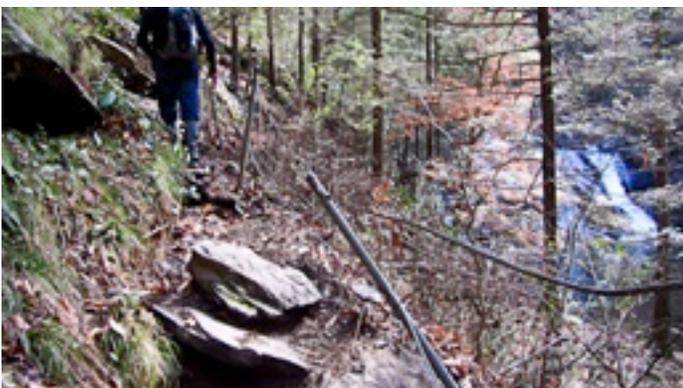
*A number of photos demonstrating the portion of the trail downstream/southeast of the waterfall. Trail is minimally constructed, often with tread less than 12". No evidence of corridor maintenance. Many locations where crib wall or guide wires were installed to maintain footing but are in disrepair and pose safety hazards.*

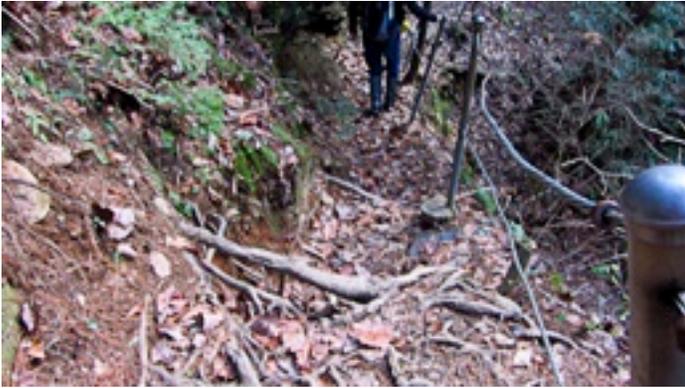
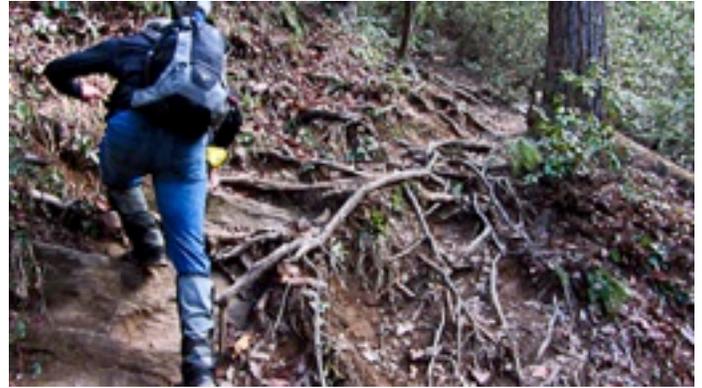
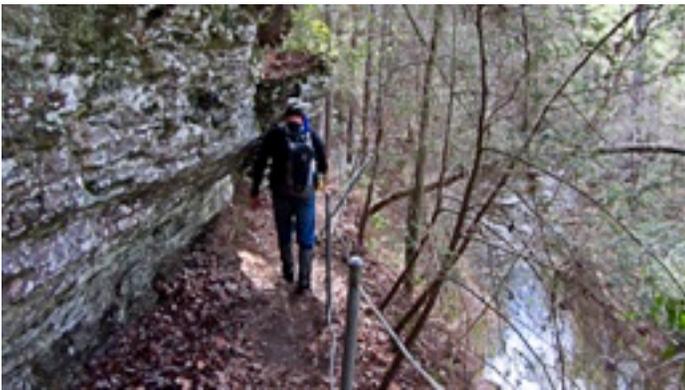
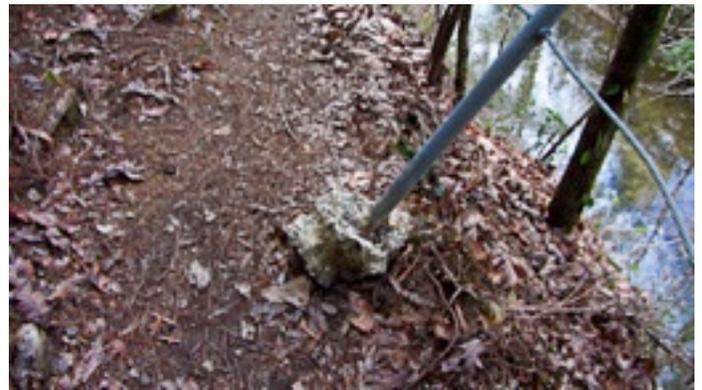
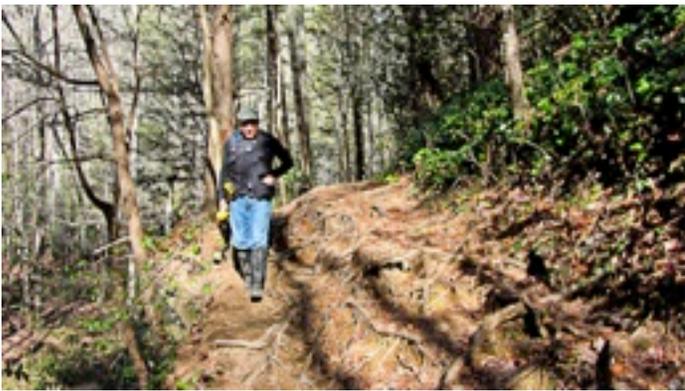
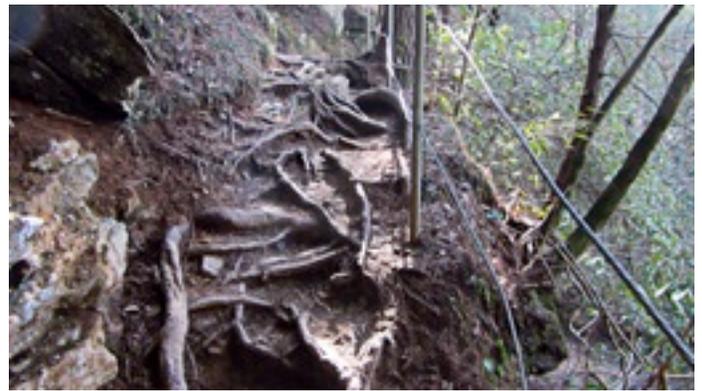
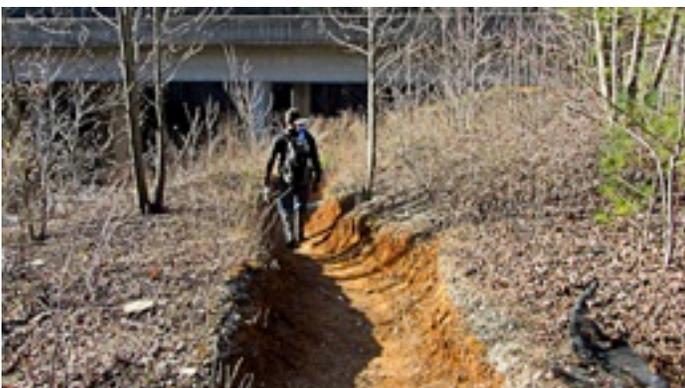
*A number of photos demonstrating the portion of the trail upstream of the waterfall. Trail is minimally constructed but more defined from higher levels of use. Significant erosion in many locations. More guide wires that are in disrepair and may pose safety hazards. Incised trail (~24" deep), with no attempts at water management, carrying sediment toward Panther Creek.*

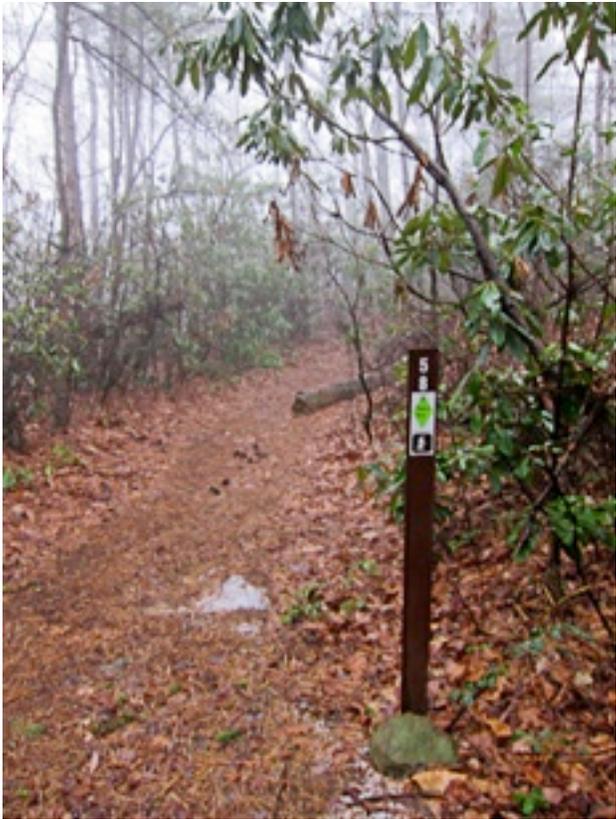
*Top Left: The trail starts at a junction with the Bartram trail near Courthouse Gap.*

*Bottom Left: A large sediment deposit at the base of the steep ascent to Pinnacle Knob.*

*Bottom Right: The overlook provides fantastic views when not clouded in; however someone has spray painted a red line on the rocks.*

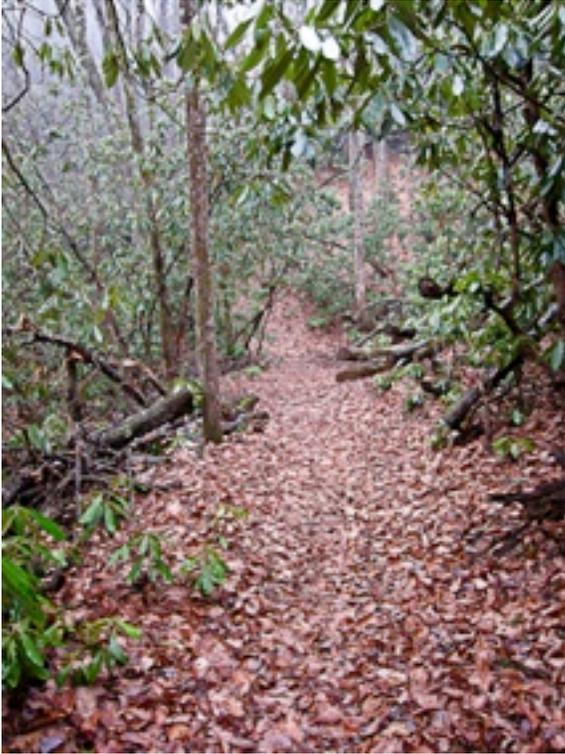
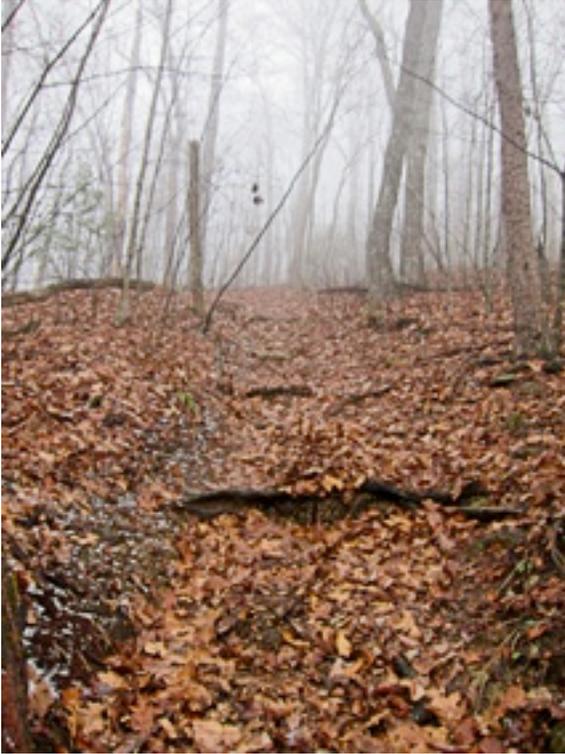
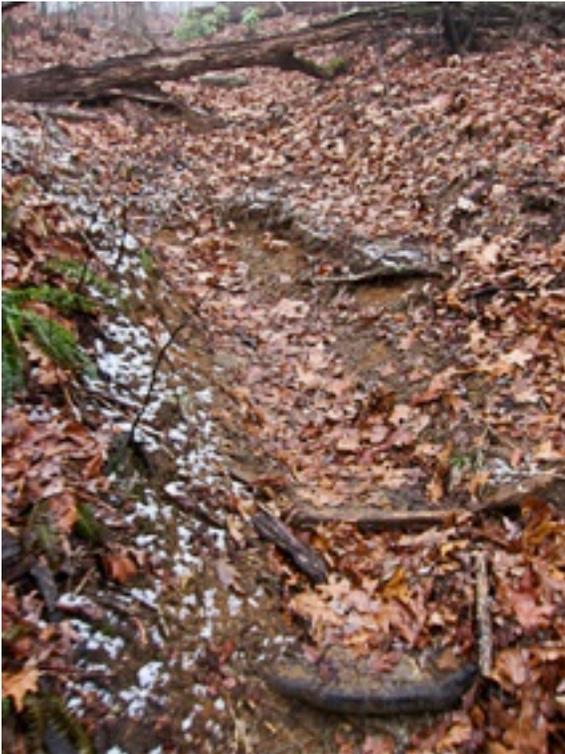
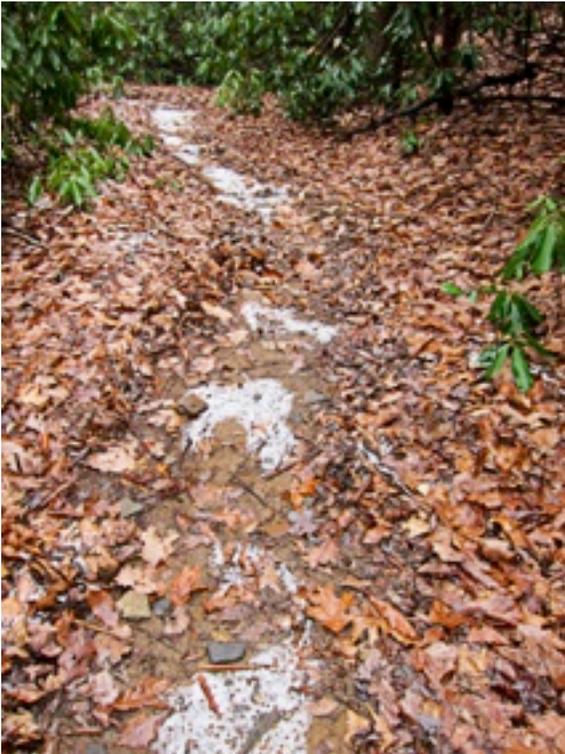
*Trail is very steep throughout and demonstrating signs of a large amount of soil loss and deposition*

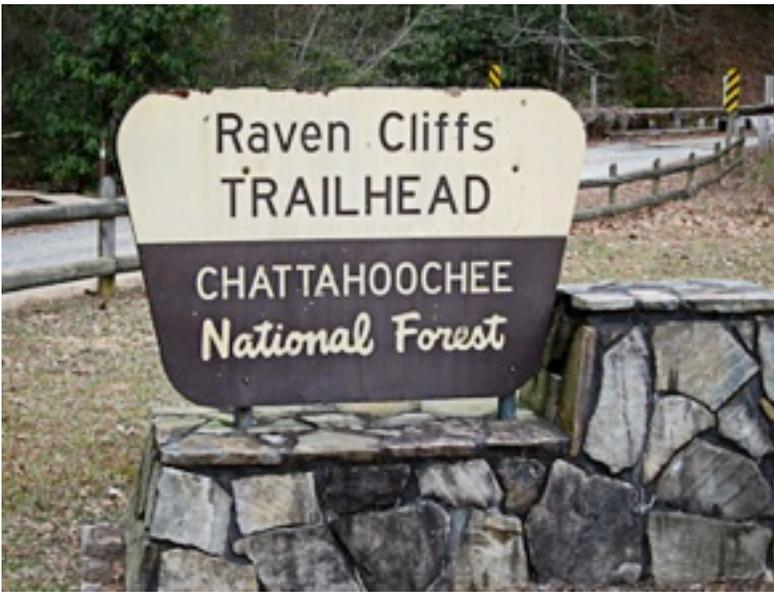
*Left, Above and Below: Signage directing traffic to the Trailhead and the trail. Raven Cliffs is a destination area in the Raven Cliffs Wilderness.*

*Right: The fall-line ascent to view the falls is eroded to a width of more than 10 feet.*

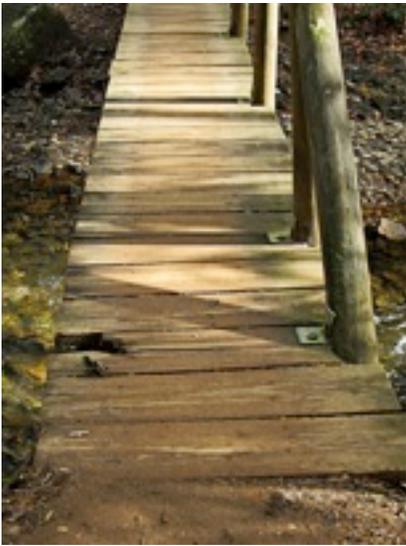
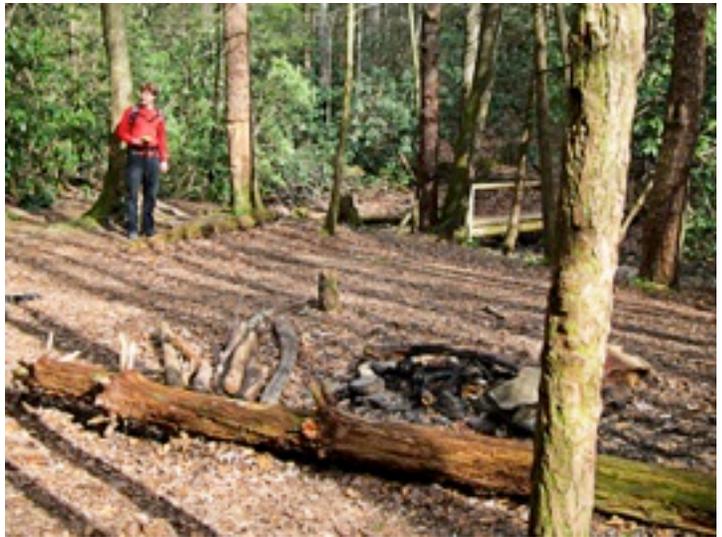
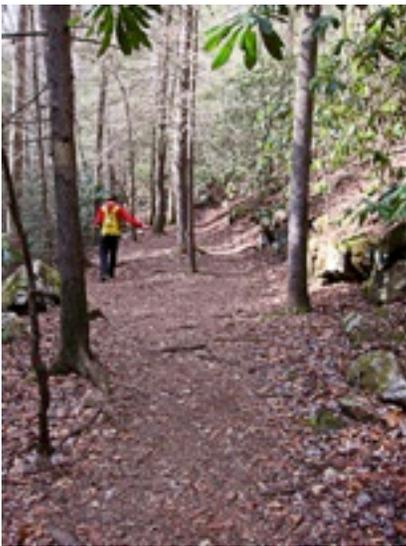
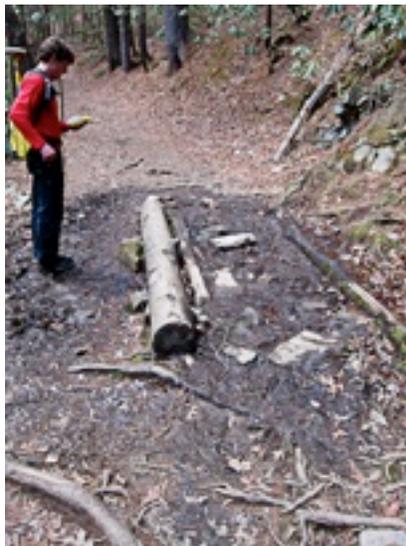
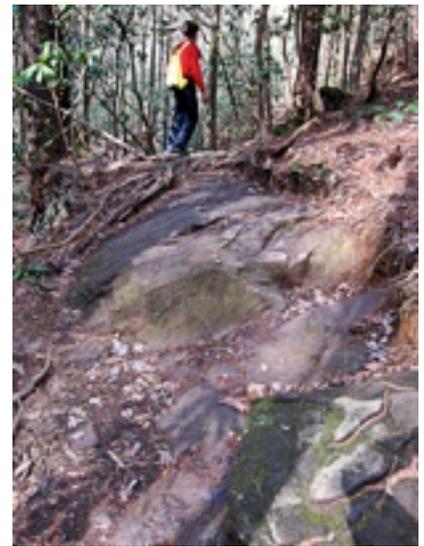
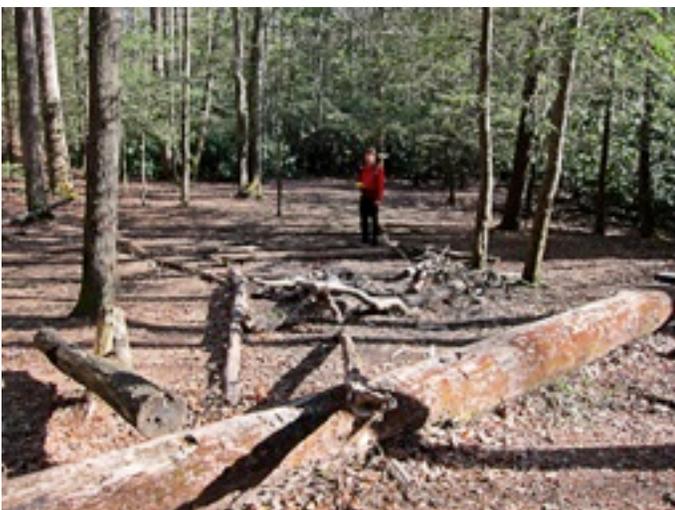
*Very high use trail, including large, user-developed camping areas with extensive vegetation impacts and massive fire rings adjacent to trail. Poor alignment and lack of consistent or effective maintenance has led to degraded condition.*

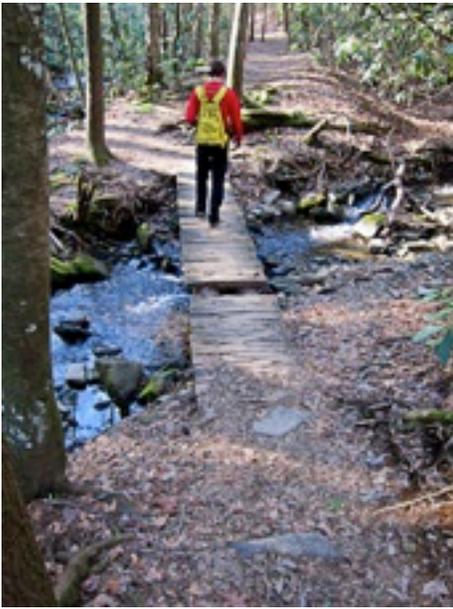
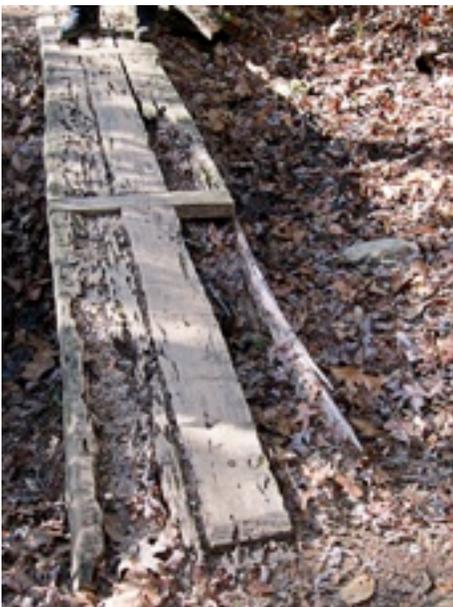
*Left, Above and Below: Many bridges along the trails are in need of repair and approaches to water crossings show little or no attempt to control sediment.*

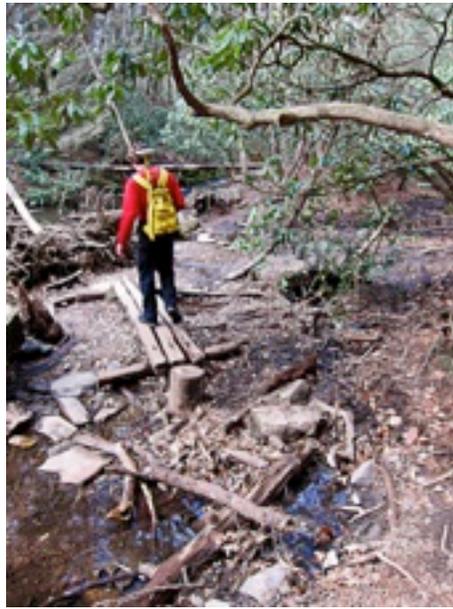
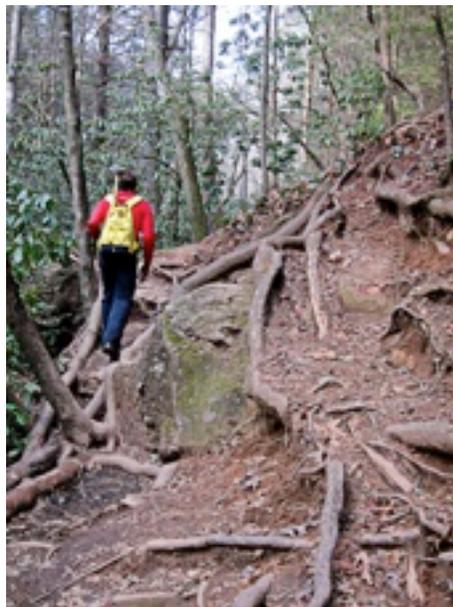
*Middle, Above and Below: Lack of tread definition has led users to attempt multiple routes and cause extensive trampling impacts and likely increased sedimentation to the water sources*

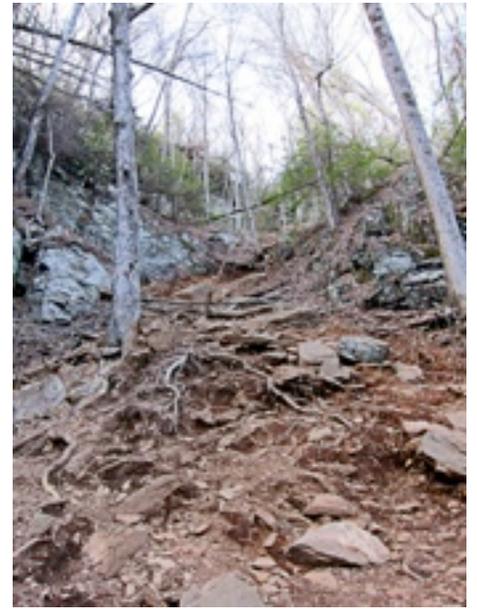
*Right, Above and Below: Lack of user management/routing has led to extensive resource impacts at the cliffs. Fall-line trail above is approximately 20' wide and actively eroding. Below, a typical Wilderness visitor demonstrates displeasure with his trail experience.*

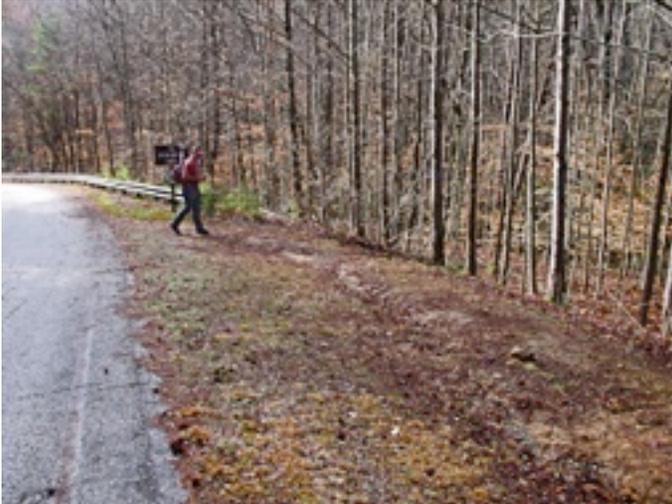
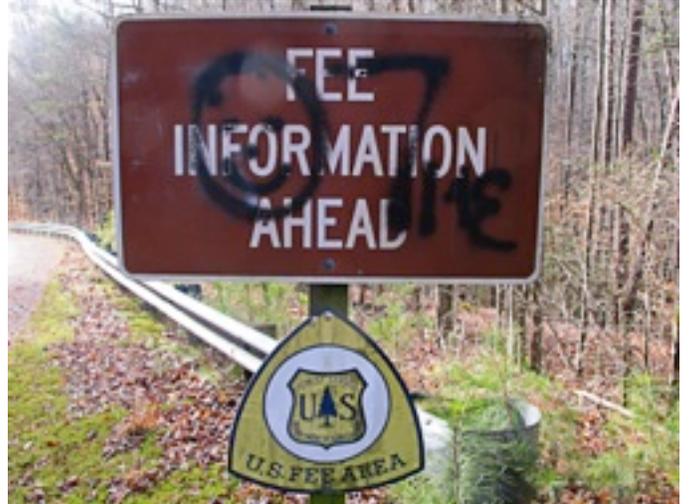
*Top Left and Right: Beginning of trail along Lake Russell access road and vandalized fee area sign*

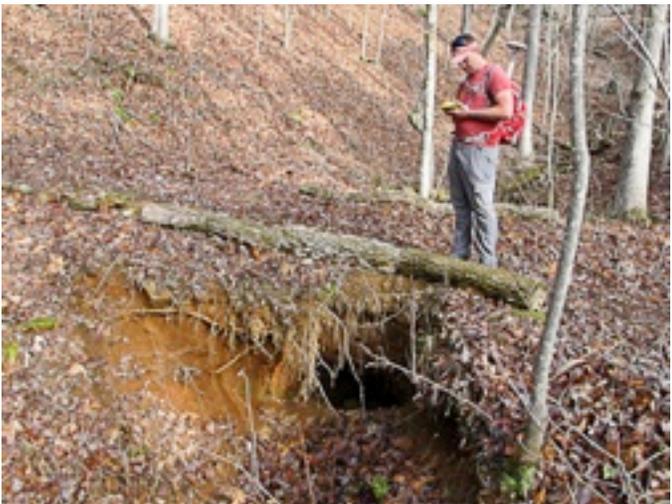
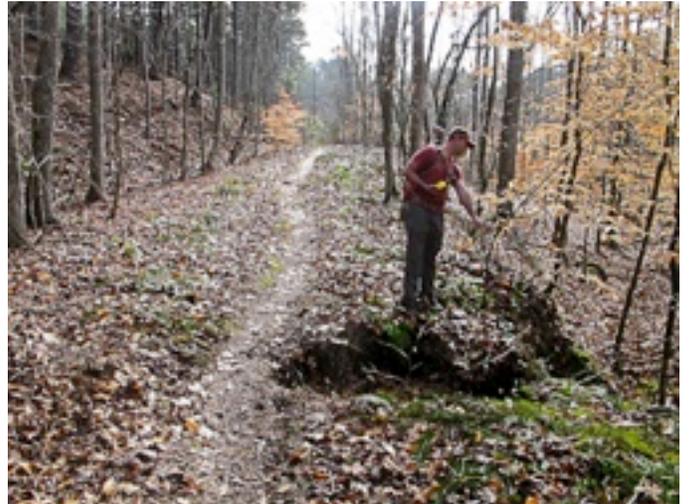
*Middle Left and Right: Stormwater from access road causing significant scour of the old road bed*

Priorities	<p>High- arrest stormwater blow out issues on old road bed before 8' deep channels cut through trail</p> <p>Medium- Bring trail up to Class 3 design parameters, and connect to Lake Russell Loop at Nancytown parking area.</p> <p>Medium- Institute regular maintenance program, including water management on old road, bridge and switchback repair, corridor brushing, relocation of overly steep sections on upper half of trail.</p>

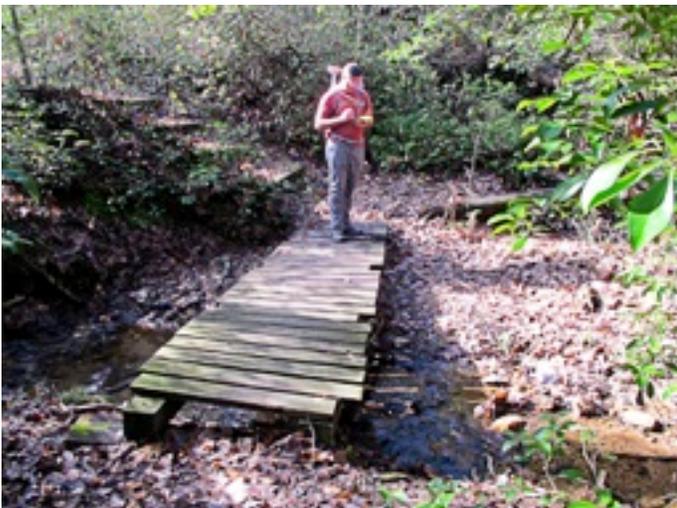
*Left: Rotting bridge over minor creek that could be replaced with stepping stones*

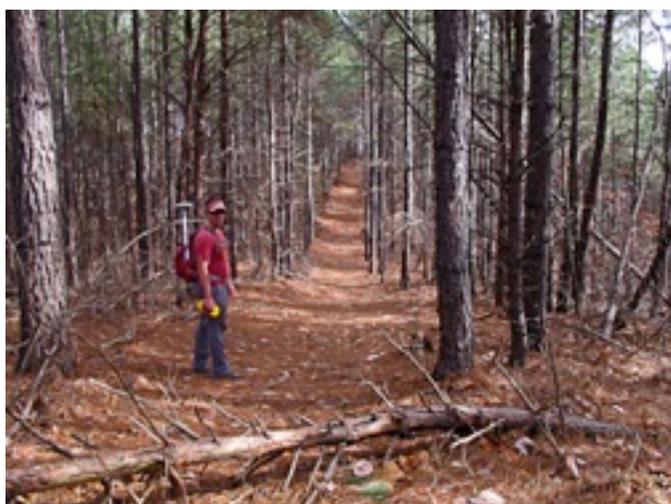
*Above: Old fire break employed as trail*

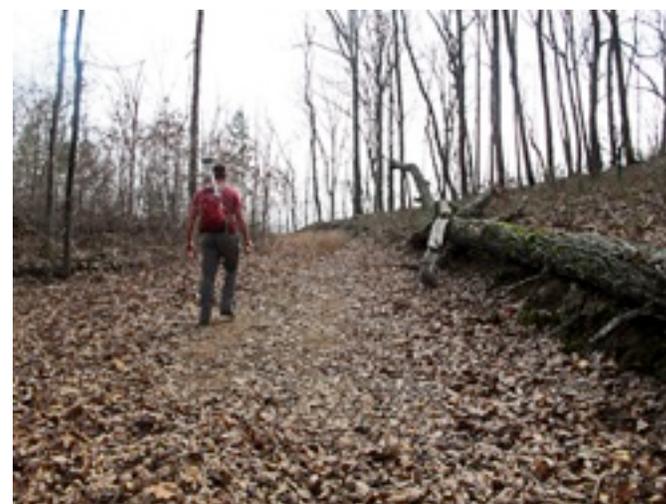
*Above: Old road bed, approximately 25-foot wide employed as trail*

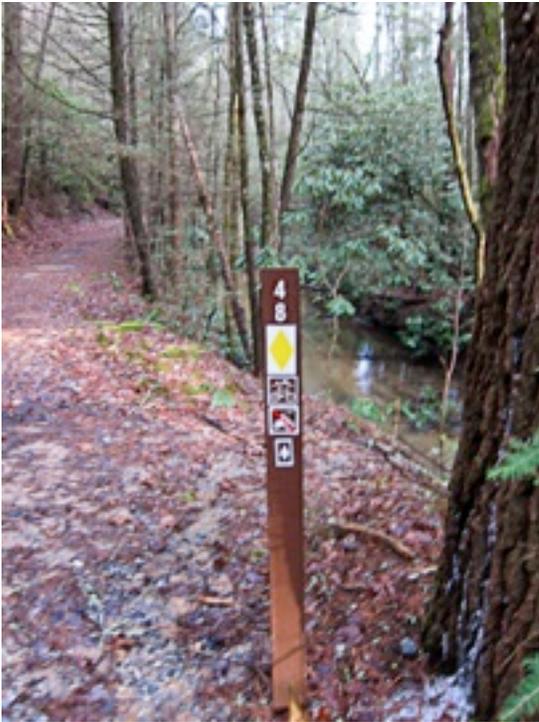
*Top Left: Carsonite with regulatory information along creek, but no gate or width restriction.*

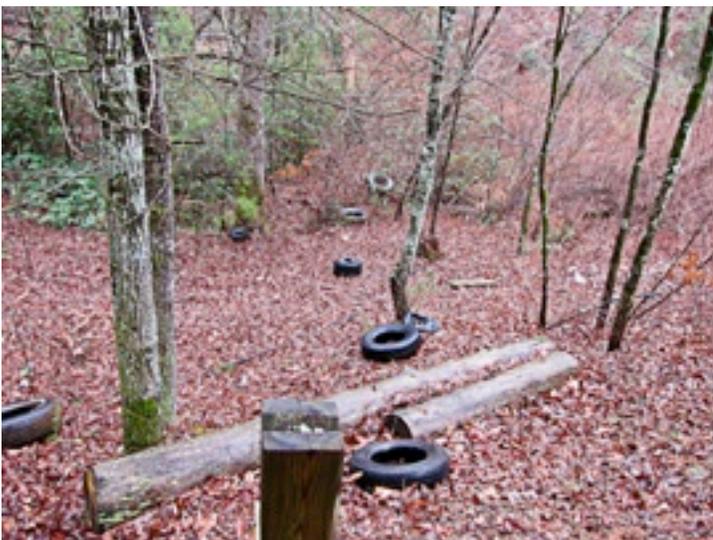
*Bottom Left and Right: Trash and dumping are prevalent near the FSR access road. A campsite at the falls shows signs of OHV and fullsize trucks driving into the stream.*

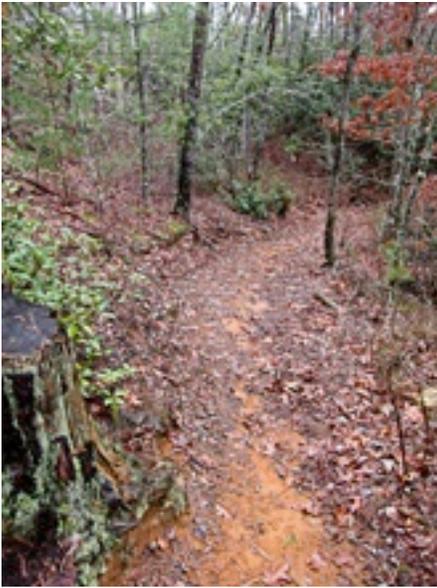
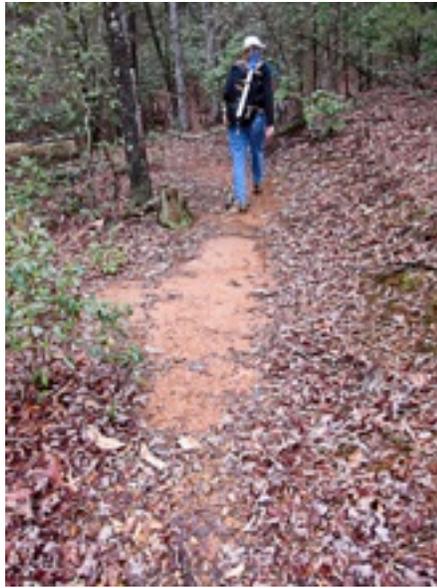
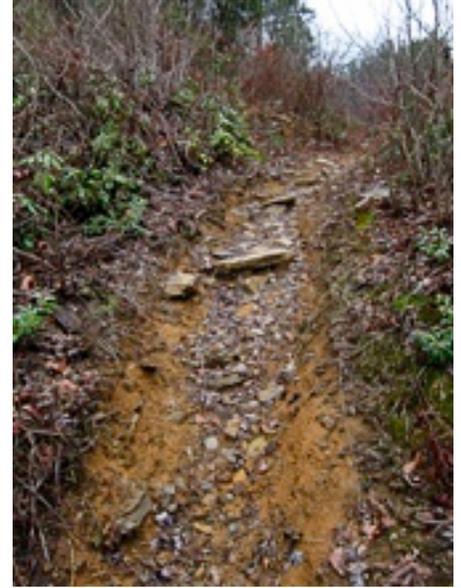
*Above: Trail is actively eroding despite relatively recent construction. Design grades are too steep along some stretches and lack of rolling contour allows stormwater to build up erosive momentum*

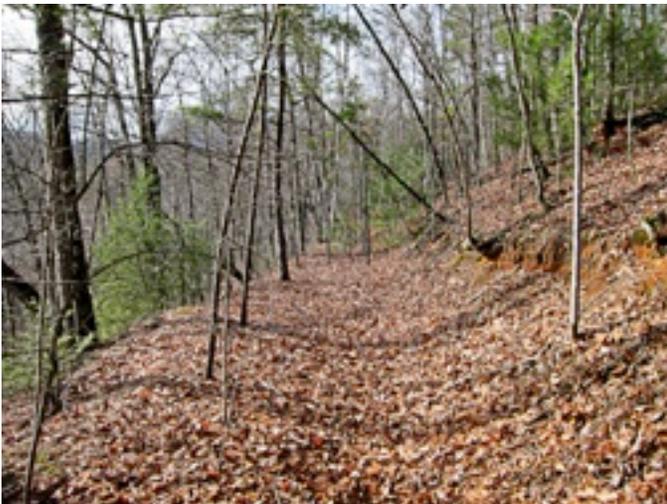
*Above: Portions of the trail are sited on old road beds*

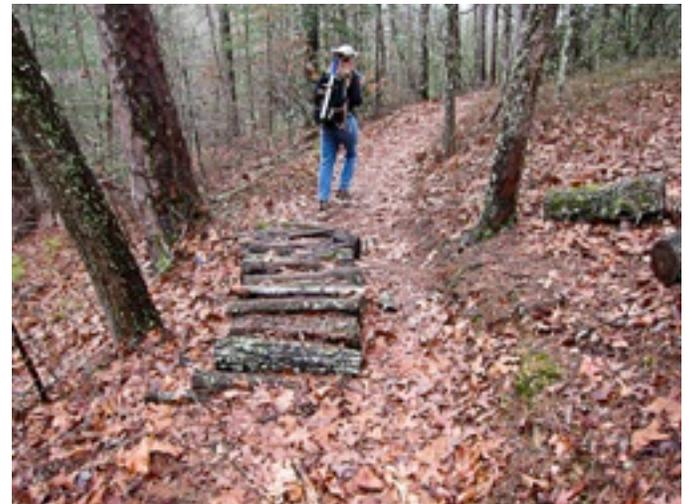
*Above: Poorly constructed technical trail feature*

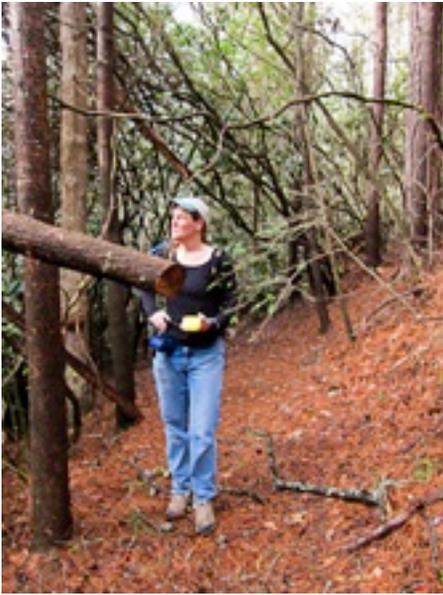
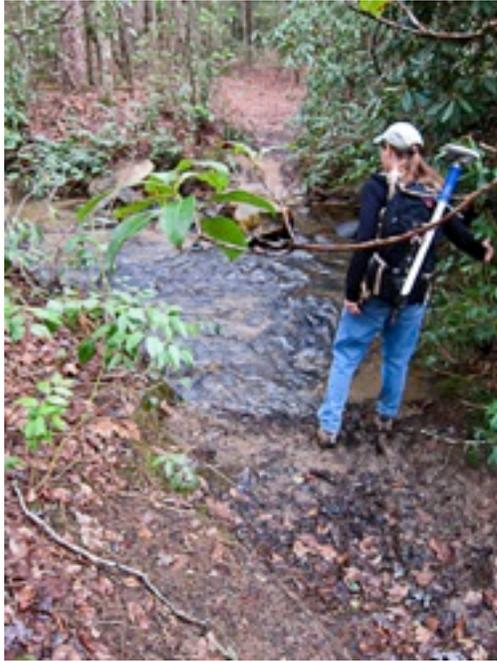
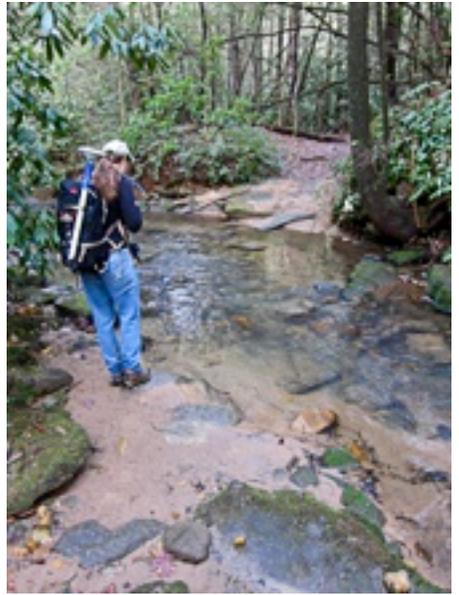
*Above: Corridor clearing activity that poses safety hazard to mountain bikers. Unimproved water crossings on loop heading back to FSR.*

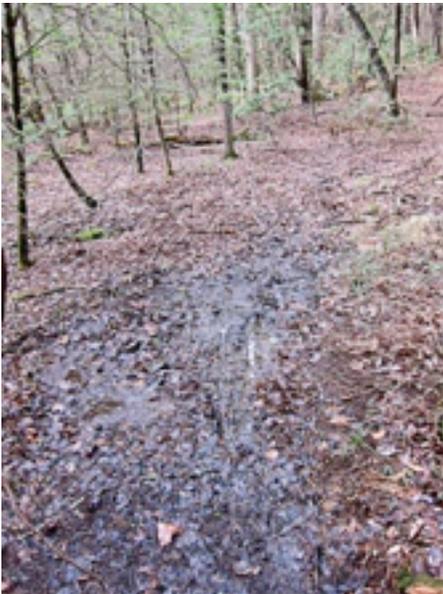
*Above: Lower section of trail has a number of muddy areas and some areas show signs of considerable off-highway vehicle use*

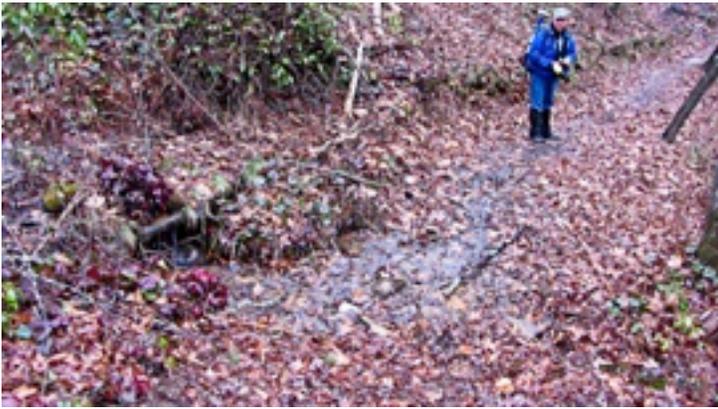
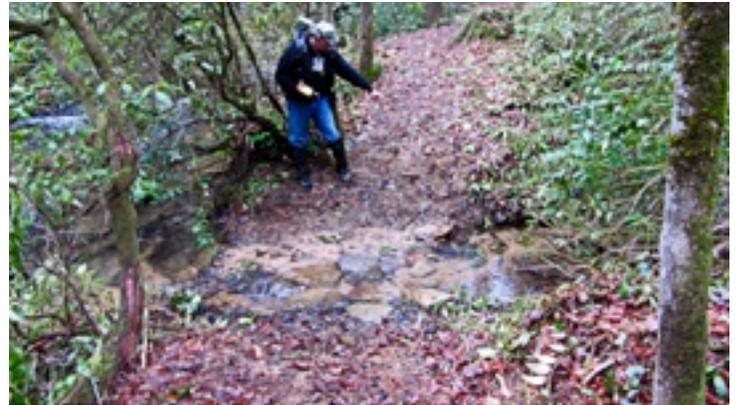
*Above and Right: Trail location in seep and attempt to armor a drainage crossing*

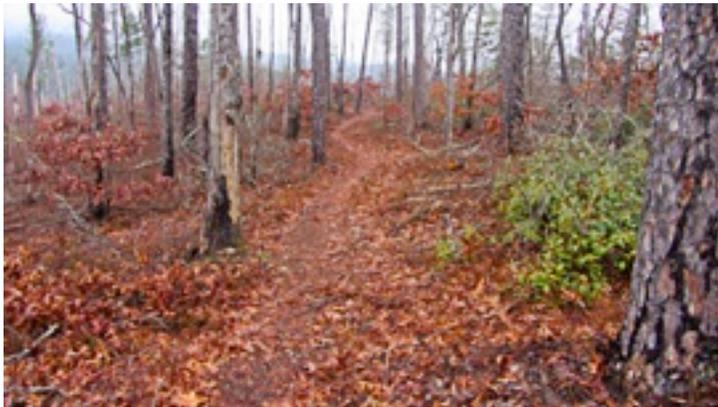
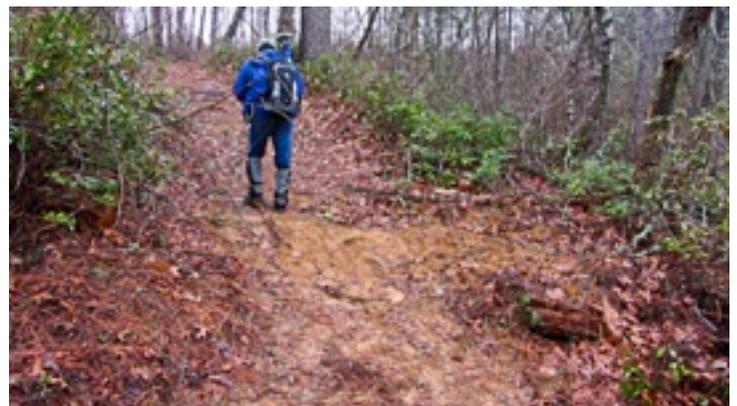
*Left and Below: Fall-line trail location requires water management, but should be more substantial than demonstrated below*

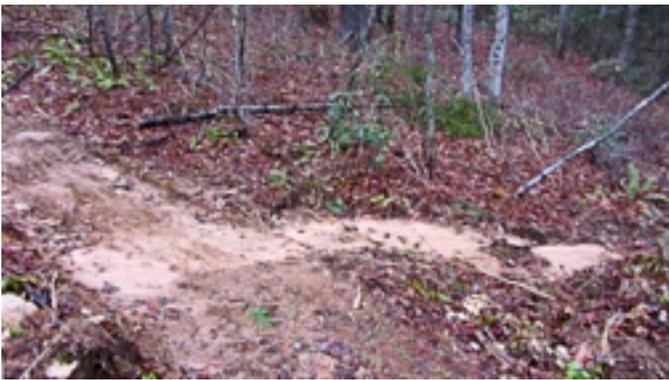
*Above: A number of strange and failing wood structures, constructed to avoid wet conditions, pose a safety hazard*

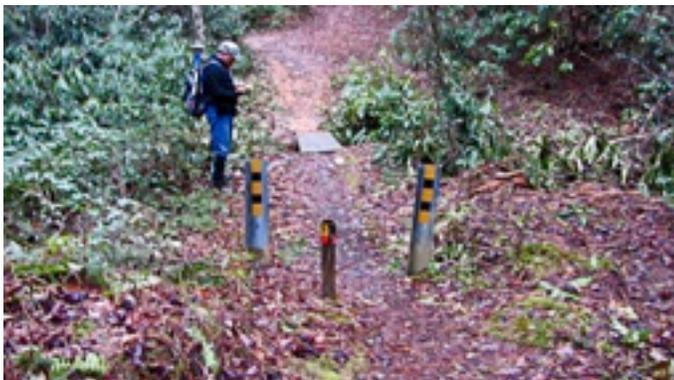
*Above and Right: Lack of rolling contour and water management leading to erosion/deposition*

*Below: Width restriction with route around due to lack of anchoring vegetation*

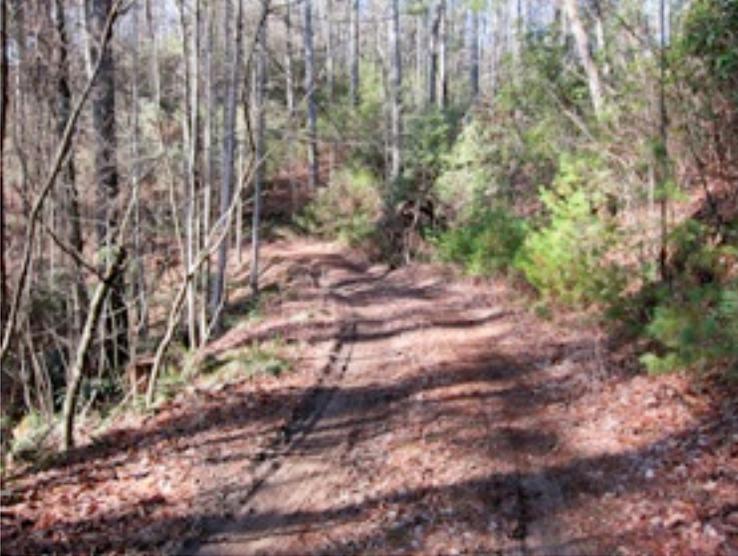
*Above Left: The Willis Knob loop is often co-located with open FSR.*

*Above Right: The ford at Pig Pen gap is functioning well.*

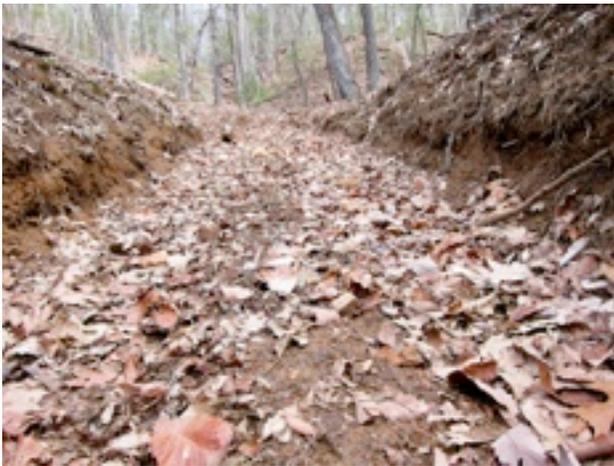
*Above Left: Soil loss is compounded by the poorly implemented maintenance.*

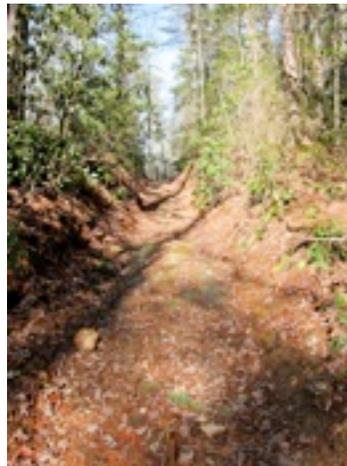
*Above Middle: The trail is commonly below grade with no way for water to leave the trail.*

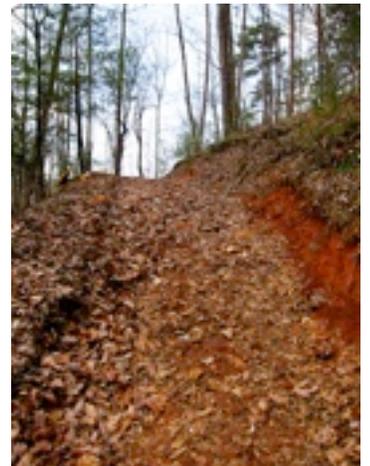
*Above Right: Steep grades and highly erodible soils are a disaster for equestrian use.*

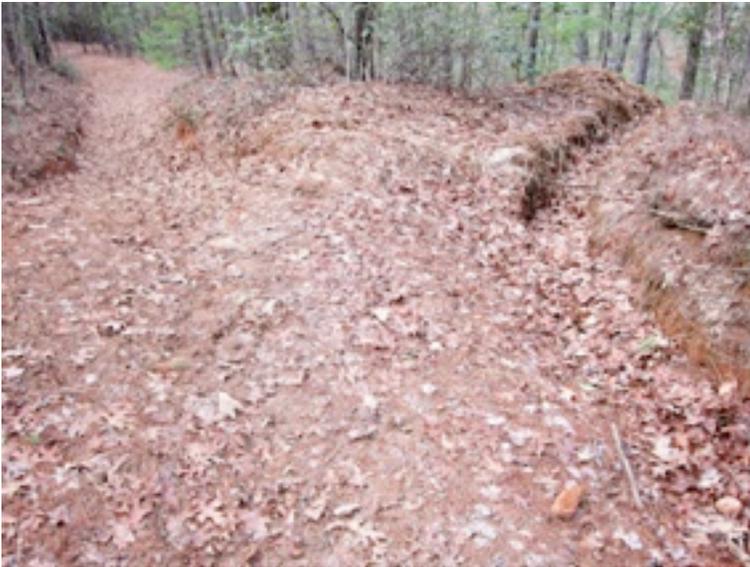
*Above Left: Water turn out, essentially constructed as a ditch, fills quickly and organic litter build up shows that the drain lacks sufficient outslope*

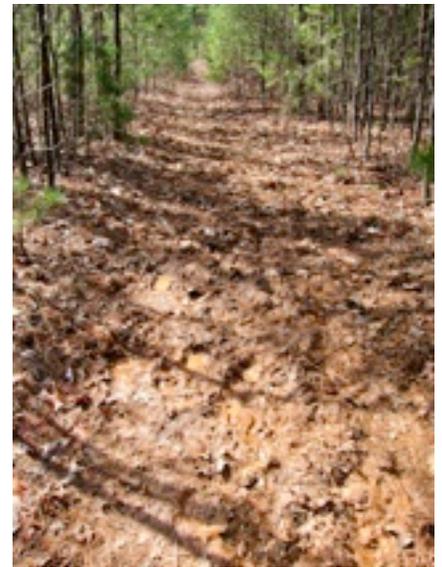
*Above Right: Trail located in flat terrain near the bottom of watershed have no possible drainage and become linear mudholes*

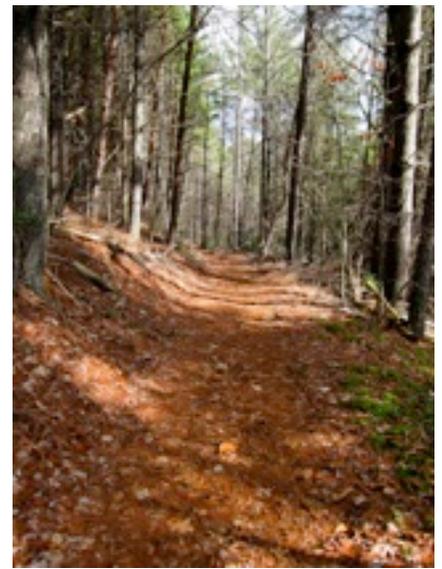
*Above Right: Trail located on old road bed that has positive cross slope in good condition*

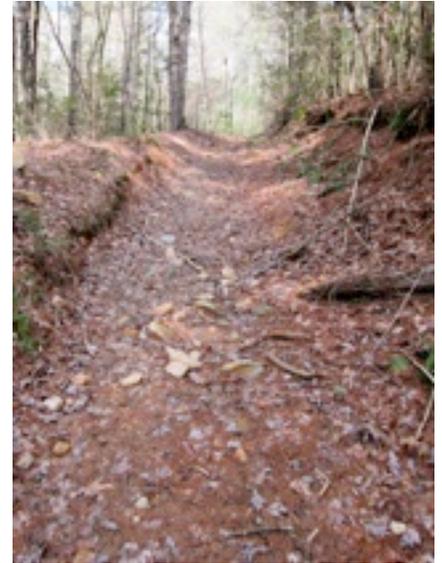
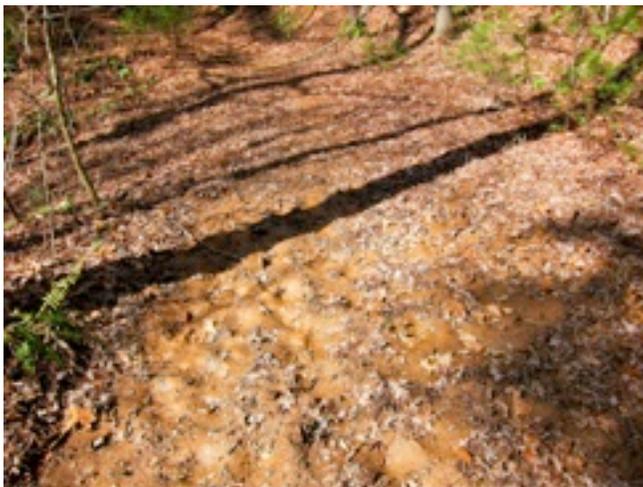
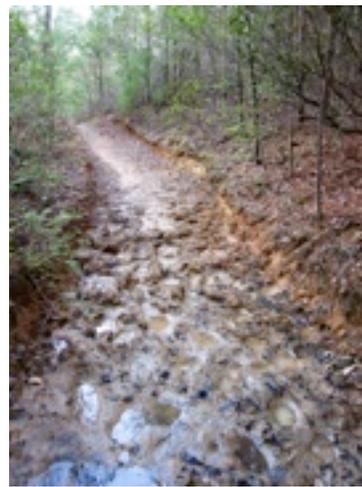
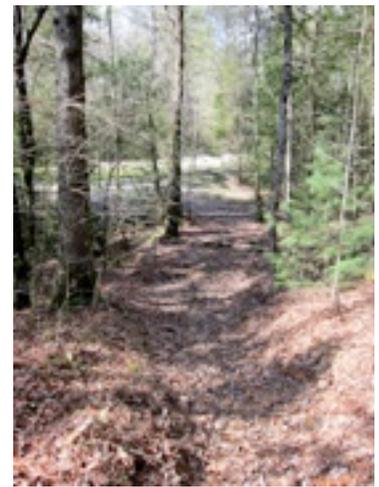
*Above and Below: Trail sections that are far too steep for equestrian use in these soil conditions become incised as tread material is loosened and lack of water management allows stormwater to entrain the sediment and carry it downslope, in some cases (below far right) directly to the river.*

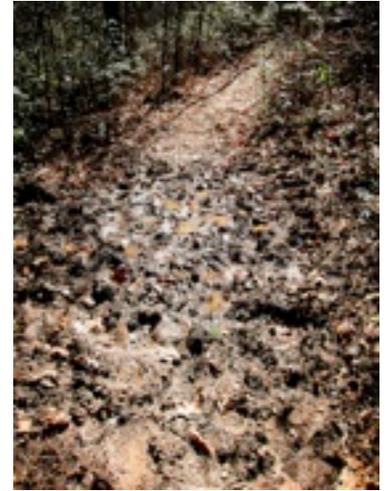
*Above Right: Lack of water management upslope results in mudhole formation at the bottom of the gradient*

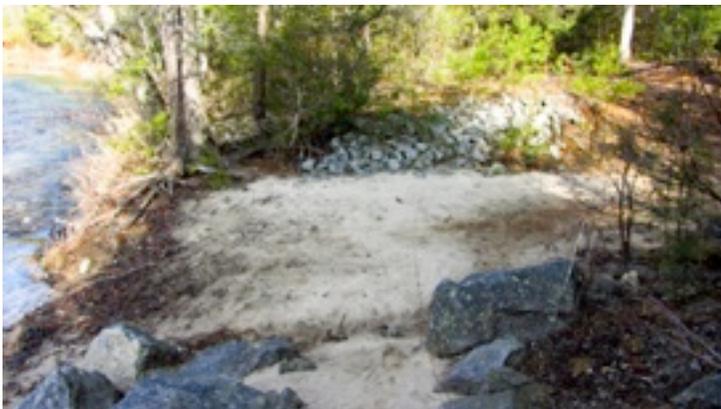
*Above: Sand deposition at River access. Rip rap and ballast function is difficult to ascertain*

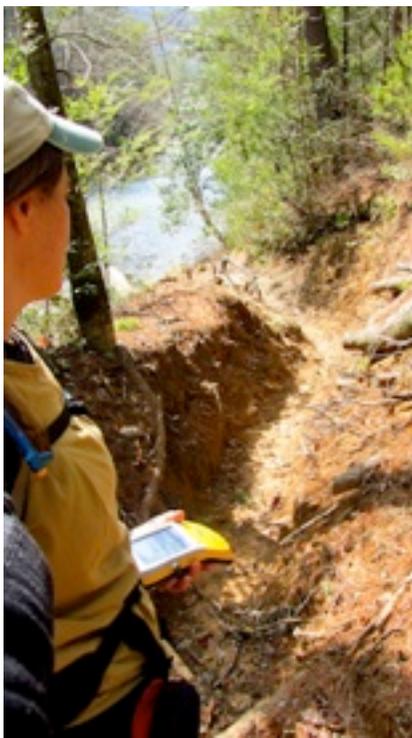
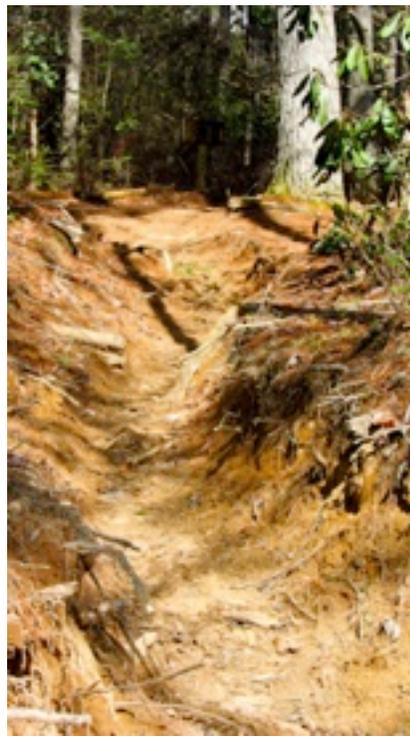
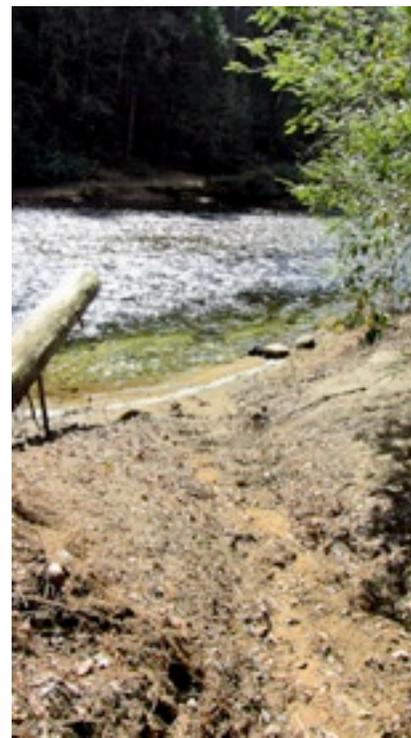
*Left: River access without sufficient water management. Incised condition demonstrates the amount of sediment that has migrated below the normal high water line*

*Below: River access without sufficient water management. Incised condition demonstrates the amount of sediment that has migrated below the normal high water line*
