# FOREST-WIDE COLLABORATIVE TRAILS ASSESSMENT

CHATTAHOOCHEE-OCONEE  
NATIONAL FOREST

CHATTOOGA RIVER RANGER DISTRICT

JANUARY- MAY, 2012  
CONTRACT #: AG-435H-S-12-0001

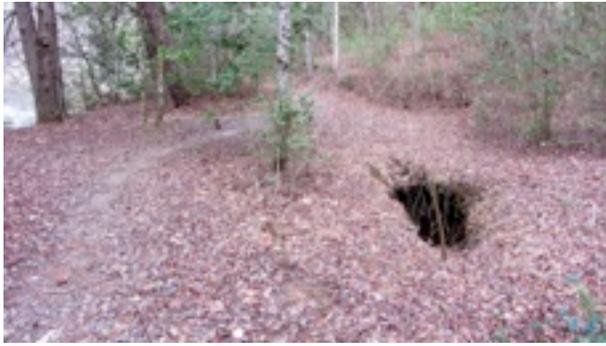
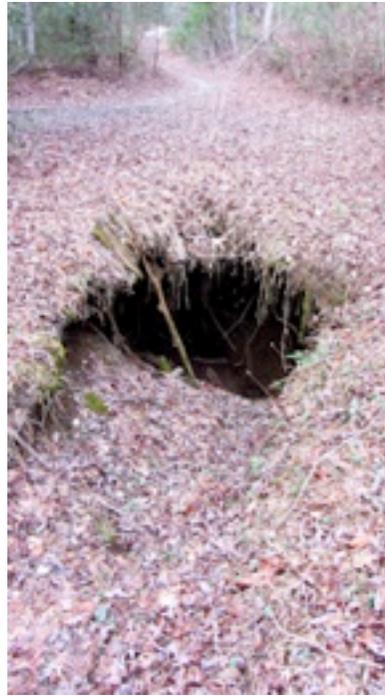
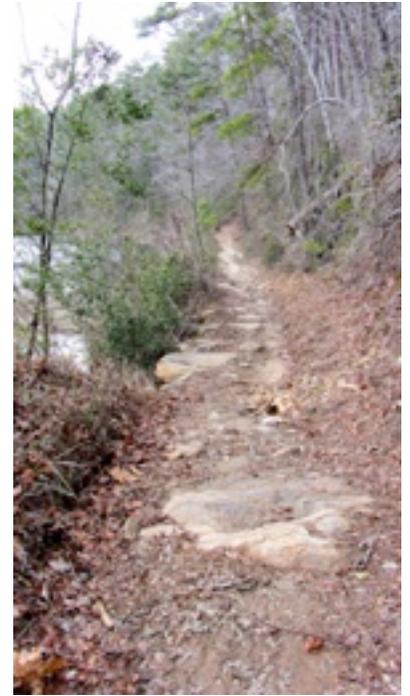
*Above and Right: Erosion issues near the Chattooga River*

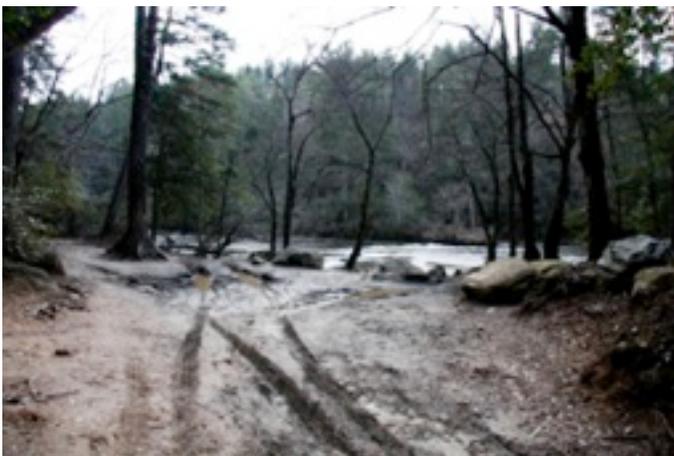
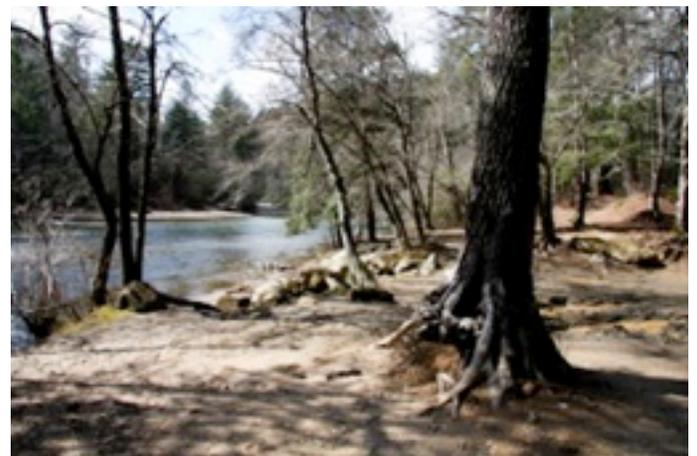
*Below: Trampling and vehicle impacts on the banks of the Chattooga River*
