Bear Creek Watershed Trails Assessment

Assessment prepared by:
Amber Shanklin, RMFI Program Director

November 14, 2012

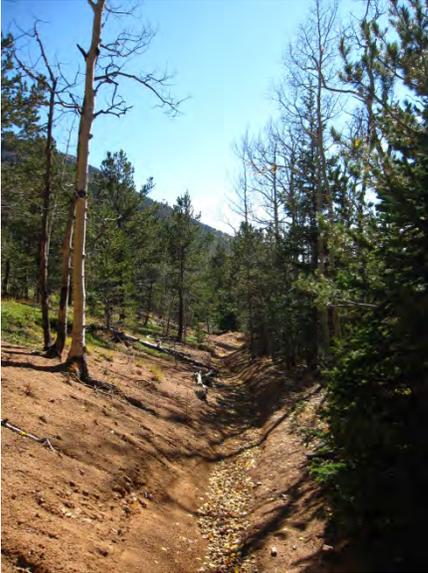
Photo 1. Erosion and downcutting along trail. Possible Solutions – construct 20 timber risers.

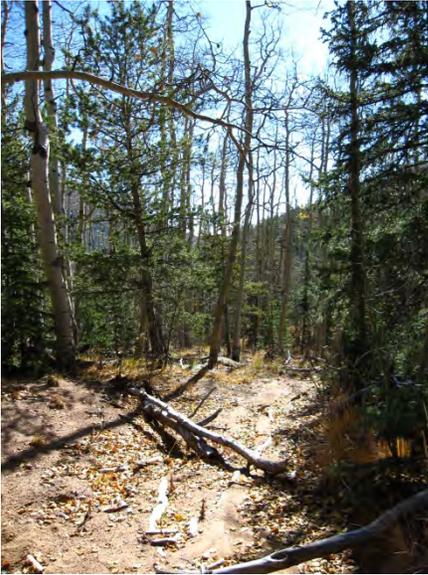
Photo 4. Sediment deposition area.
Possible Solutions – add 2 brush check dams.

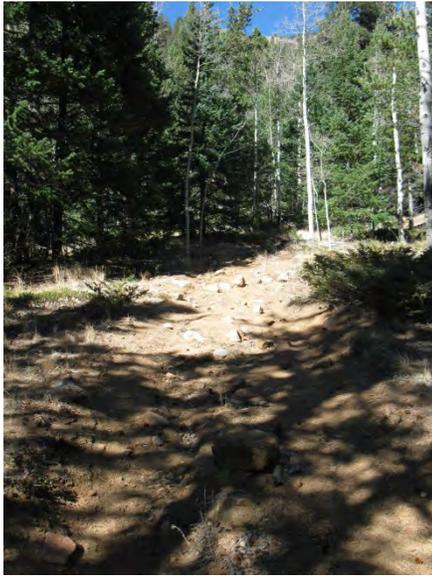
Photo 10. Loud's Cabin social trail.

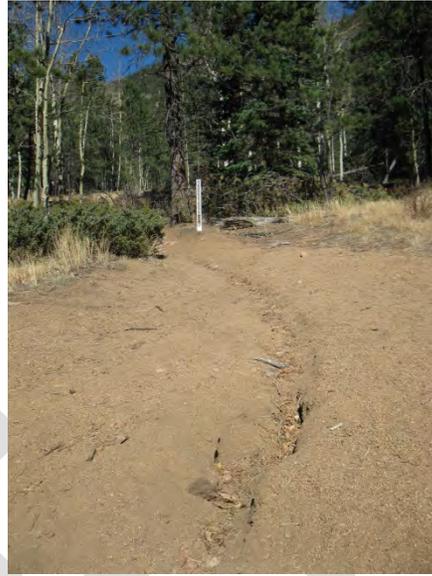
Photo 11. Loud's Cabin social trail.

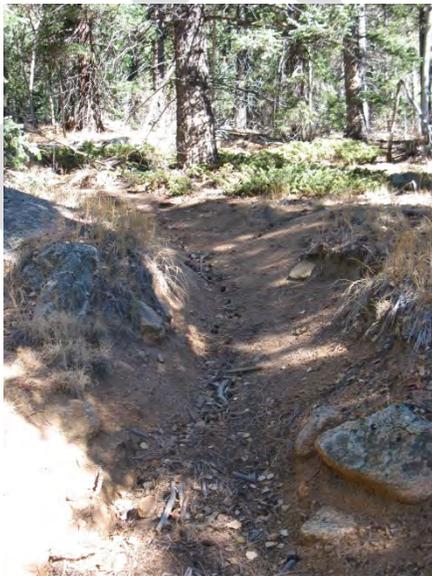
Photo 12. Loud's Cabin social trail.

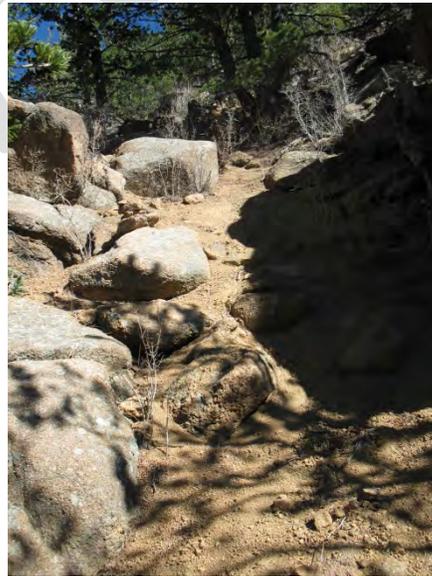
Photo 13. Loud's Cabin social trail.

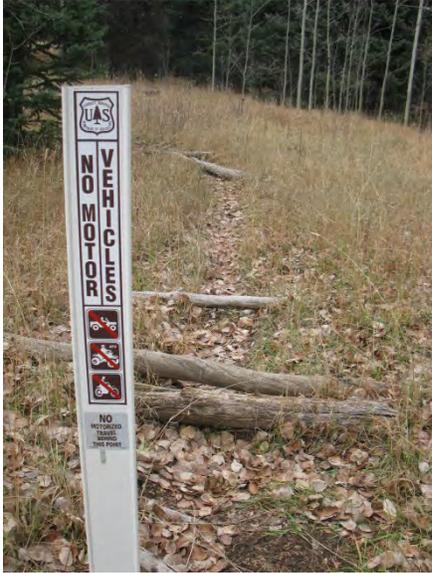
Photo 17. Jones Park social trail.

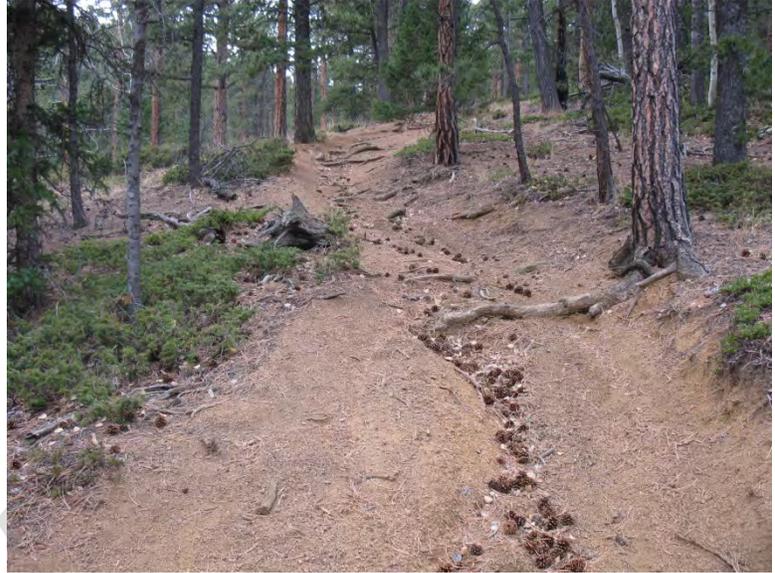
Photo 18. Jones Park social trail.

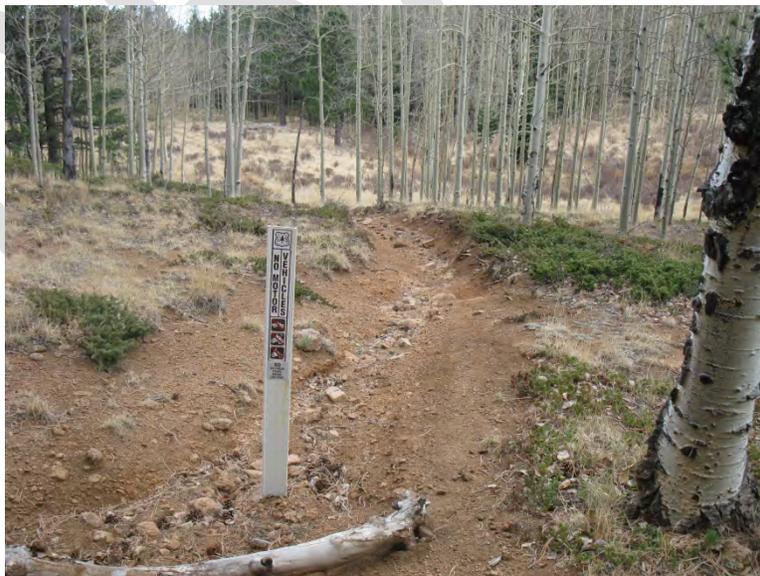
Photo 19. Jones Park social trail.

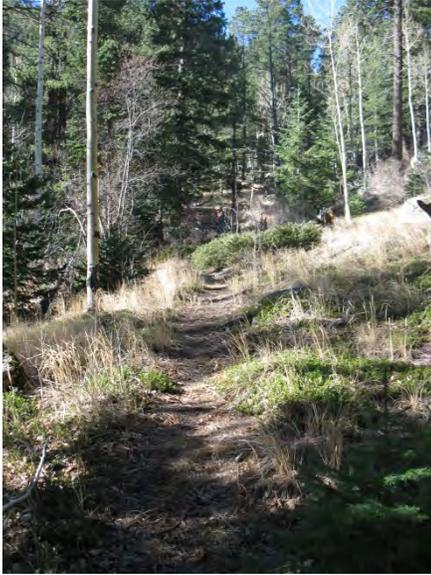
Photo 23. Tenney Crags social trail.

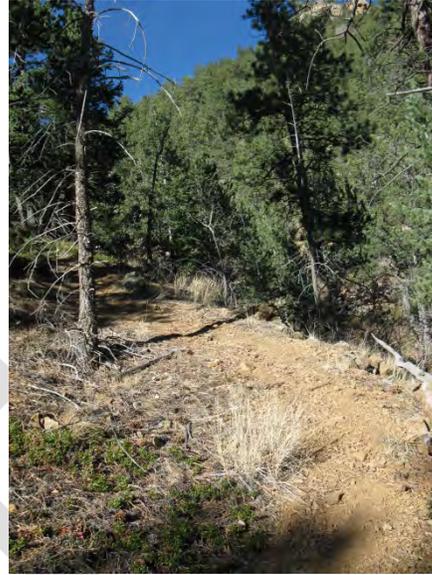
Photo 24. Tenney Crags social trail.

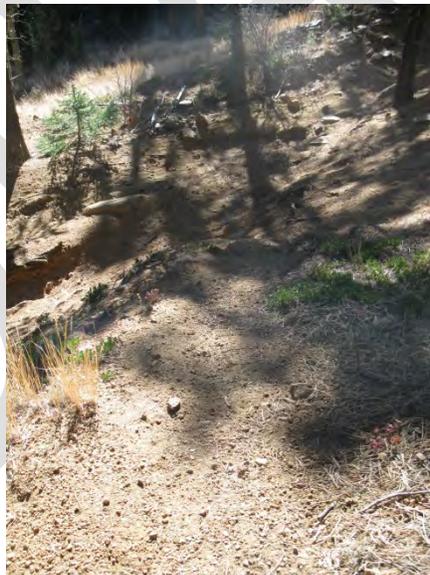
Photo 25. Tenney Crags social trail.

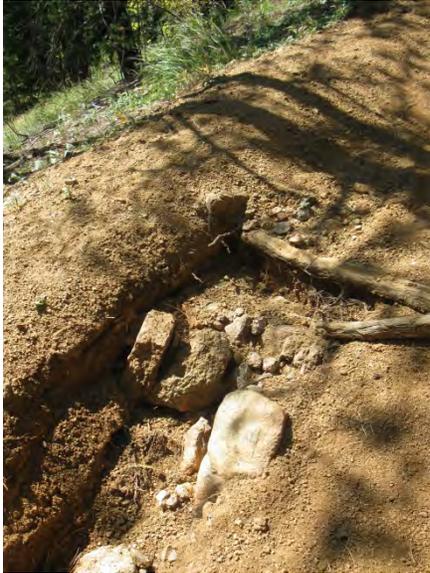
Photo 29. Headcut along trail. Possible Solutions – construction of 5 timber risers (Trail #667).

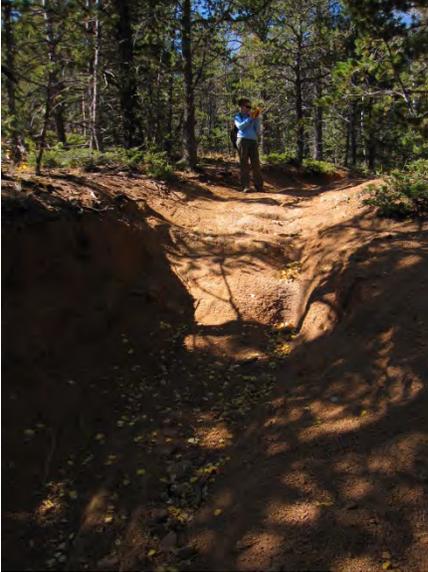
Photo 43. Extensive headcut, users have created a new trail to avoid this area (Trail #720).

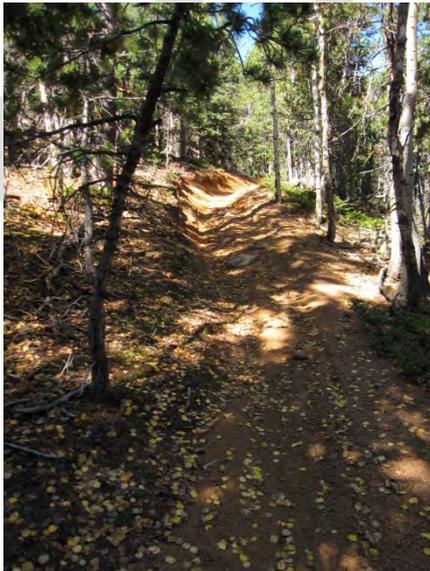
Photo 45. Erosion and downcutting in trail. Possible Solutions – construct 10 timber risers (Trail #720).
